82527

SPECIFICATION UPDATE

Release Date: July, 1996

Order Number 272876-001

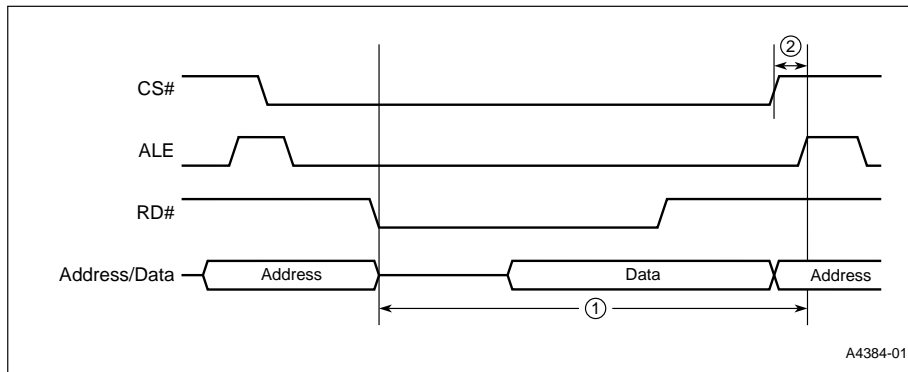
Figure 1: Bus cycle for Mode 0 or Mode 1 Operation (Read Cycle)

For mode 0 and mode 1 (Intel multiplexed modes), the control signals ALE, RD# and WR# are used to define the address and whether the cycle is a data read or write operation. The ALE signal is commonly used to latch the address information and generate a CS# signal to the 82527. The problem occurs in this configuration when the next cycle ALE is asserted before CS# of the current cycle becomes invalid. This circumstance presents a problem only when CS# is active and the next cycle's ALE occurs less than $1.5 t_{MCLK}$ after the current cycle's RD# low. ($t_{MCLK} = t_{OSC} / [(1 + DSC \text{ bit}) + DMC \text{ bit}]$ where DSC = Divide System Clock, DMC = Divide Memory Clock.

When performing “fast reads” associated with the double-read operation in mode 0 or 1, one of the following two conditions must be true:

- 1) The time from RD# low of the current cycle to the next ALE must be greater than $1.5 t_{MCLK}$, or
- 2) The CS# signal to the 82527 must be inactive before the next occurrence of an ALE, when the time from the RD# low of the current cycle to the next cycle's CS# active is less than $1.5 t_{MCLK}$.

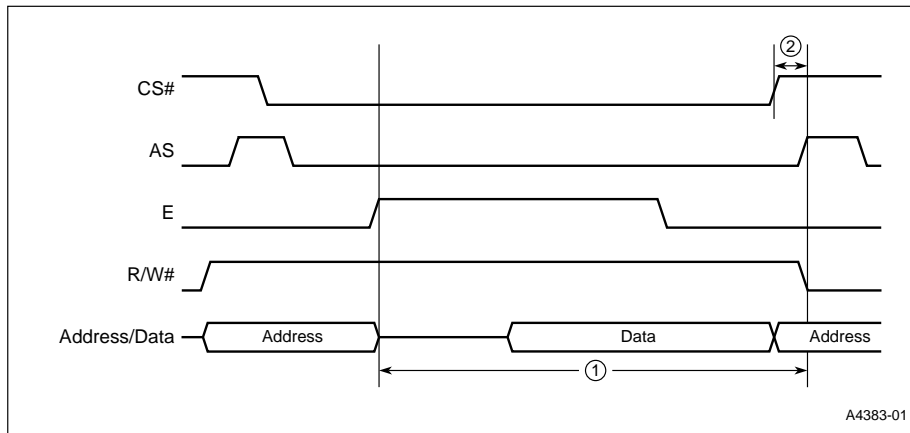
(Figure 2): Bus Cycle for Mode 2 Operation (Read Cycle)

For mode 2, the control signals AS, R/W#, and E are used to define the address, to specify whether the cycle is a data read or write operation, and to synchronize the memory accesses. The AS signal is commonly used to latch the address information and generate a CS# signal to the 82527. The problem, as outlined for modes 0 and 1, occurs when the next cycle's AS is asserted before CS# of the current cycle becomes invalid. This circumstance presents a problem only if the next cycle's AS occurs in less than $1.5 t_{MCLK}$ after the current cycle's E low while CS# is still active.

For mode 2 operation, one of the following two criteria must be true:

- 1) The time from E high of the current cycle to the next AS must be equal to or greater than $1.5 t_{MCLK}$, or
- 2) The CS# signal to the 82527 must be inactive before the next occurrence of an AS, when the time from E high of the current cycle to the next cycle CS# active is less than $1.5 t_{MCLK}$.

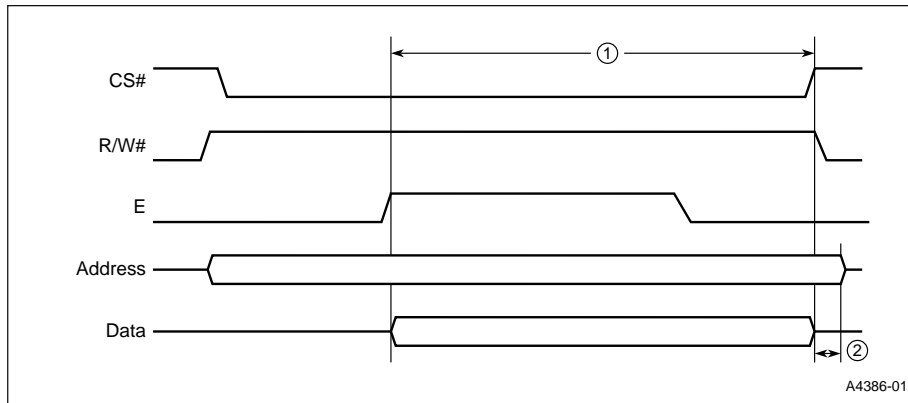
Figure 3: Bus Cycle for Mode 3 Synchronous Operation (Read Cycle)

For mode 3 synchronous operation, there is no ALE or AS signal. Mode 3 is the demultiplexed mode of the 82527. For this mode, the address information must be present through the entire cycle. However, when performing fast read operations, similar considerations as the other modes must be observed to prevent problems when performing reads from the 82527.

For mode 3 synchronous operation, one of the following two criteria must be true:

- 1) The time from E high of the current cycle to CS# invalid must be equal to or greater than $1.5 t_{MCLK}$ or
- 2) Address information must remain valid on the bus until after CS# goes inactive.

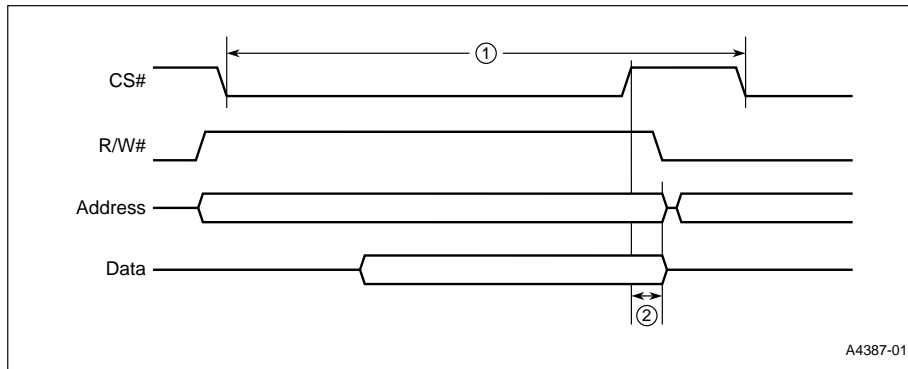
Figure 4: Bus Cycle for Mode 3 Asynchronous Operation (Read Cycle)

Mode 3 asynchronous is also a demultiplexed mode of operation on the 82527. This mode is typically used with the DSACK0# signal. When using mode 3 asynchronous with host CPUs that do not have the DSACK0# input, the following considerations must be observed to prevent problems when performing reads of the 82527.

For Mode 3 asynchronous (no DSACK0#), both of the following criteria must be true:

- 1) The time between consecutive CS# cycles must be equal to or greater than $2 t_{\text{MCLK}}$.
- 2) Address information must remain present on the bus until after CS# goes inactive.
