# **SERIES 100 FLASH MEMORY MINIATURE CARD SPECIFICATION UPDATE**

Release Date: February 1997

Order Number 297717-003

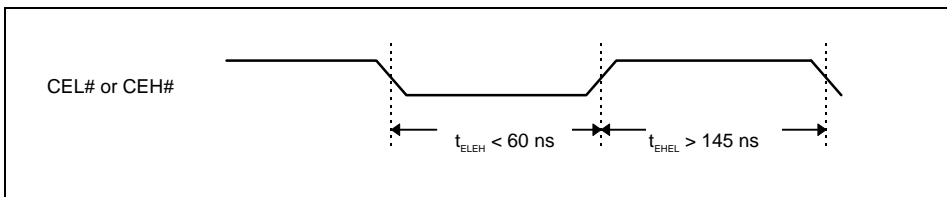
**CE# Glitch**

**PROBLEM:** If certain sequences of control signals are repetitiously applied, and if a read operation is performed immediately after, then that read operation could return data in which bits that should be zeros are returned as ones.

1. Either or both CE# inputs is asserted for less than 60 ns. This is depicted in *CE# Glitch* illustration, below.
2. On a 4-Mbyte card, the A<sub>20</sub> input is not stable prior to the assertion of either or both CE# inputs (the A<sub>20</sub> input is not connected on the 2-Mbyte card). Refer to Figure *A<sub>20</sub> Lags CE#*, below.

If either of these sequences of control inputs are repetitiously applied, incorrect data can be returned in subsequent reads.

A single application of the above sequences does not cause an errant read. The problem has only been observed after several hundred of either of the above sequences, and even then it is very intermittent.

**WORKAROUND:** If it is suspected that the Miniature Card socket controller is causing glitches, there are three ways that the card can be returned to the state where it is reliably reading data.

1. Perform a single word write operation, even one where the data written is all ones. A word write operation consists of a setup command—40h to recover from CEL#, 4000h for CEH# or 4040 for CEL# and CEH—followed by the data. If the data written is all ones, then the contents of the card will not be changed. Any zeros written to the array will be written correctly.
2. Put the card in standby mode, deassert CE#, for more than 50 ms.
3. Assert CEL# or CEH#, drive them low, for at least 13  $\mu$ s.

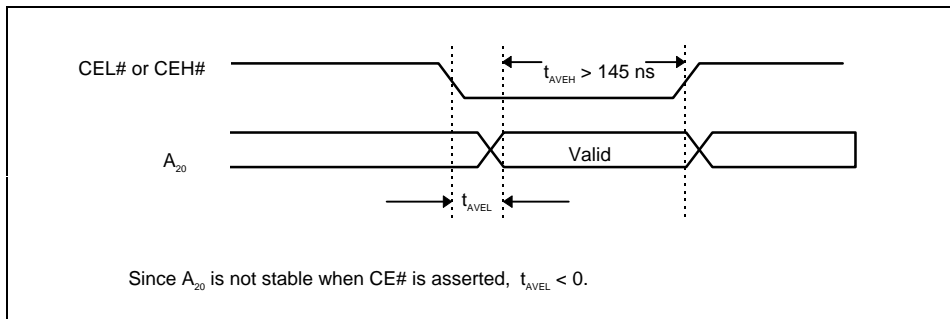
**A<sub>20</sub> Lags CE#**

Finally, this problem was observed very infrequently on a few systems when using 4-Mbyte cards. In those systems, the controller applied A<sub>20</sub> about 30 ns after CE# was asserted. This caused one chip-pair to experience a glitch just prior to the second chip-pair being read.

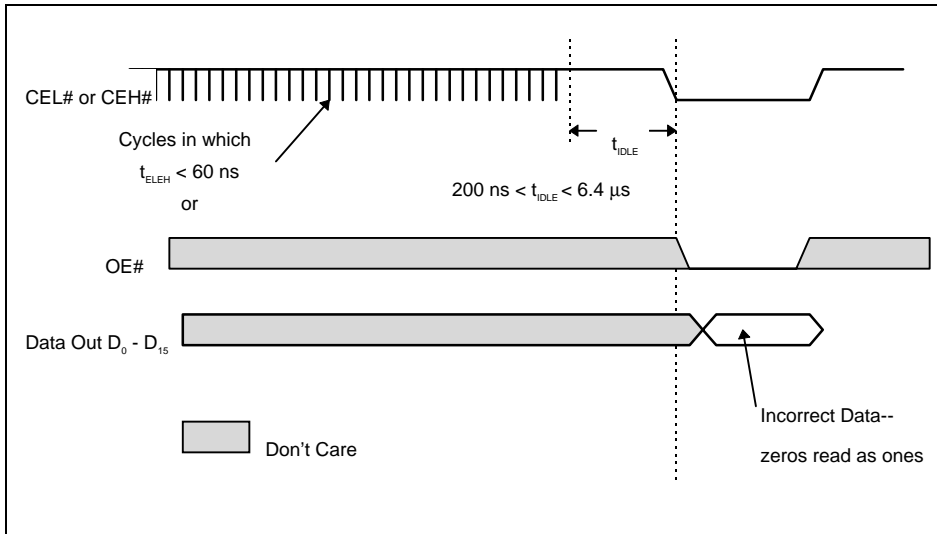
**A Series of CE# Glitches**

The most likely operation that could cause this condition is erasing one set of chip-pairs in a 4-Mbyte card, and polling the chips continuously until they are finished. While the chip pair is erasing, hundreds or thousands of read operations are performed on that chip pair. If the card controller hardware applies a glitch to the other chip pair—the pair that is not being erased—an incorrect read could result when the other chip pair is read. Refer to *A Series of CE# Glitches* for an illustration of this problem.

**IMPLICATION:** Once an offending series of glitches has been applied, data read from the card is suspect. This is a read issue only. There are no issues with programming or erasing.
