# **28F008SA/SA-L SPECIFICATION UPDATE**

Release Date: February 1997

Order Number 297183-007

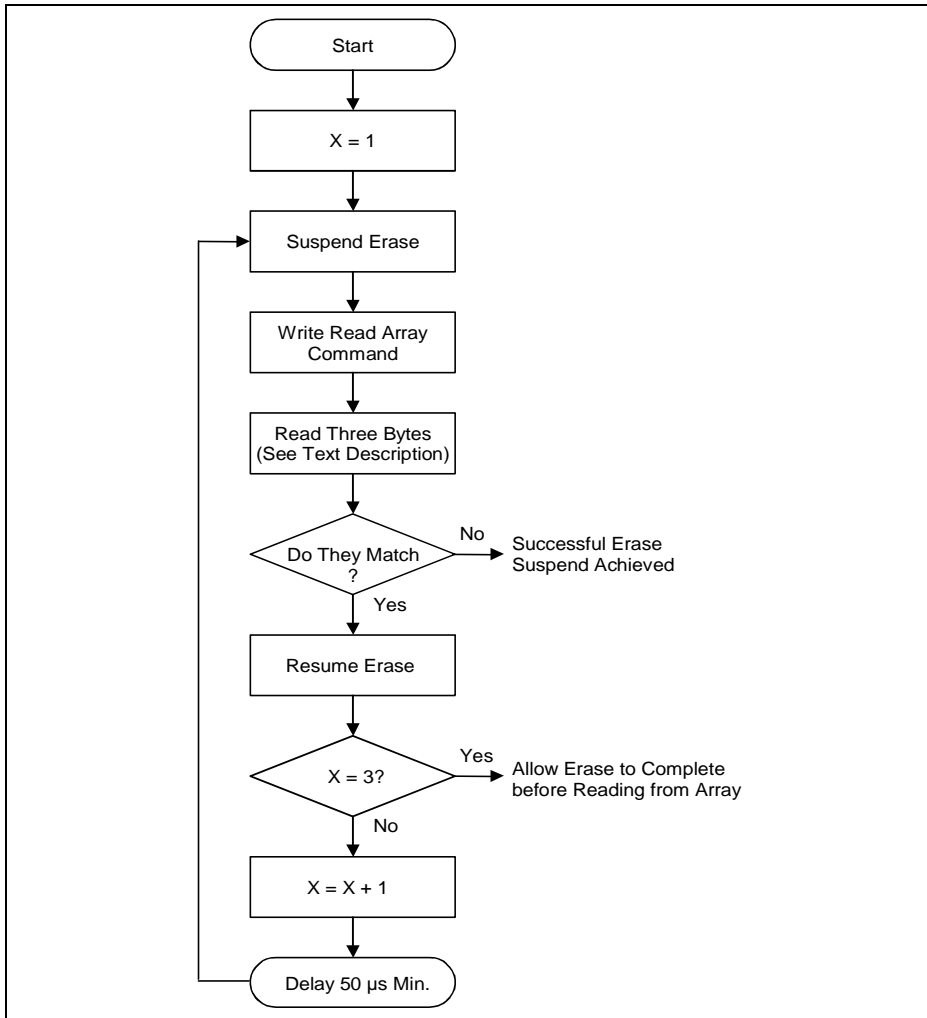
**Erratum Identification/Resolution**

Affected components in erase suspend to array mode will occasionally, after the Read Array command is written to them, output invalid array data due to an error in the State Machine circuitry. The device in this instance enters an invalid erase suspend mode and outputs invalid data bytes. Statistically, this has occurred approximately once every 500 erase suspend attempts.

It is important to note that even if the device is in an invalid erase suspend mode, writing the Read Status Register command will still enable transition to erase suspend to status mode and subsequent reading of Status Register data correctly. This erratum only affects array read attempts while erase is suspended.

**WORKAROUND:** The following procedure will reliably and consistently alert system software that the 28F008SA/28F008SA-L has entered the invalid erase suspend mode. In almost all cases, this solution will also enable successful erase suspend. Reference the *Erratum Identification/Resolution* figure for a graphic description of the steps outlined below:

1. Write the Erase Suspend command to the device.
2. Poll the Status Register to determine when Erase Suspend has been achieved.
3. Write the Read Array Command to the device.

4. Read three bytes of data from a block **other than that being erased**.
  - At least one of the three bytes should have a **known different value** compared to the other two.

- Hold device addresses  $A_0$ – $A_1$  and  $A_{10}$ – $A_{19}$  constant through the three reads.
  - Toggle addresses  $A_2$ – $A_9$  to access different byte locations for the three reads.

5. **If the values at these three locations DO NOT match (as expected), you have successfully entered erase suspend to array mode.**
6. If the values at these three locations match, you have not successfully entered erase suspend to array mode on this attempt. Instead, you have entered the invalid erase suspend mode.

- Write the Erase Resume command to the device.
7. Read the device outputs (poll the Status Register) to determine when erase resumption has been achieved.

8. Wait 50  $\mu$ s.
9. Re-execute the erase suspend attempt up to two more times (or three times total).
10. If not successful after three attempts, issue the Erase Resume command, and allow the internal erase algorithm to complete before attempting to read from the array.

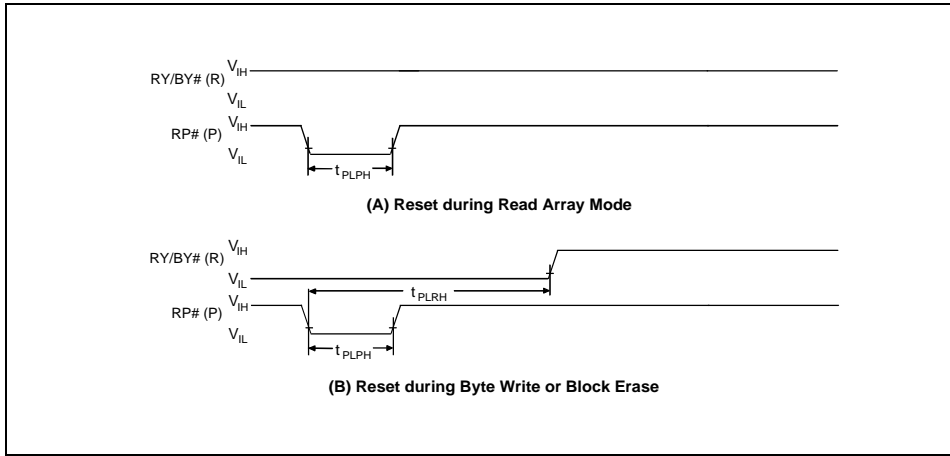
**AC Waveform for Reset Operation**

**PROBLEM:** Two reset specifications have been added to the 28F008SA. Please add this information the existing datasheet. The next datasheet revision will incorporate these reset specifications.

Sym	Parameter	Notes	V <sub>CC</sub> = 5V		Unit
			Min	Max	
$t_{PLPH}$	RP# Pulse Low Time (If RP# is tied to V <sub>CC</sub> , this specification is not applicable)		100		ns
$t_{PLRH}$	RP# Low to Reset during Block Erase or Byte Write (If RP# is tied to V <sub>CC</sub> , this specification is not applicable)	2,3		12	μs

In read modes, RP#-low deselects the memory, places output drivers in a high-impedance state and turns off all internal circuits. RP# must be held low for a minimum of 100 ns. Time  $t_{PHQV}$  is required after return from power-down until initial memory access outputs are valid. After this wake-up interval, normal operation is restored. The CUI is reset to read array mode and status register is set to 80H.

During block erase or byte write, RP#-low will abort the operation. RY/BY# remains low until the reset operation is complete. Memory contents being altered are no longer valid; the data may be partially erased or written.
