28F016SA/DD28F032SA SPECIFICATION UPDATE

Release Date: July 1996

Order Number: 297408-006

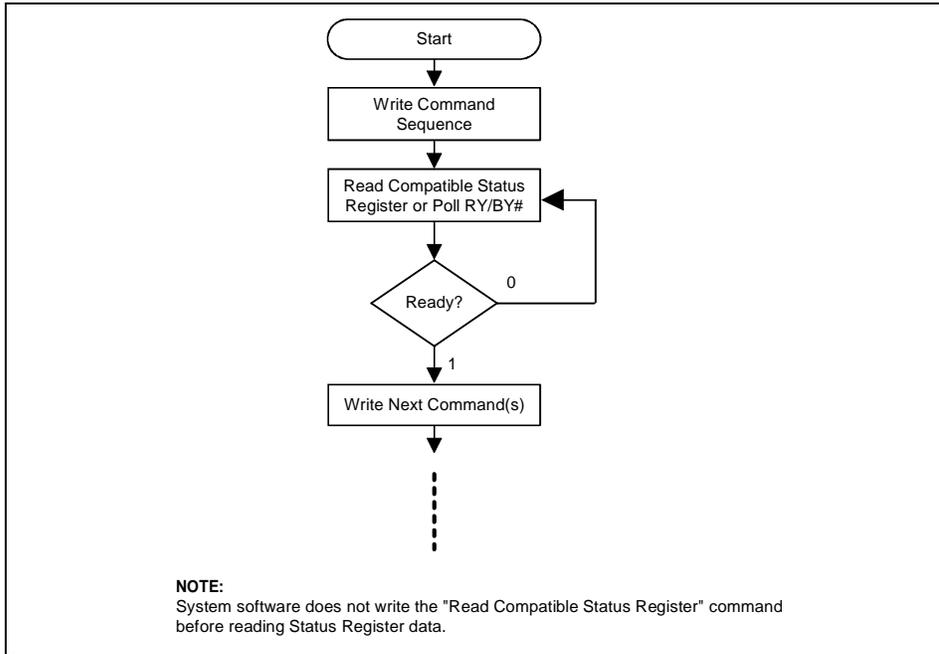
Example System Software Flowchart That Will Not Encounter “Completion with Command Error or Invalid Device Operation” Condition

PROBLEM: Systems in which software, after initiating device automation via a queueable command sequence, writes another command(s) to the device before automation completes may initiate unintended device operations.

In addition, the unintended device operation can initiate inadvertent program or erase attempts to Block 0 in systems which use the Sequential/Single Load to Page Buffer Commands (74H and E0H, respectively). Data alteration can only occur if Block 0 is not locked and V_{PP} equals V_{PPH} .

Option 1: Polling for “Ready” Indication

Systems that poll the RY/BY# pin or WSMS bit (CSR.7) for “Ready” indication before writing another command to the device will not encounter this errata. This is illustrated in the *Example System Software Flowchart, etc.* figure below, and in flowcharts 11-1 and 11-2 (without erase suspend) of the *16-Mbit Flash Product Family User’s Manual*.

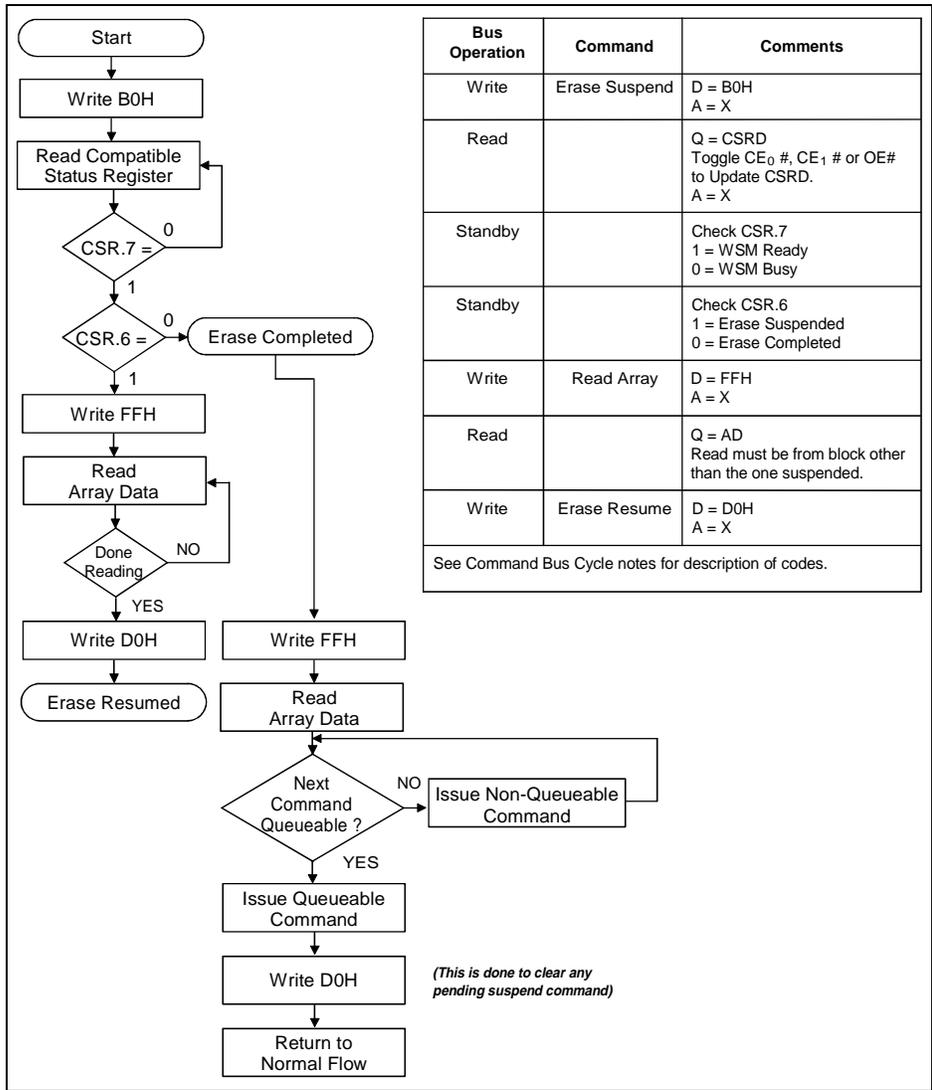
Erase Suspend to Read Array with Compatible Status Register

PROBLEM: If an Erase Suspend command is issued after completion of the Erase Cycle (either Single Block Erase or Erase All Unlocked Blocks) or too late in the Erase cycle, such that the Erase completes before the Status Register Suspend bit is set, the device will queue this unserviced Suspend request.

- A. If another Erase command is issued at some time later, the device then assumes that the pending Suspend request is still valid and will automatically Suspend the current Erase.
- B. If any queueable command is in the command queue waiting for execution while another queueable command is in progress, the Write State Machine will suspend its operation after completing the current command. (Refer to the *16-Mbit Flash Product Family User's Manual*, Section 11-1 for the queueable command list.)

WORKAROUND: Intel developed a software workaround to this errata, by inserting a second Resume command (DOH) following any queueable command in the Erase Suspend flowcharts. Both Erase Suspend to Read Array flowcharts (*16-Mbit Flash Product Family User's Manual*, Figures 11-3 and 11-12) detailing this workaround are attached to this errata (see the *Erase Suspend to Read Array with Compatible Status Register* and *Erase Suspend to Read Array with Extended Status Register* figures, which follow). This erratum results in the *Erase Suspend with Compatible Status Register* flowchart being incompatible with the 28F008SA *Erase Suspend* flowchart.

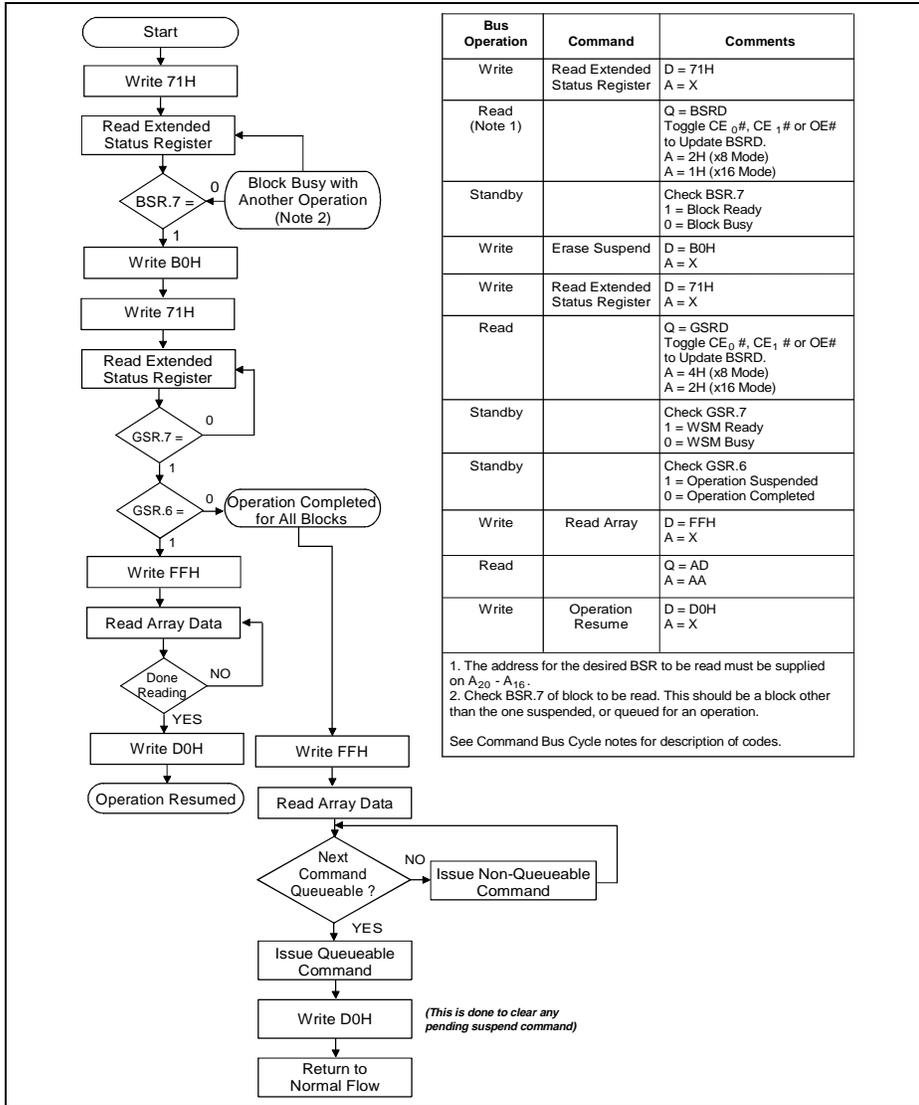
Erase Suspend to Read Array with Extended Status Register

1. The address for the desired BSR to be read must be supplied on A₂₀ - A₁₆.
 2. Check BSR.7 of block to be read. This should be a block other than the one suspended, or queued for an operation.
 See Command Bus Cycle notes for description of codes.
