28F016XS

SPECIFICATION UPDATE

Release Date: November 1996

Order Number 297553-007

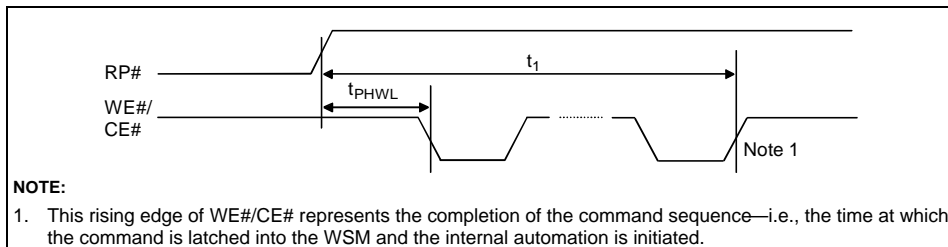
Operation Delay after Power-Up and Exit from Power-Down or Reset

PROBLEM: With the program/erase voltage (V_{PP}) at 5V, the internal V_{PP} detector may not stabilize for up to 5 μ s (illustrated by t_1 , in the figure below) after RP# transitions inactive (high). This causes an invalid V_{PP} Level bit indication when reading the Block Status Registers and termination of program, erase or lock block operations due to invalid device V_{PP} error detection. Affected operations include Word Write (40H/10H), Block Erase (20H) and Lock Block (77H).

Note that this erratum only affects systems operating at 5V V_{PP} .

IMPLICATION: The 5V V_{PP} power-up/reset time delay to first program or erase operation is impacted.

WORKAROUND: Upon reset, power-up, or wake-up from software sleep or hardware deep power-down, allow 5 μ s (t_1) before initiating a Write/Erase command (as listed earlier) or reading the V_{PP} Level bit of the Block Status Registers (BSR.1). The figure, *Operation Delay after Power-Up and Exit from Power-Down or Reset*, illustrates this timing requirement (t_1) in more detail.

Operations are initiated by the device on the rising (trailing) edge of the last WE#/CE# pulse in the command sequence. For example, when performing WE#-Controlled Writes, two-cycle command operations such as word/byte write or erase are initiated on the rising edge of the WE# pulse corresponding to the Address/Data or Confirm command. Similarly, when performing CE#-Controlled Writes, operations are initiated on the last rising CE# edge of the command sequence.
