# **28F016SV**

## **SPECIFICATION UPDATE**

Release Date: February 1997

Order Number 297554-009

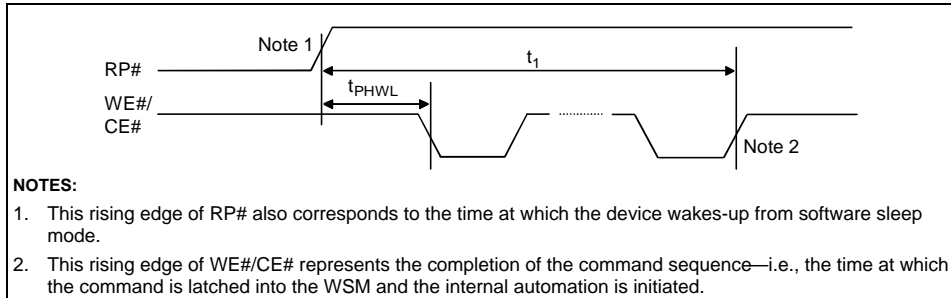
### Queueable Operation Delay after Power-Up and Exit from Sleep, Power-Down, or Reset

**PROBLEM:** With the program/erase voltage ( $V_{PP}$ ) at 5V, the internal  $V_{PP}$  detector may not stabilize for up to 5  $\mu$ s (illustrated by  $t_1$  in the figure, *Queueable Operation Delay after Power-Up and Exit from Sleep, Power-Down, or Reset*, which follows) after RP# transitions inactive (high). This causes an invalid  $V_{PP}$  Level bit indication when reading the Block Status Registers and termination of program, erase or lock block operations due to invalid device  $V_{PP}$  error detection. Affected operations include Word/Byte Write (40H/10H), Single Block Erase (20H), Erase All Unlocked Blocks (A7H), Two-Byte Write (FBH), Page Buffer Write to Flash (0CH), and Lock Block (77H).

Operations are initiated by the device on the rising (trailing) edge of the last WE#/CE# pulse in the command sequence. For example, when performing WE#-Controlled Writes, two-cycle command operations such as word/byte write or erase are initiated on the rising edge of the WE# pulse corresponding to the Address/Data or Confirm command.

(Three-cycle command operations are initiated on the rising edge of the third WE# pulse.) Similarly, when performing CE#-Controlled Writes, operations are initiated on the last rising CE# edge of the command sequence.
