28F008SC

SPECIFICATION UPDATE

Release Date: February 1997

Order Number 297729-004

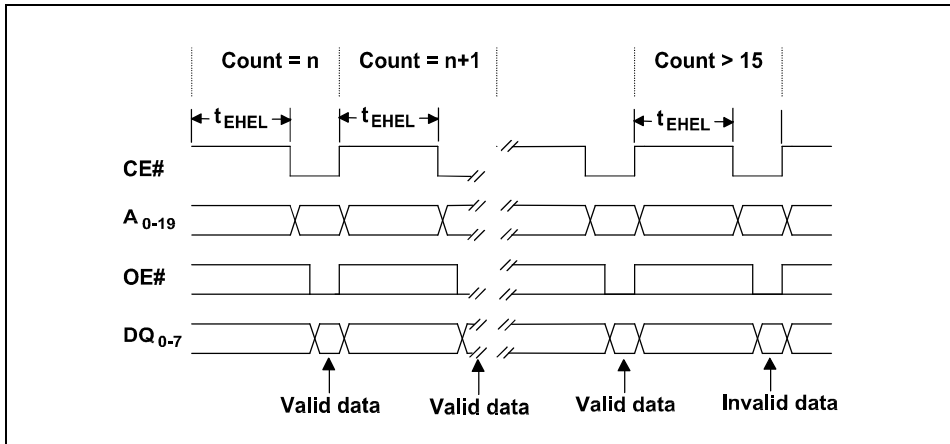
PROBLEM: The component may return invalid data if more than fifteen successive read operations are performed where CE# is deasserted between each read and the corresponding CE#-high pulse width resides within the specifications outlined in the table below.

Successive Read Operations That Have Long CE#-High Pulse Widths

IMPLICATION: This erratum only affects 2.7V and 3.3V V_{CC} read operations. For these low voltage systems, the usage of the flash memory will affect the exposure to this anomaly. Systems that execute code directly out of the flash memory will be less susceptible to the problem because the flash memory is continuously being accessed for information at a fast rate. In which case, CE# may be driven active while only the address changes to retrieve subsequent data from the component (see below figure, *Access The Flash With CE# Active*) or the CE#-high time will be very short (less than 100 ns) to maximize read throughput. If it is determined that your applications accesses the flash memory in this manner, you will not have problem with this erratum.

1. Read more than four good reads for A-1 and A-3 stepping and only one read for A-6 stepping during each assertion of CE# as illustrated in the figure above.

- 2. Issue a Byte Write command and program FFh to any location before executing a read operation. Programming FFh will not alter stored data, but it will give the component sufficient time to prepare for the read operation.

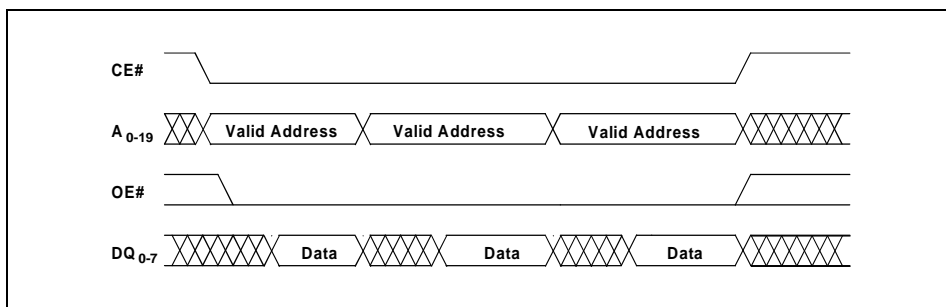
Access The Flash With CE# Active

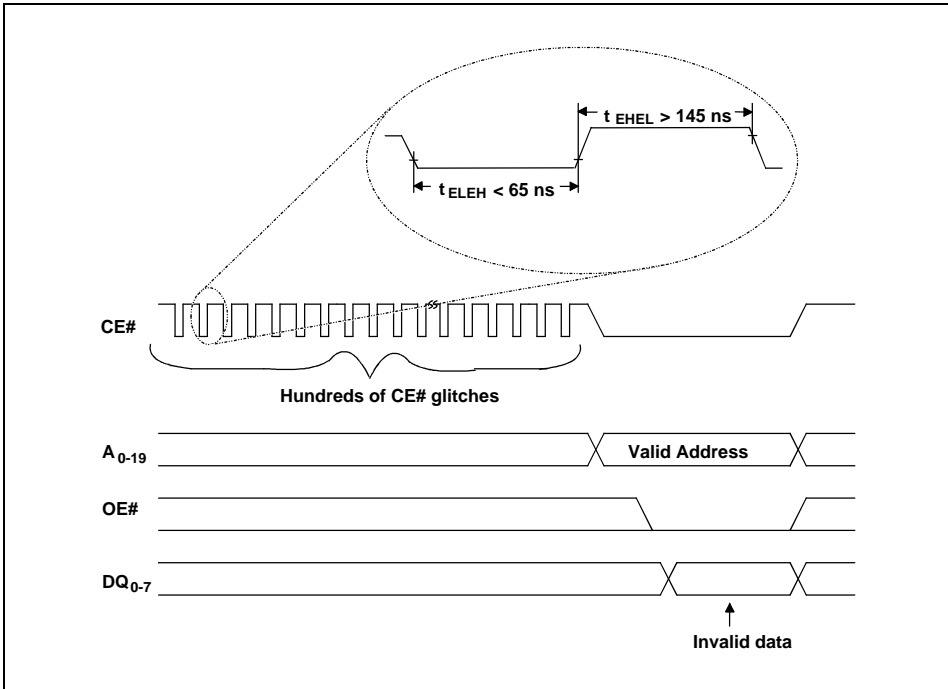
PROBLEM: A noisy CE# control signal may cause an invalid read. This erroneous read only occurs after the device has received over one hundred consecutive short CE# glitches ($t_{EHL} < 65\text{ ns}$) with intermittent CE#-high time (t_{EHL}) greater than 145 ns (see the figure below, *A Long Series of CE# Glitches May Induce an Invalid Read*).

A Long Series of CE# Glitches May Induce an Invalid Read

After valid data is read, the device must receive another series of CE# glitches (over one hundred) to induce an invalid read. CE# glitches sequences, other than defined in the figure above, have no adverse effect.

IMPLICATION: This erratum may affect read operations in systems that have a lot of noise on the flash memory's CE# input. If CE# is generated asynchronously from the upper address lines, noise on CE# can sometimes occur when upper address lines transition from one state to another. However, applications that access flash memory sequentially will have stable upper address lines and will therefore produce fewer CE# glitches. Systems that execute code from flash memory or download code from flash memory into DRAM will usually access the device sequentially; therefore, they will be less susceptible to this erratum.

Add system logic to prevent CE# glitches such as latched CE# control logic or pullup/pulldown resistors to the address bus.

If the device receives over one hundred consecutive CE# glitches, issue a Byte Write command and program FFh to any location before executing a read operation. Programming FFh will not alter stored data, but it will give the component sufficient time to prepare for the read operation.

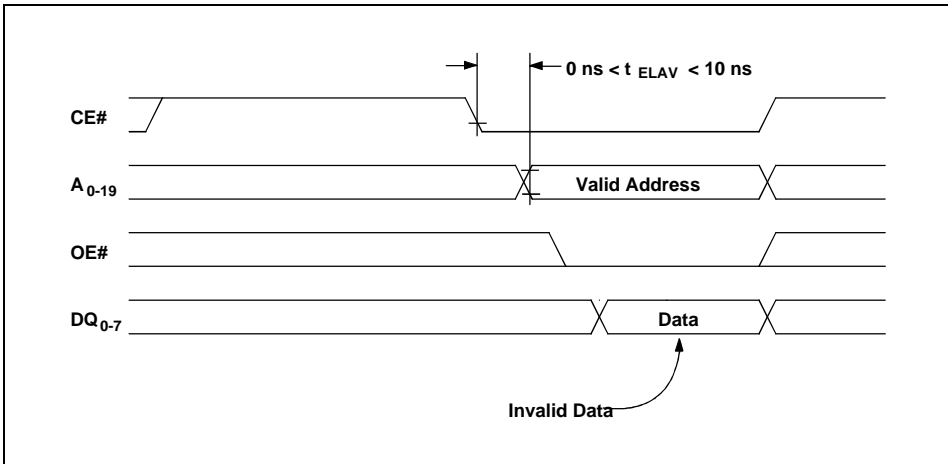
PROBLEM: If an address line transition occurs 0 ns to 10 ns after CE# goes low, the component may return invalid data. Note, this only effects 5V V_{CC} read operations.

Switching Address Lines after CE#-Low may Cause an Invalid Read

If CE# is held low for longer than 10 ns, the device will output valid data t_{AVQV} after an address transition occurs.

IMPLICATION: This erratum affects 5V systems where address lines stabilize sometime after CE# goes active. So, carefully analyze the address bus valid to CE#-low relationship.

Delay the assertion of CE# until all address lines stabilize. This can be accomplished by adding additional logic or capacitance to delay CE# (maximum CE# slew rate = 10 ns).

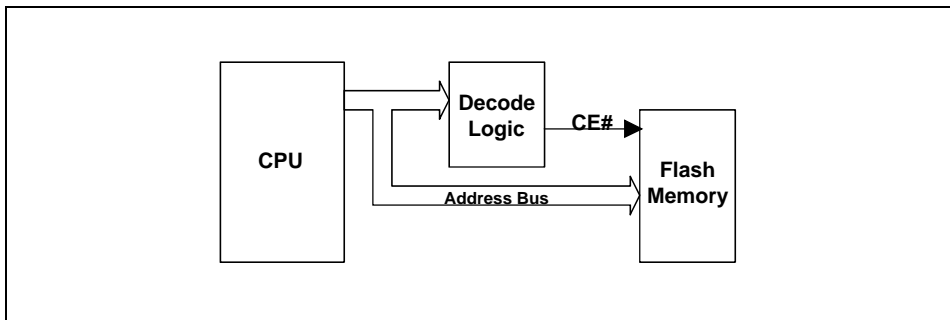
Systems that decode CE# from the CPU's upper address lines will typically provide a valid address prior to asserting CE# (see the figure below, *Typical CE# Decoding Scheme That Is Less Susceptible to this Erratum*). Additionally, applications that access data sequentially will have stable upper address lines. Therefore, CE# will typically remain low when the lower address lines transition to retrieve new data. Systems that execute code from flash memory or download code from flash memory into DRAM will usually access the device sequentially and will therefore be less susceptible to this erratum.

Typical CE# Decoding Scheme That Is Less Susceptible to This Erratum

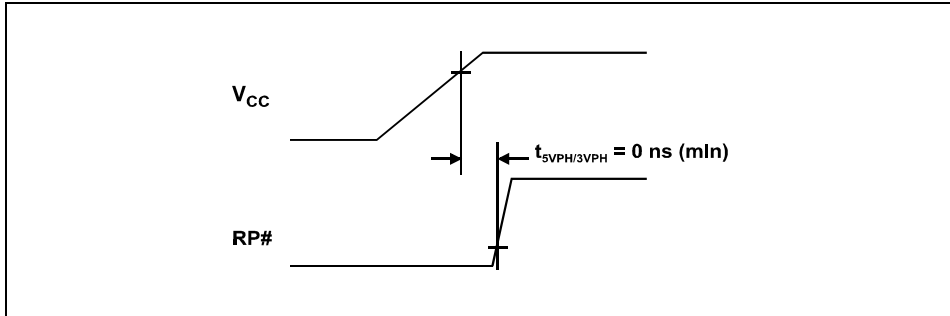
PROBLEM: RP# must be held low while V_{CC} ramps to a valid level during power transitions.

Hold RP# Active While V_{CC} Ramps

Holding RP# low during power-up blocks spurious write initiated by system control logic which may occur as the system voltage transitions to a stable level. Intel recommends the usage of RP# for CPU/memory reset synchronization, write protection, and deep power-down mode.

IMPLICATION: This erratum only affects power-up operations. Systems that tie the flash memory's RP# input to the system RESET# signal typically will not have a problem with erratum because the RESET# signal is usually held low during the power-up sequence to properly synchronize the CPU. However, systems that ties RP# directly to V_{CC} will be more exposed to this problem. So, carefully analyze RP# during the power-up condition to fully understand its behavior.

Use a simple RC delay network to hold RP# low during the power-up condition or tie the RP# input to the system RESET# signal. This workaround will eliminate your exposure to this problem and also provide your design with addition power-up security.
