28F008S5

SPECIFICATION UPDATE

Release Date: February 1997

Order Number: 297796-003

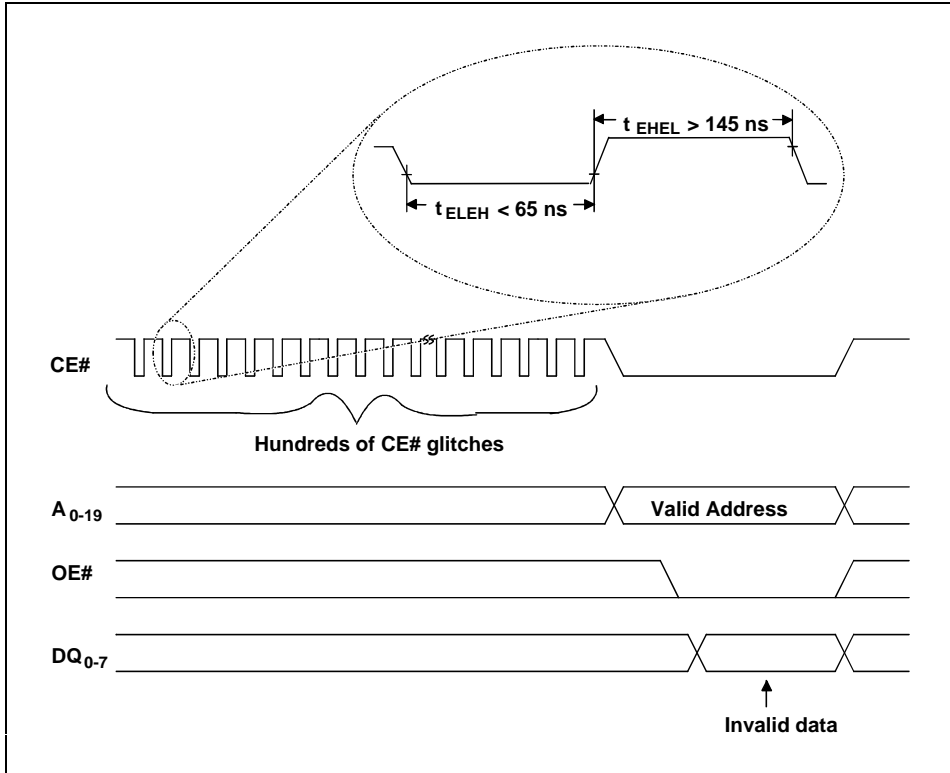
A Long Series of CE# Glitches May Induce an Invalid Read

PROBLEM: A noisy CE# control signal may cause an invalid read. This erroneous read only occurs after the device has received over one hundred consecutive short CE# glitches ($t_{EHL} < 65 \text{ ns}$) with intermittent CE#-high time (t_{EHEL}) greater than 145 ns (see the figure below, *A Long Series of CE# Glitches May Induce an Invalid Read*).

After valid data is read, the device must receive another series of CE# glitches (typically over one hundred) to induce an invalid read. CE# glitches sequences, other than defined in the above figure, *A Long Series of CE# Glitches May Induce an Invalid Read*, have no adverse effect.

IMPLICATION: This erratum may affect read operations in systems that have a lot of noise on the flash memory's CE# input. If CE# is generated asynchronously from the upper address lines, noise on CE# can sometimes occur when upper address lines transition from one state to another. However, applications that access flash memory sequentially will have stable upper address lines and will therefore produce fewer CE# glitches. Systems that execute code from flash memory or download code from flash memory into DRAM will usually access the device sequentially; therefore, they will be less susceptible to this erratum.

Add system logic to prevent CE# glitches such as latched CE# control logic or pullup/pulldown resistors to the address bus.

If the device receives over one hundred consecutive CE# glitches, issue a Byte Write command and program FFh to any location before executing a read operation. Programming FFh will not alter stored data, but it will give the component sufficient time to prepare for the read operation.

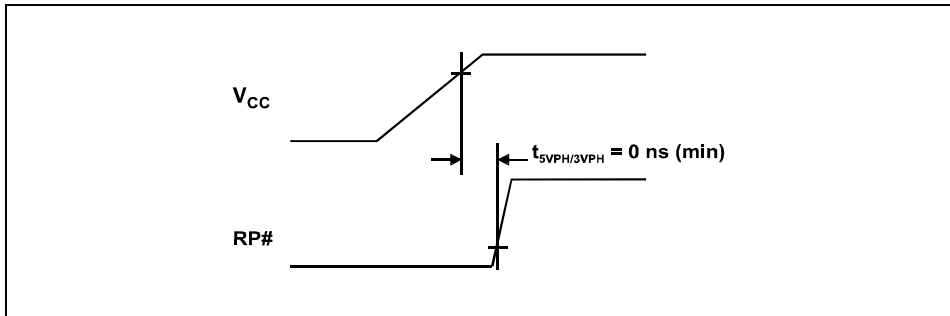
Hold RP# Active While V_{CC} Ramps

PROBLEM: RP# must be held low while V_{CC} ramps to a valid level during power transitions.

Holding RP# low during power-up blocks spurious write initiated by system control logic which may occur as the system voltage transitions to a stable level. Intel recommends the usage of RP# for CPU/memory reset synchronization, write protection, and deep power-down mode.

IMPLICATION: This erratum only affects power-up operations. Systems that tie the flash memory's RP# input to the system RESET# signal typically will not have a problem with erratum because the RESET# signal is usually held low during the power-up sequence to properly synchronize the CPU. However, systems that ties RP# directly to V_{CC} will be more exposed to this problem. So, carefully analyze RP# during the power-up condition to fully understand its behavior.

Use a simple RC delay network to hold RP# low during the power-up condition or tie the RP# input to the system RESET# signal. This workaround will eliminate your exposure to this problem and also provide your design with additional power-up security.
