28F008S3

SPECIFICATION UPDATE

Release Date: February 1997

Order Number 297799-003

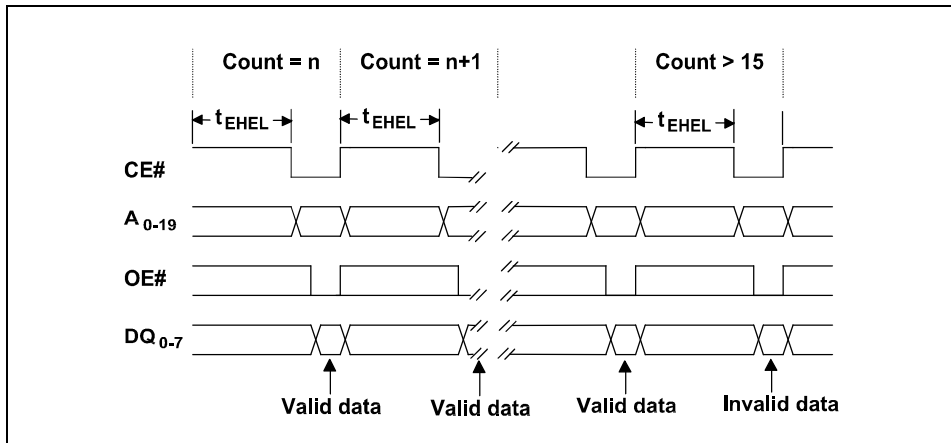
Successive Read Operations That Have Long CE#-High Pulse Widths

PROBLEM: The component may return invalid data if more than fifteen successive read operations are performed where CE# is deasserted between each read and the corresponding CE#-high pulse width resides within the specifications outlined in the table below.

Stepping	CE#-High Pulse Width (t_{EHEL})	
	Min	Max
A-1 and -3	100 ns	40 μ s
A-6	240 ns	700 ns

1. Read more than four good reads for A-1 and A-3 stepping and only one read for A-6 stepping during each assertion of CE#, as illustrated in the figure above.
2. Issue a Byte Write command and program FFh to any location before executing a read operation. Programming FFh will not alter stored data, but it will give the component sufficient time to prepare for the read operation.

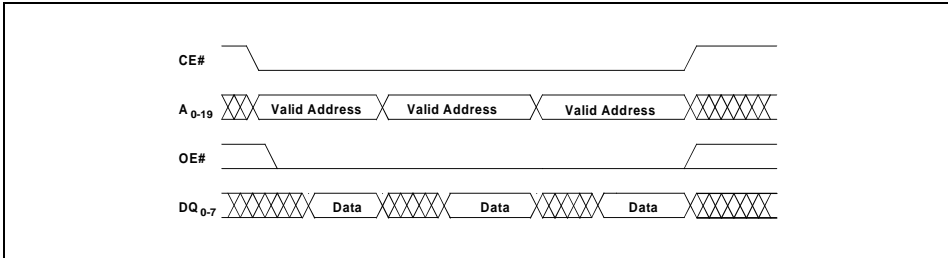
Access the Flash with CE# Active

IMPLICATION: The use of the flash memory will affect the exposure to this anomaly. Systems that execute code directly out of the flash memory will be less susceptible to the problem because the flash memory is continuously being accessed for information at a fast rate. If this is the case, CE# may be driven active while only the address changes to retrieve subsequent data from the component (see the figure below, *Access the Flash with CE# Active*) or the CE#-high time will be very short (less than 100 ns) to maximize read throughput. If it is determined that your applications accesses the flash memory in this manner, you will not have problem with this erratum.

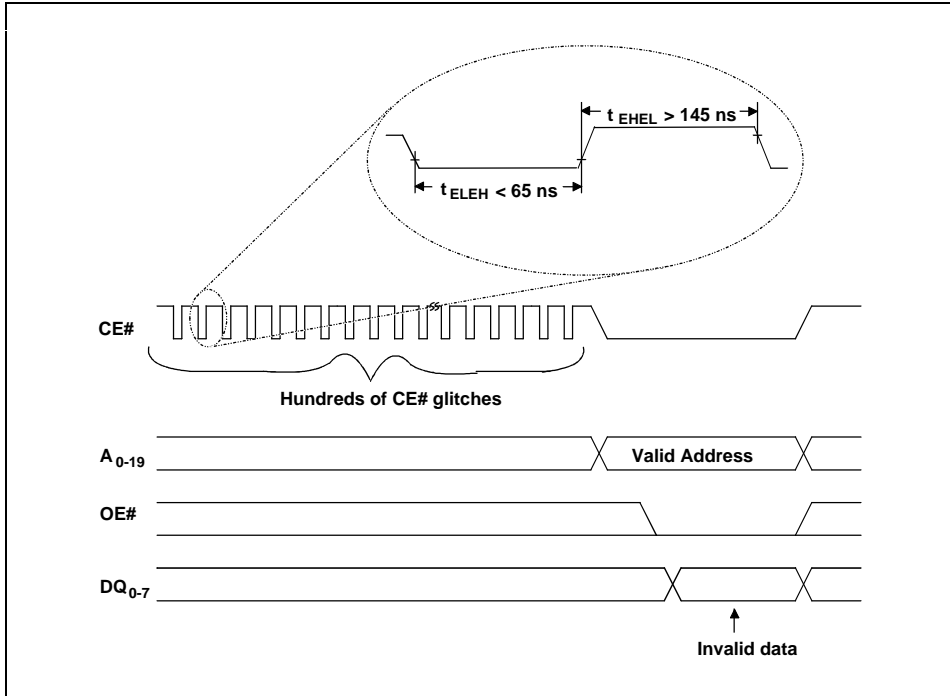
A Long Series of CE# Glitches May Induce an Invalid Read

PROBLEM: A noisy CE# control signal may cause an invalid read. This erroneous read only occurs after the device has received over one hundred consecutive short CE# glitches ($t_{EHL} < 65$ ns) with intermittent CE#-high time (t_{EHEL}) greater than 145 ns (see the figure below, *A Long Series of CE# Glitches May Induce an Invalid Read*).

After valid data is read, the device must receive another series of CE# glitches (typically over one hundred) to induce an invalid read. CE# glitches sequences, other than defined in the figure above, have no adverse effect.

IMPLICATION: This erratum may affect read operations in systems that have a lot of noise on the flash memory's CE# input. If CE# is generated asynchronously from the upper address lines, noise on CE# can sometimes occur when upper address lines transition from one state to another. However, applications that access flash memory sequentially will have stable upper address lines and will therefore produce fewer CE# glitches. Systems that execute code from flash memory or download code from flash memory into DRAM will usually access the device sequentially; therefore, they will be less susceptible to this erratum.

Add system logic to prevent CE# glitches such as latched CE# control logic or pullup/pulldown resistors to the address bus.

If the device receives over one hundred consecutive CE# glitches, issue a Byte Write command and program FFh to any location before executing a read operation. Programming FFh will not alter stored data, but it will give the component sufficient time to prepare for the read operation.
