80960HA/HD/HT SPECIFICATION UPDATE

Release Date: January, 1997

Order Number: 272830-002

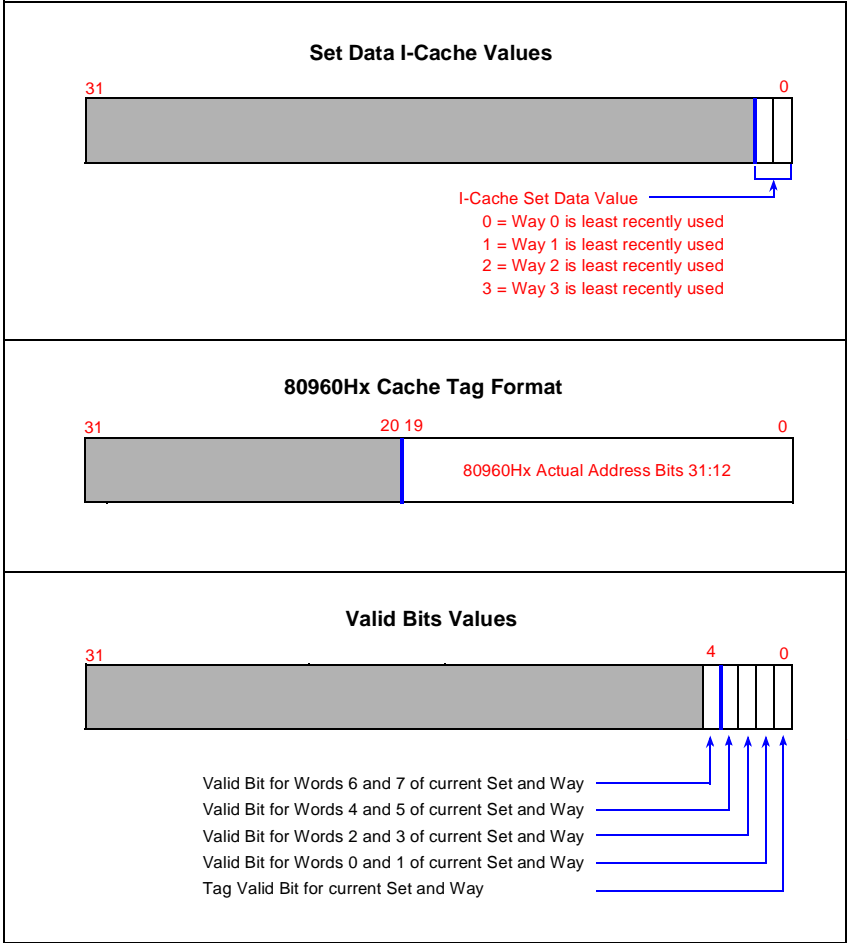
Page 6-64, Figure 6-6

The figure for Valid Bits Values incorrectly shows bit positions 0-8 as the location of the valid bits. The corrected figure shows the valid bits in positions 0-4.

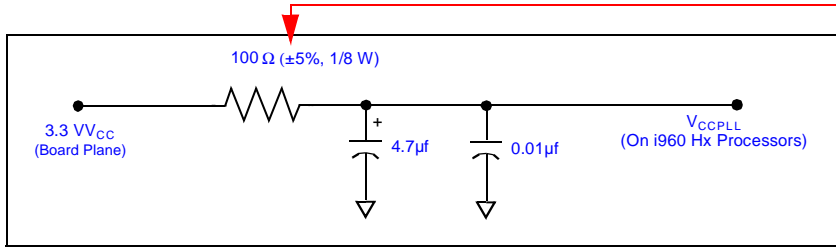
Figure 13-9. VCCPLL Lowpass Filter

Page 13-37, Figure 13-9
 The text near at the top of the figure read:
 100Ω
 The corrected text reads:
 100Ω (±5%, 1/8 W)
