80960JA/JF/JD

SPECIFICATION UPDATE

Release Date: July, 1996

Order Number: 272852-001

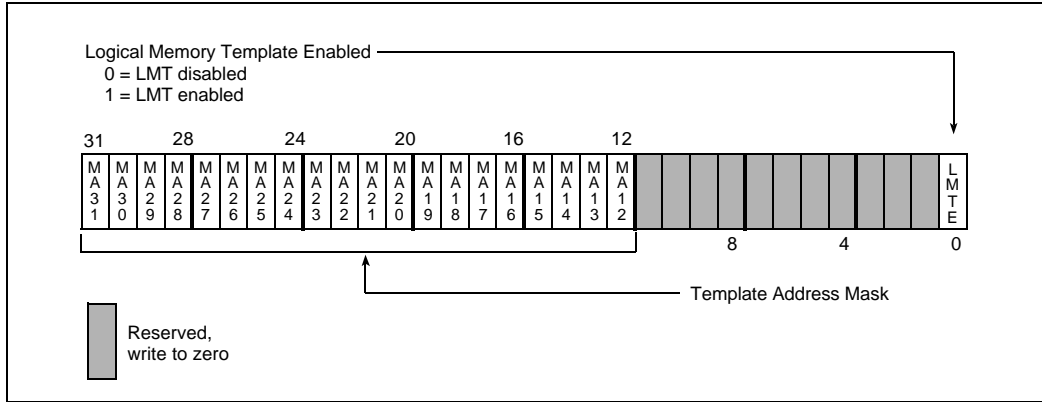
Figure C-25. Logical Memory Template Mask Registers (LMMR0-1)

Figure C-25, LMMR0-1 Register Diagram is a duplicate of LMADR0-1 register. Figure 12-5 (page 12-5) displays the register correctly.
