80960CA/CF SPECIFICATION UPDATE

Release Date: July, 1996

Order Number: 272875-001

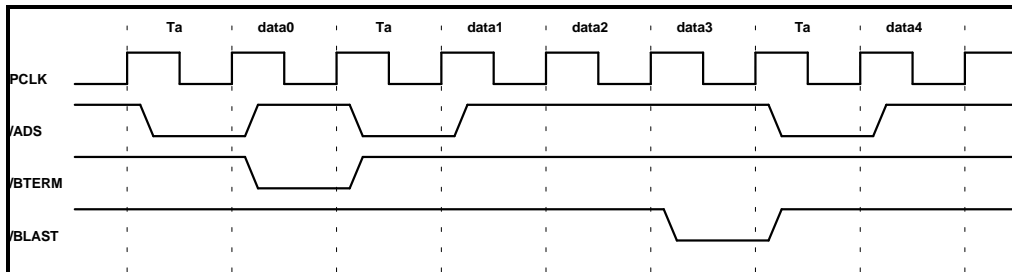
Figure 1: Timings for Correct Operation

If BTERM# is asserted during data(0), ADS# will be asserted again for data(1) and the access will end by asserting BLAST# while reading data(3).

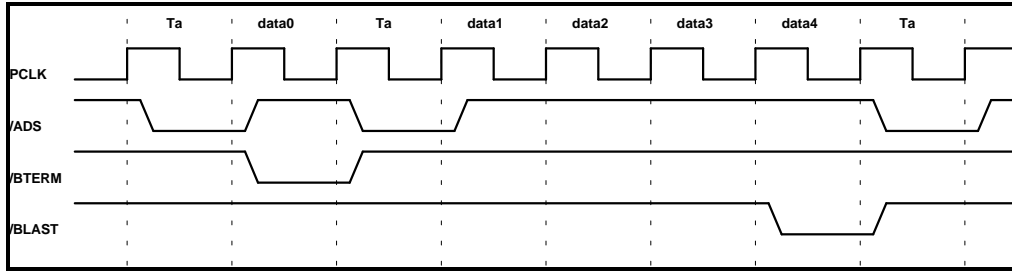
Figure 2: Timings for Incorrect Operation

The access spans over data3. For example, BLAST# is asserted while data4 is read.

IMPLICATION: Memory and I/O systems must accept these forms of access when using BTERM.

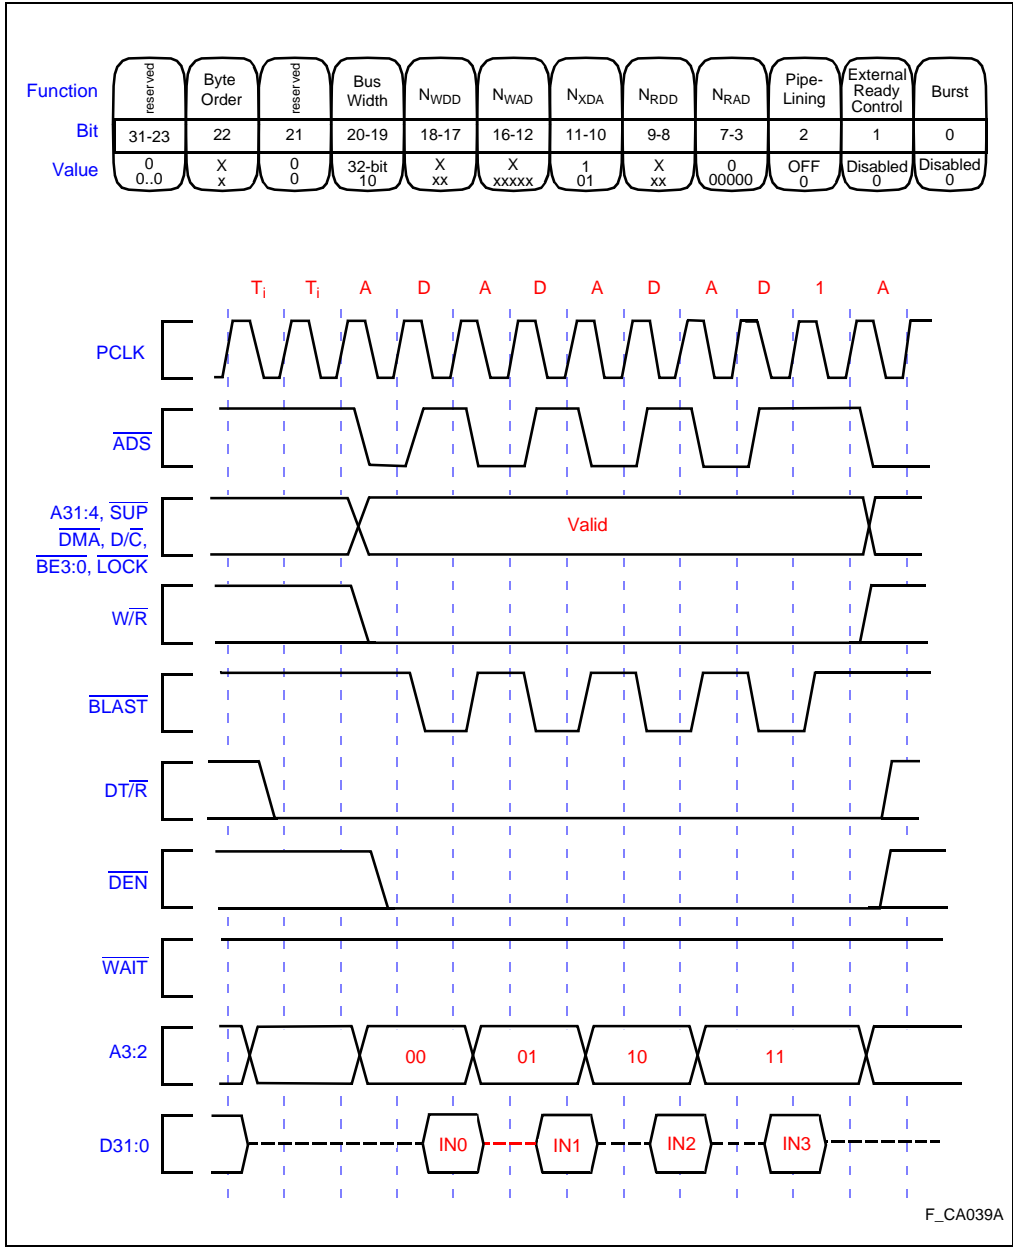
Figure 11-2. Quad-word Read from 32-bit Non-burst Memory

Errata 10/31/94 SRB.
Wait signal incorrectly shown as transitioning; it now correctly shows that the signal is asserted high throughout.

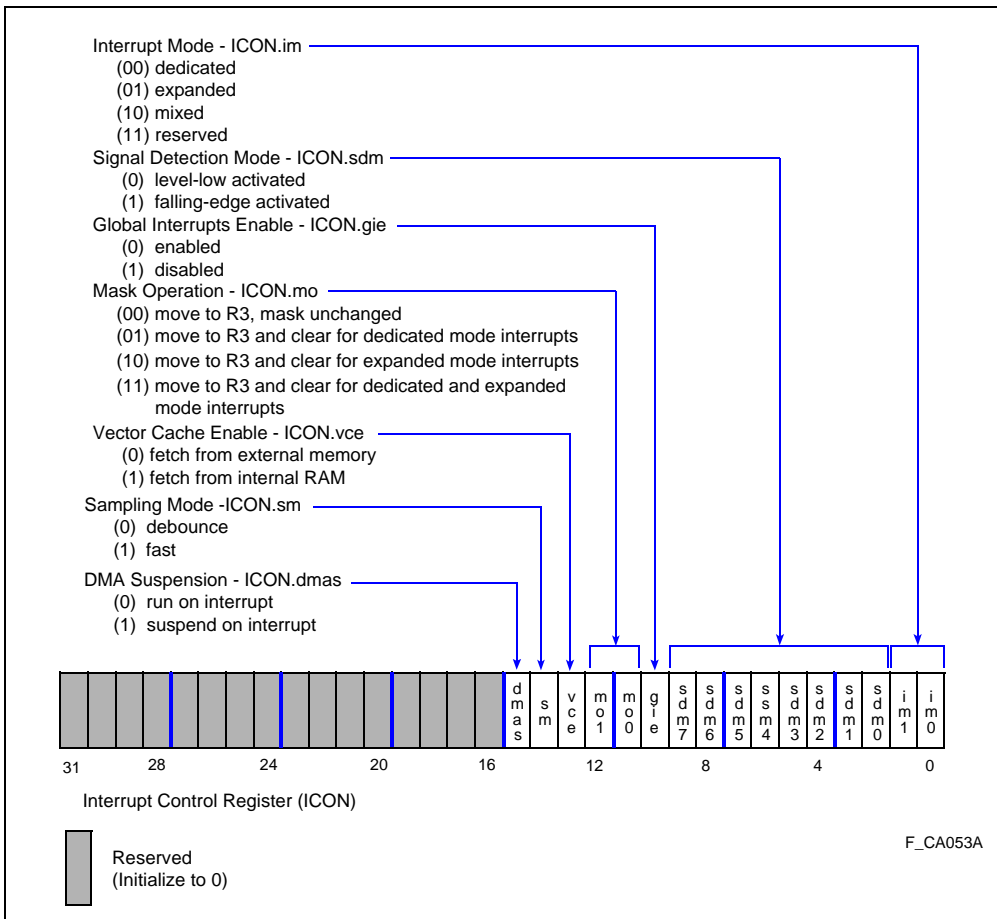
Figure 12-6. Interrupt Control (ICON) Register

Errata (12-06-94 SRB)
 Vector Cache Enable bits (ICON.vce) incorrectly defined.
 Bit 0 was "debounce"; it now is correctly defined as "Fetch From External Memory".
 Bit 1 was "Fast"; is now correctly defined as "Fetch From Internal RAM".

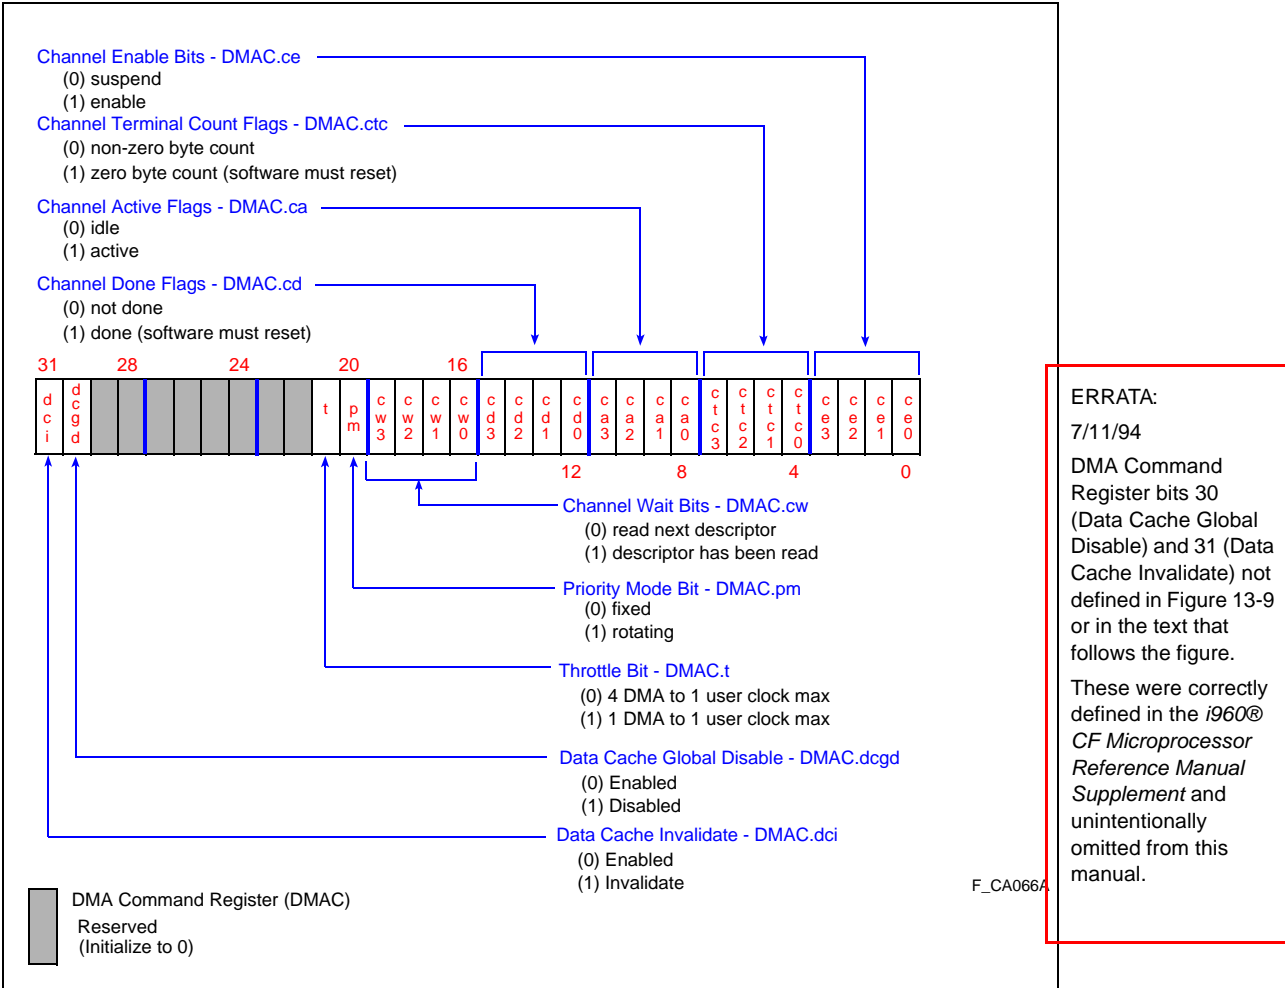
Figure 13-9. DMA Command Register (DMAC)

ERRATA:
 7/11/94
 DMA Command Register bits 30 (Data Cache Global Disable) and 31 (Data Cache Invalidate) not defined in Figure 13-9 or in the text that follows the figure.
 These were correctly defined in the *i960® CF Microprocessor Reference Manual Supplement* and unintentionally omitted from this manual.

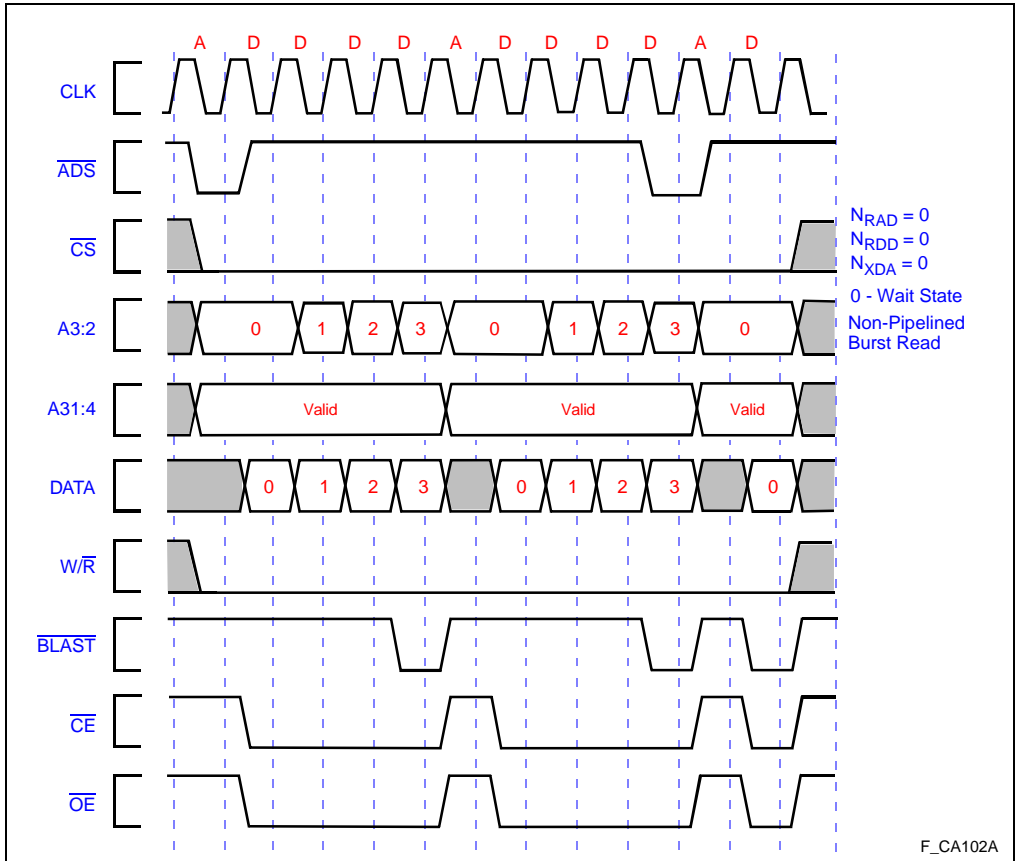
Figure B-2. Non-Pipelined SRAM Read Waveform

ERRATA (10-31-94) SRB
 On pg B-5, Fig B-3, the ADS# signal incorrectly showed a deassertion in the 6th cycle and the 3rd deassertion in the 11th cycle.
 It now correctly shows NO deassertion in the 6th cycle and the last deassertion in the 10th cycle. (2nd deassertion removed; 3rd deassertion shifted left 1 cycle).

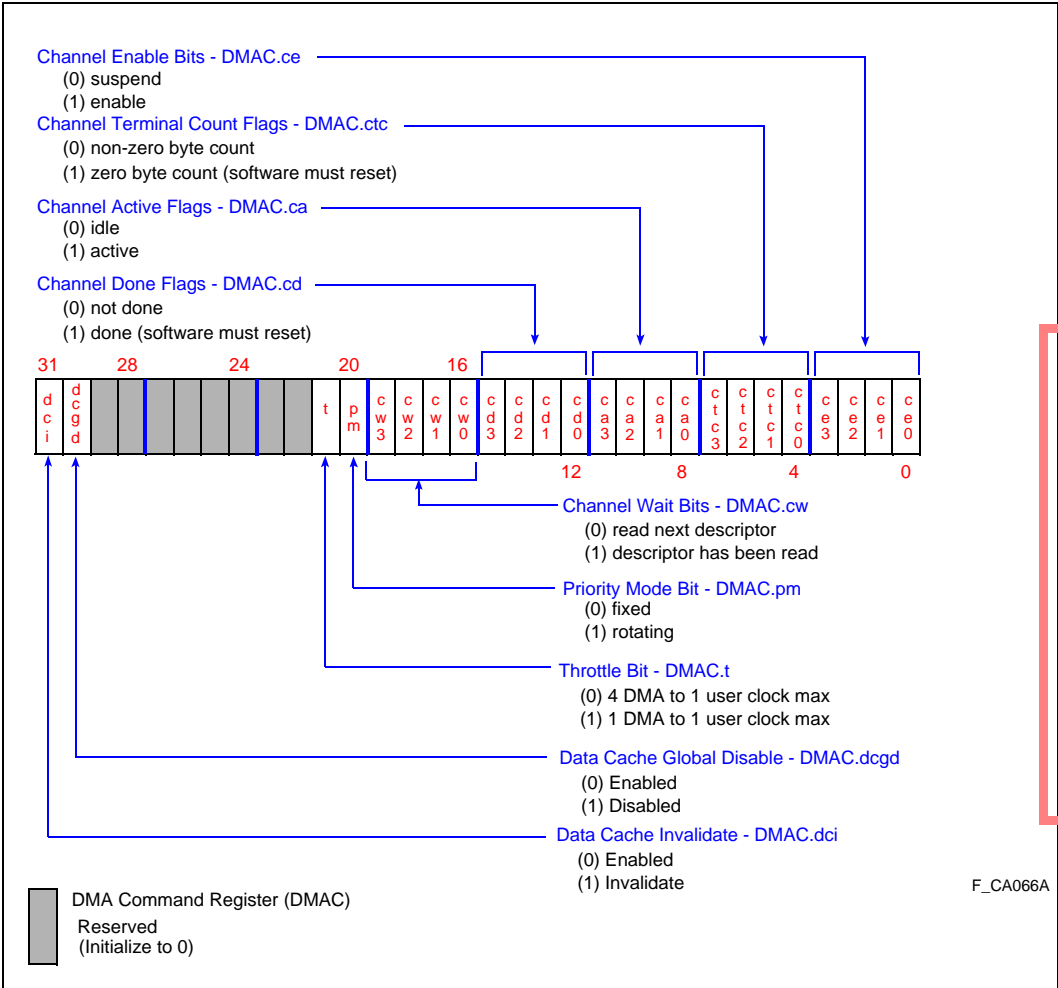
Figure F-12. DMA Command Register (DMAC)

ERRATA: 7/11/94
 DMA Command Register bits 30 (Data Cache Global Disable) and 31 (Data Cache Invalidate) not defined in Figure 13-9 or in the text that follows the figure.
 These were correctly defined in the i960® CF Microprocessor Reference Manual Supplement and unintentionally omitted from this manual.

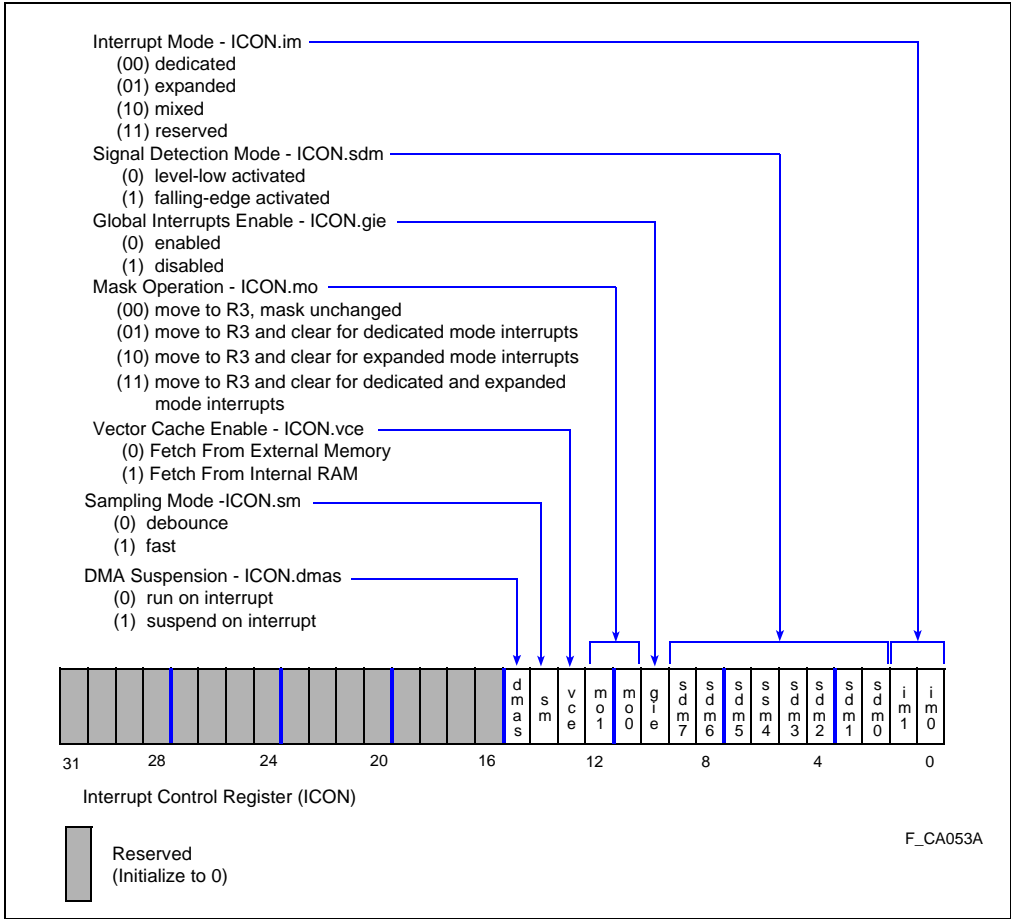
Figure F-16. Interrupt Control (ICON) Register

Errata (12-06-94 SRB)
 Vector Cache Enable bits (ICON.vce) incorrectly defined.
 Bit 0 was "debounce"; it now is correctly defined as "Fetch From External Memory".
 Bit 1 was "Fast"; is now correctly defined as "Fetch From Internal RAM".
