# **i960<sup>®</sup> Rx I/O PROCESSOR SPECIFICATION UPDATE**

Release Date: March, 1997

Order Number: 272918-007

The i960<sup>®</sup> Rx I/O Processor may contain design defects or errors known as errata. Characterized errata that may cause the i960<sup>®</sup> Rx I/O Processor's behavior to deviate from published specifications are documented in this specification update.

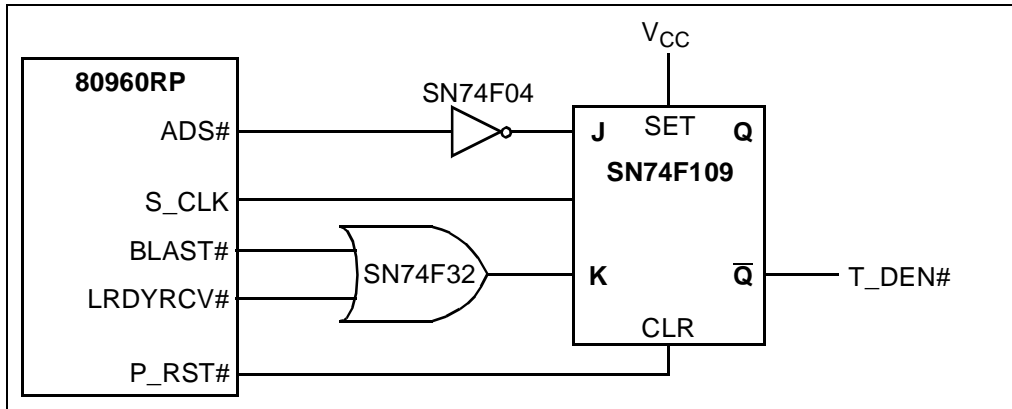
*Using DEN# with an In-Circuit Emulator:* For ICE users, it is not recommended that you use the 80960Rx's DEN# signal directly to your transceivers. When executing an ICE microcode transaction, the expected behavior is that DEN# would remain de-asserted during the entire transaction. However, DEN# asserts as described above. If your design uses DEN# to enable transceivers, the transceivers will be enabled. This may result in bus contention.

**WORKAROUND:** To use an ICE with your 80960Rx design, alternatives to DEN# are:

- Ground the OE# pin of the transceiver
- Re-create a DEN# signal with the circuit shown below

The circuit asserts T\_DEN# (Q#) at the start of the first data cycle when ADS# asserts and BLAST# and LRDYRCV# de-asserts. T\_DEN# deasserts at the end of the last data cycle when ADS# de-asserts and BLAST# and LRDYRCV# assert. During RESET, T\_DEN# de-asserts.

Equivalent components may be used in place of the components shown.
