Intel386™ EX EMBEDDED PROCESSOR SPECIFICATION UPDATE

Release Date: January, 1997

Order Number: 272873-004

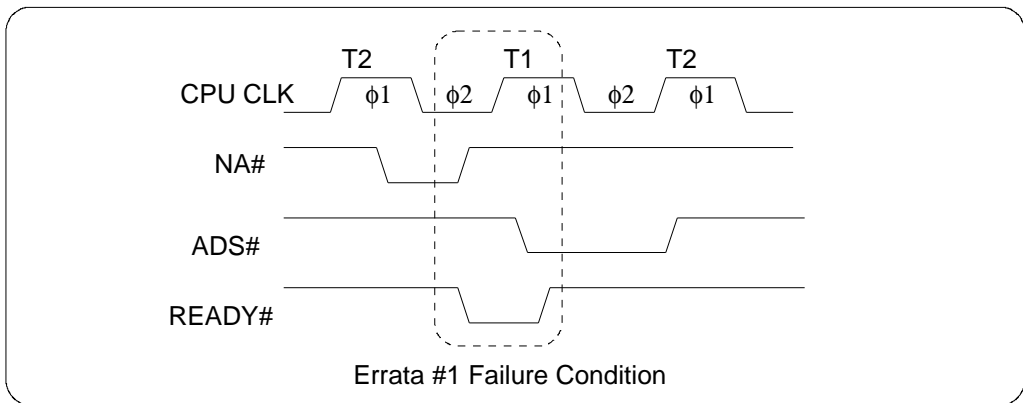
1. *Watchdog Timer (WDT) Bus Monitor Failure During Bus Pipeline Operation*

PROBLEM: The errata applies to the WDT unit when using the Bus Monitor Mode and Bus Pipeline operation. If a pipelined bus cycle is requested at the same time the current bus cycle is completed, the WDT down counter is not reloaded or stopped. This condition means that the WDT could time-out and erroneously report a system failure. The waveform below shows the errant condition.

The errata condition is caused by the system generating READY# immediately after NA# has been requested, and a T1 cycle is generated (rather than a T2P cycle). Essentially, the system is requesting a pipelined access, but does not need it because READY# has been returned. Such a condition is not typically expected when using the pipeline feature.

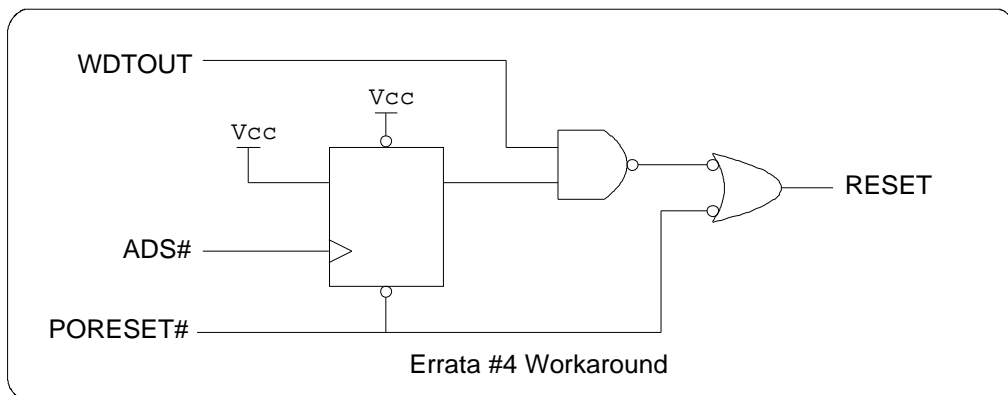
IMPLICATION: This errata only applies to a system design that uses the WDTOUT signal to generate a device reset. The WDT will time out and reset the device before the CPU self-test can complete.

WORKAROUND: The WDTOUT signal cannot be directly tied to the RESET input during self-test since there is no mechanism to increase the default value loaded into the WDT counter. The circuit shown below can be used to block WDTOUT until the first ADS# is generated. The signal PORESET# is a power-on reset signal generated by the system. WDTOUT is an output of the Intel386 EX processor, and RESET is an input to the processor. Please note that the circuit below has not been tested in a real design and is provided as an example only.

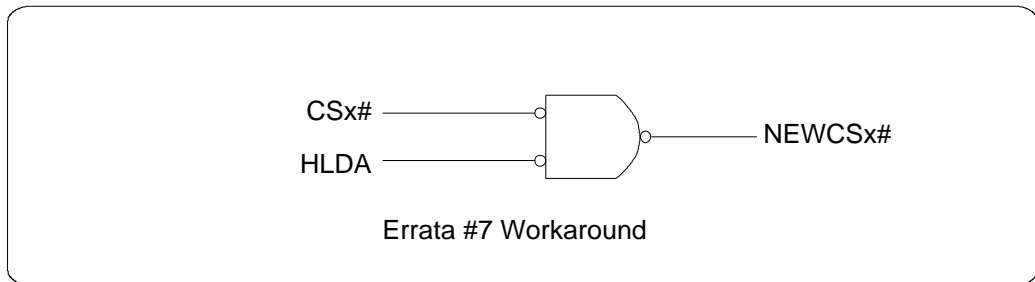
PROBLEM: When the device enters a bus HOLD state because of a HOLD or DMA Cascade operation, the Chip Select that was valid in the previous cycle can remain active during the bus hold. This can cause bus contention when another bus master gains control of the bus.

WORKAROUND: Qualify a chip-select with HLDA such as shown in the circuit below. The chip-select will go inactive if HLDA goes active. If using a PLD device, then HLDA should be used to qualify the chip-select as shown in the following diagram.

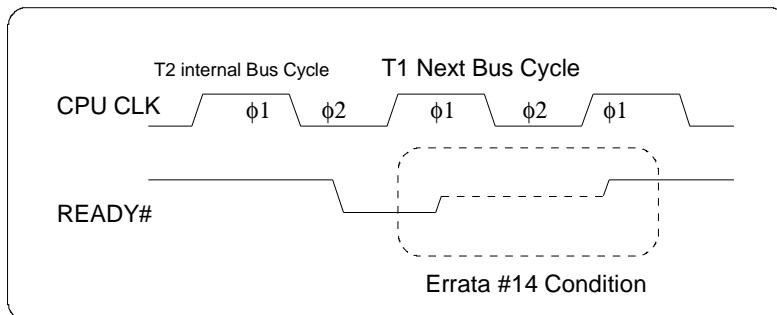
14. READY# Floats In T1 After Internal Bus Cycle Due to LBA#

PROBLEM: During internal bus cycles, the LBA# signal does not remain active into the next T1 bus state, causing READY# to float during T1. This is unlike bus cycles controlled by the Chip Select Unit (CSU), where READY# is driven inactive during T1 of the next bus cycle.

WORKAROUND: Pull-up READY# if the float condition will cause system logic to operate improperly.

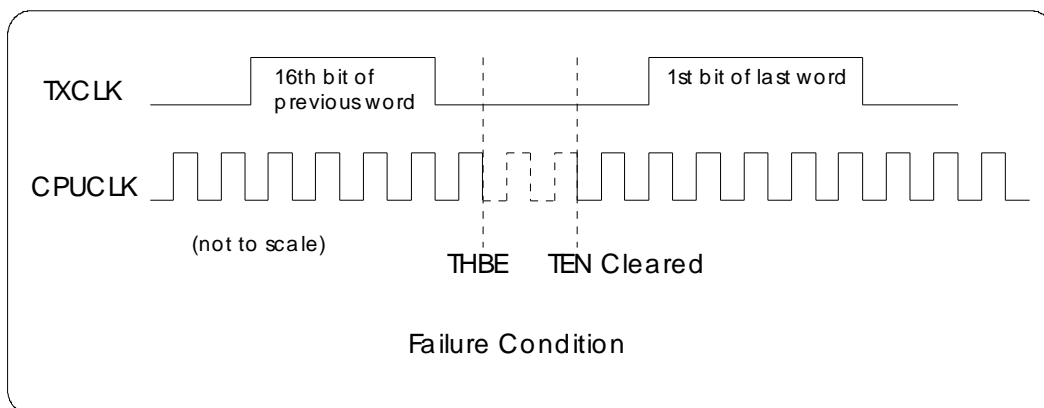
PROBLEM: When the SSIO is transmitting data (master or slave mode) the transmitter is turned off by clearing the TEN bit of the SSIOCON1 register. One way of indicating to the software to clear this bit is by waiting for the Transmit Holding Buffer Empty (THBE) signal to go active, indicating that the word written to the holding register is ready for transmission from the shift register. Even if the software waits for this signal and then writes to SSIOCON1 to disable TEN, depending on when TEN is cleared, the last word transmit may or may not take place.

If the TXCLK is significantly slower than the CPUCLK, it is possible for the THBE bit to be set and the TEN bit to be cleared all during the low time of the TXCLK (see diagram). In this case, even though the last word to be transmitted has been loaded into the shift register, it will not be shifted out.

WORKAROUND: In order to assure that the last word is transmitted, the TEN bit must not be cleared until after the TXCLK transitions from low to high when the 1st bit of the last word is being transmitted. Consequently, the way to assure that this happens is to either: 1) utilize a timer to assure that enough time elapses from when the THBE bit goes high until the TXCLK goes high, or 2) execute a fixed number of NOPs after THBE goes high before clearing TEN. In either case, the length of the delay is dependent upon the frequency of TXCLK and the CPUCLK.

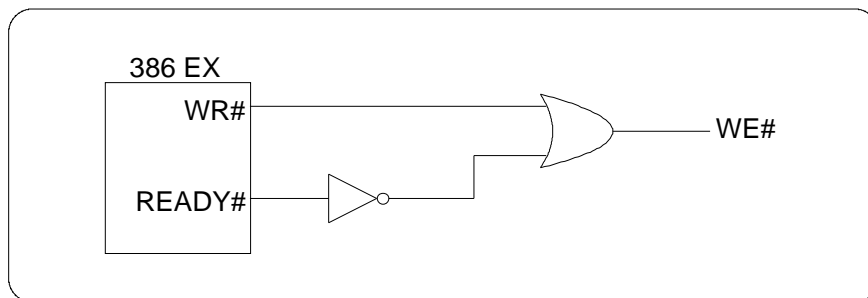
IMPLICATION: This errata applies to all applications that use the WR# signal as the write strobe to memory or I/O.

WORKAROUND: The circuit shown below may be used to generate a write strobe if the READY# signal is not generated too early in the T2 cycle. Please note this circuit has not been tested in a real design and is provided as an example only. For applications which cannot use the circuit below it is necessary to implement an external WE# signal using a simple state machine design. An example of what that state machine could look like is available in the EV386EX evaluation board design, or in the Point of Sales Terminal reference design available from the WEB, BBS or through literature.

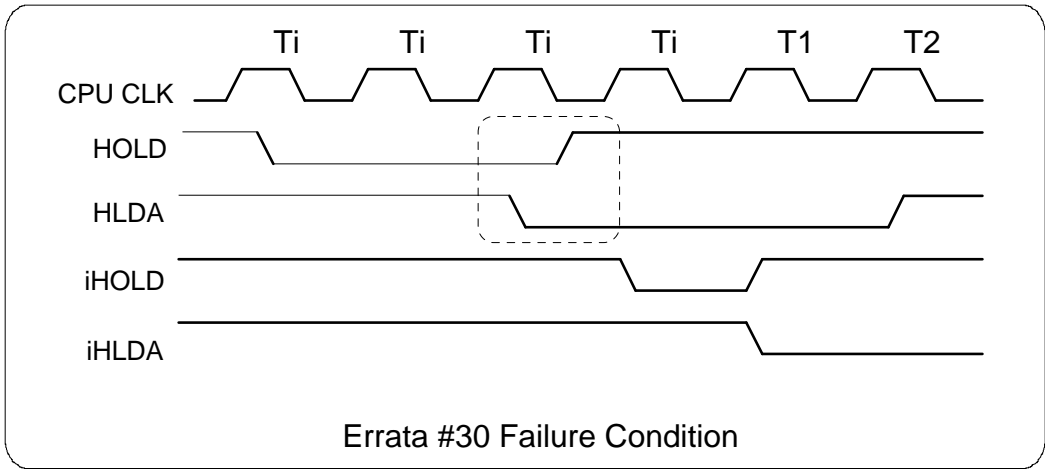
30. *HLDA Inactive To HOLD Active Arbitration Could Improperly Float The Bus*

PROBLEM: In a HOLD/HLDA cycle the HOLD signal must not be re-asserted until after HLDA is returned inactive. If, however, HOLD is asserted in the same T-state that HLDA goes inactive a problem may occur where the bus arbiter relinquishes control to the core and at the same time floats the bus by asserting the HLDA pin. The following waveform shows the conditions that cause this error. The signals iHOLD and iHLDA are internal signals and represent the HOLD input to the core and the HLDA output from the core (equivalent to the HOLD and HLDA signals on a Intel386™ SX processor). In this diagram a T1 occurs because a request was pending by the core during the previous HOLD cycle. One T-state after the arbiter releases the bus (HLDA = 0) it removes its iHOLD, and then the core removes iHLDA. As soon as the iHLDA is released, the T1 state starts. However, because of the timing of the next HOLD request, the bus arbiter re-asserts iHOLD and HLDA even though the core has not asserted iHLDA. The result is that the core continues to run its bus cycle and, at the same time, the bus arbiter has floated the external bus. It is also possible for the following to occur when HOLD/HLDA arbitration is at issue: HOLD is driven active during the T1 or Tw of a valid bus cycle. The processor begins the next bus cycle and generates HLDA. HLDA is active for only one T-state. ADS# is extended through the bus cycle. The alternate bus master sees the HLDA and performs its bus activity. HOLD is then driven inactive and the bus is returned to the Intel386™ EX Processor. At this point there is bus contention.

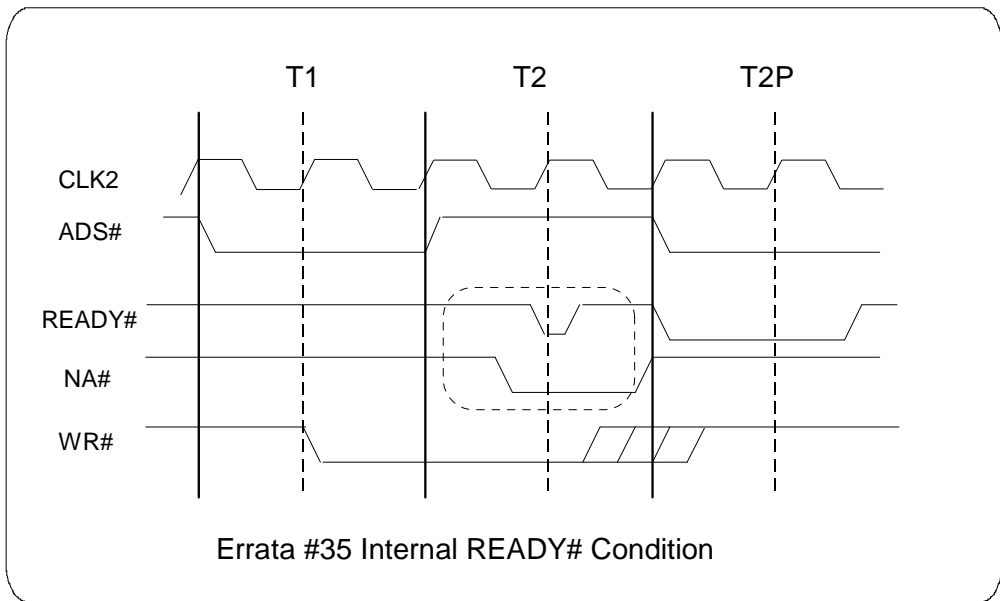
IMPLICATION: This errata applies to all applications programming zero wait states on chip select and generating an internal READY#. The temporary transition of READY# will only occur when switching from non-pipeline to pipeline mode.

WORKAROUND: None. Do not trigger any external state machine on asserted READY# signal in T2 unless it occurs at the end of the T2 state where expected.

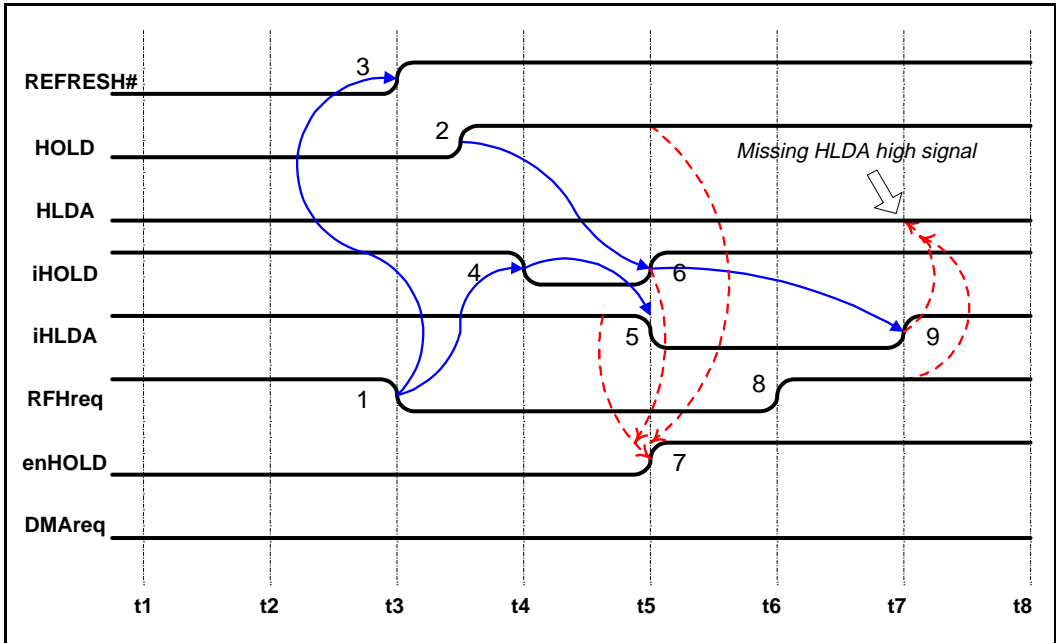
Figure 3. HOLD with Short REFRESH Interval

Figure 3 shows Condition #1a where an external HOLD and refresh request conflict can occur. The table below describes each signal name used:

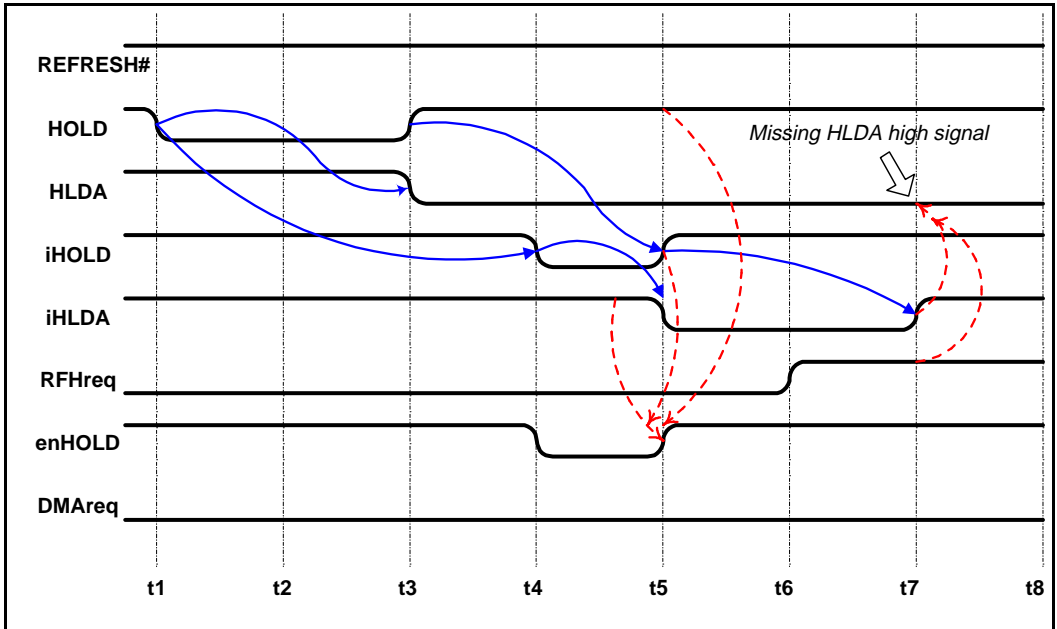
Figure 4. Quick HOLD Assert and Deassert with Slow REFRESH Interval

- B. HOLD is removed and reasserted within one bus cycle. Refer to Figure 4. This condition will cause the problematic window with fast iHOLD deassertion (t4) and assertion (t5). Note that if HOLD is deasserted because of pending REFRESH and reasserted again within one bus cycle, the problem will not occur since the iHOLD signal is never deasserted due to refresh. The reassertion of the HOLD would then be serviced upon completion of the refresh.

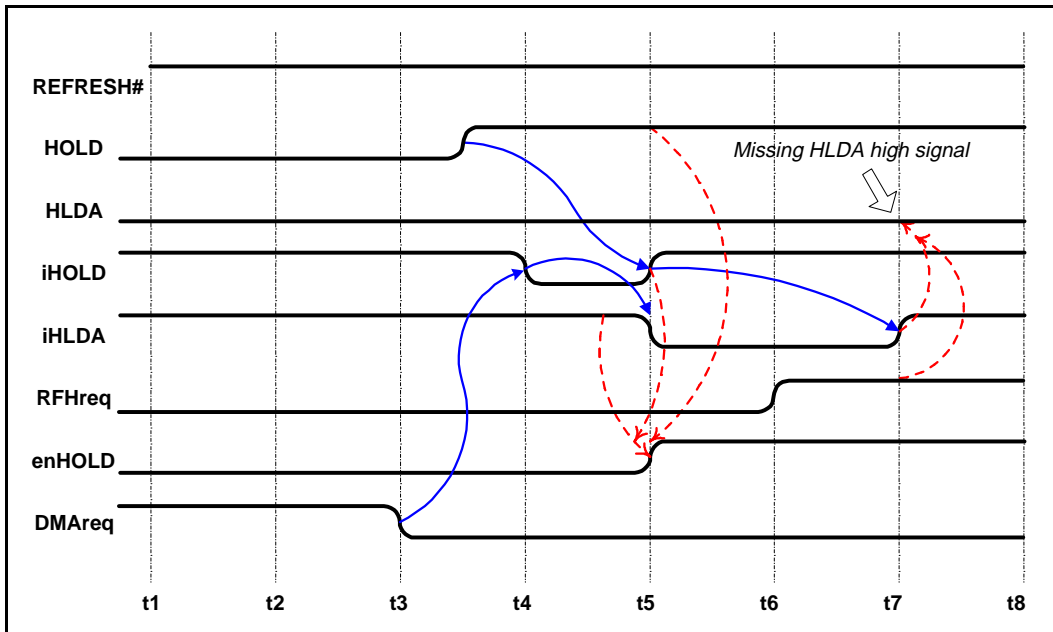
Figure 5. DMA, HOLD and REFRESH with Normal Interval

DMAREQ is a signal internal to the processor. This signal is not always within the user's control and could be internally deasserted, such as in autoinitialize mode. To avoid issues

with this type of situation, it is recommended that the user deassert the external request DREQ after the last transfer has completed. It is further recommended that DREQ only be deasserted after a valid DMA acknowledge (DACK# goes low) has been returned. If a DREQ is held active and then deasserted during or shortly after the autoinitialize sequence, the problematic window can be induced and cause the errata to occur. See errata #28 for additional details on DMA programming restrictions.

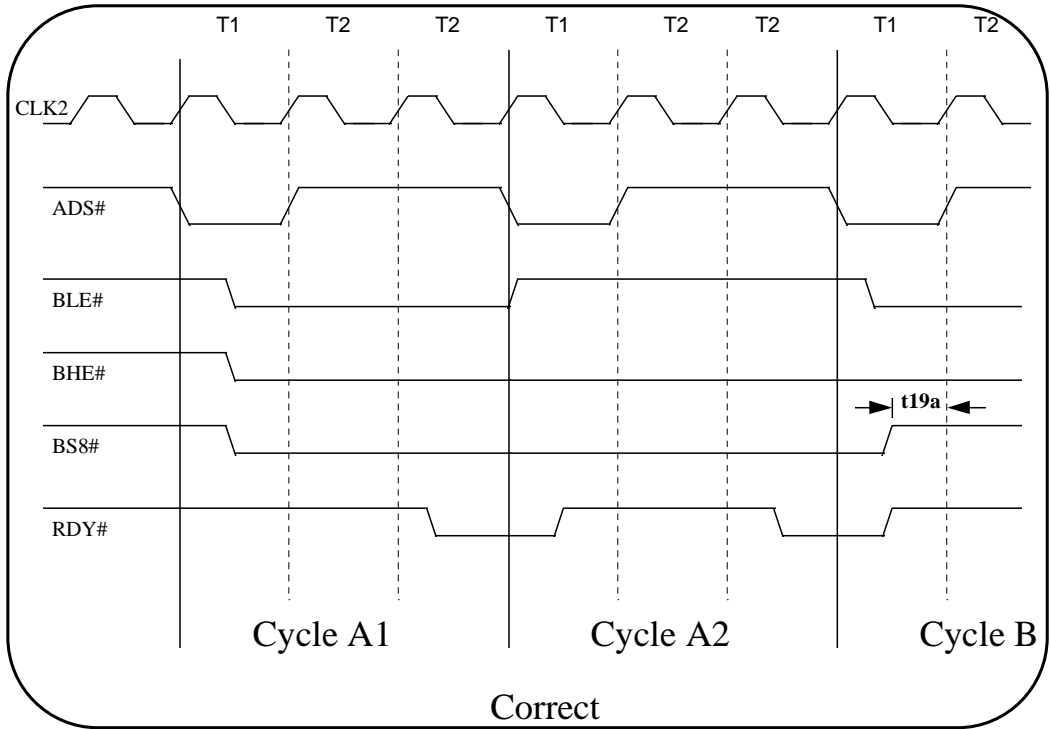
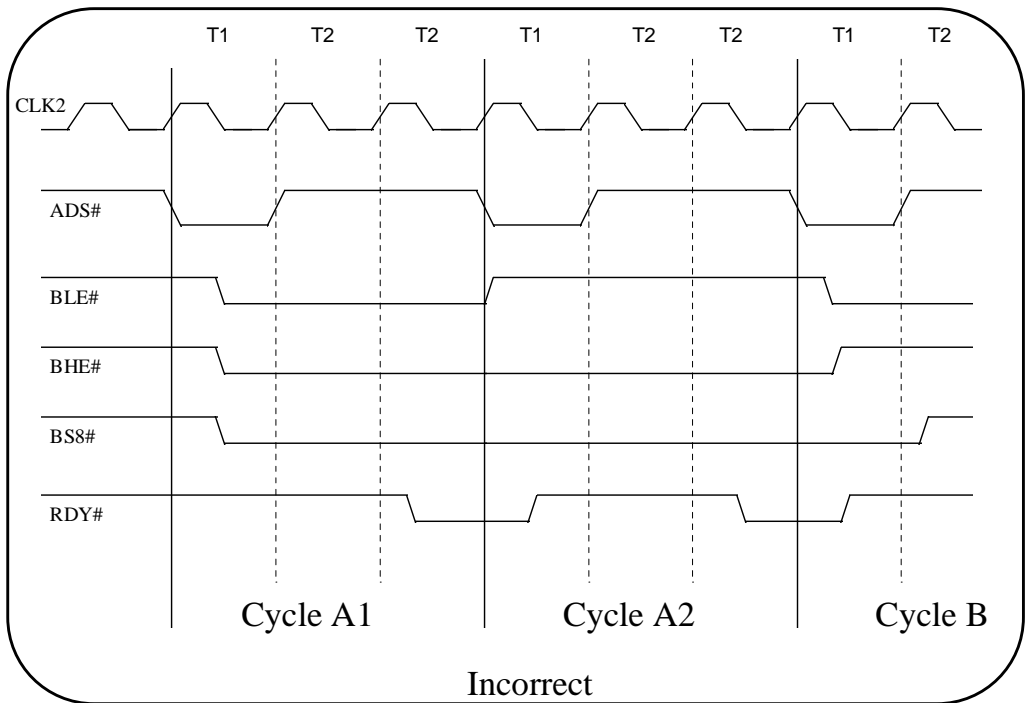
The reason this occurs is as follows: the processor latches the state of BS8# at the beginning of the first T2 of CYCLE B (to perform byte-steering within the processor) and resets this latch only in the next Ti or T1 state. Therefore, if BS8# is kept active into the first T2 of CYCLE B, then the byte-steering logic of the processor incorrectly assumes that CYCLE B is also a cycle to an 8-bit device. This causes the bytes to end up on the wrong data path.

Here are example waveforms demonstrating incorrect vs. proper latching of BS8#:
