80C186XL AND 80C188XL EMBEDDED MICROPROCESSORS SPECIFICATION UPDATE

Release Date: July, 1996

Order Number 272895-001

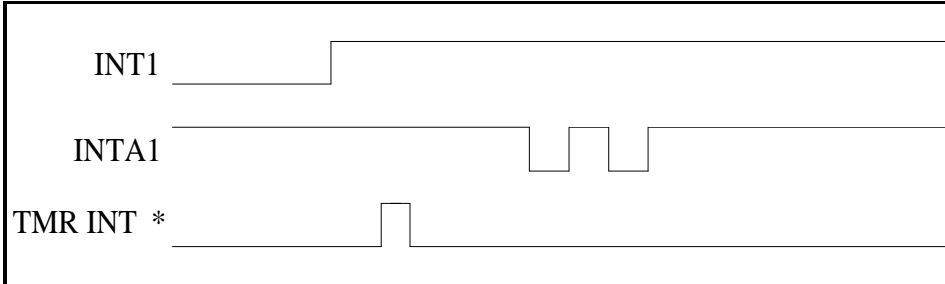
Figure 1. Correct INT 1 Acknowledge Sequence With Higher Priority Timer Interrupt

Correct operation of the device acknowledges the interrupt on INTA1# after an interrupt on INT1. Normally, this occurs even if there is a higher priority interrupt after INT1 but before the acknowledge (Figure 1).

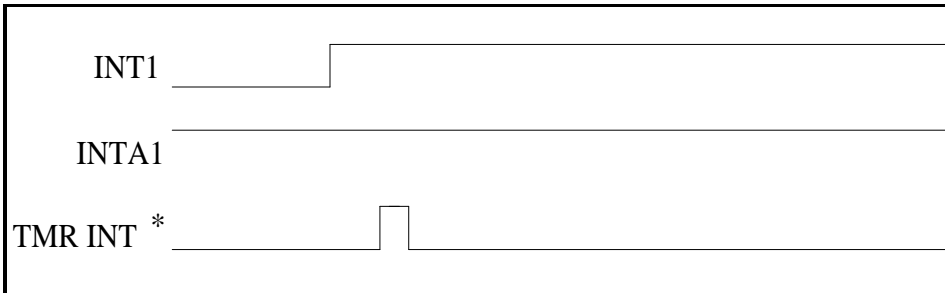
Figure 2. Incorrect INT 1 Acknowledge Sequence With A Higher Priority Timer Interrupt

The errata occurs when a higher priority interrupt occurs between INT 1 and its expected acknowledge. The processor completes internal interrupt acknowledge cycles as seen on the status lines but no acknowledge cycle is sent on the INTA1# output (Figure 2).

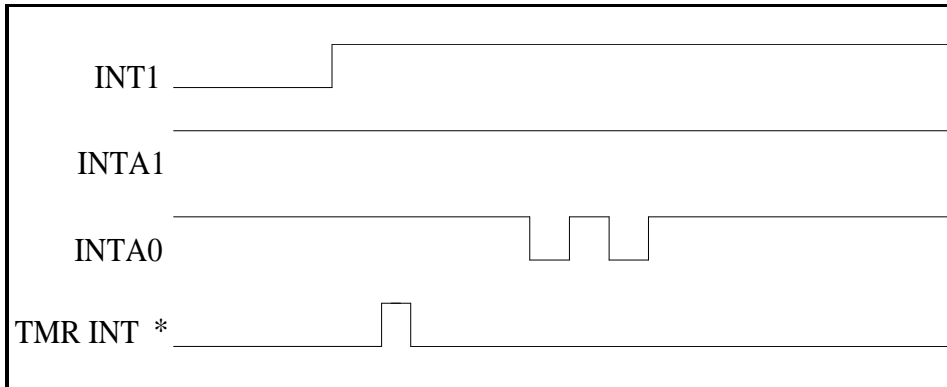
Figure 3. INT 0 And INT 1 Acknowledge Failure Due To Higher Priority Timer Interrupt

If INT 0 and INT 1 are configured in cascade mode and a higher priority interrupt occurs between INT 1 and its expected acknowledge, then the acknowledge will appear on INTA0# instead (Figure 3).

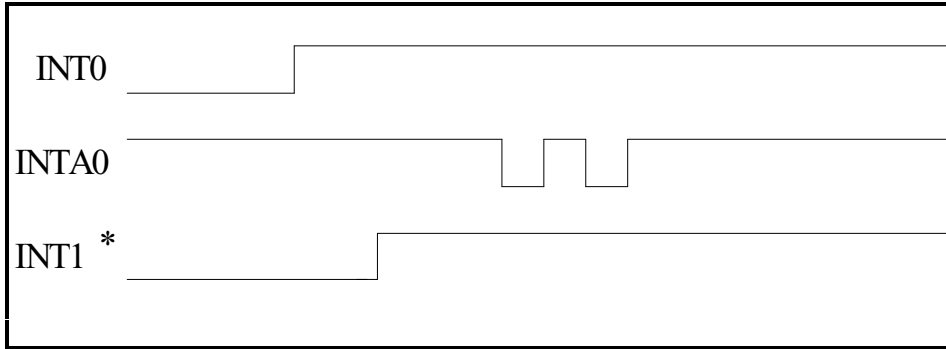
Figure 4. Correct INT 0 Acknowledge operation with a simultaneous INT 1

Correct operation acknowledges INT 0 on INTA0#. Normally, this occurs even if there is a higher priority INT 1 after INT 0 but before the acknowledge (Figure 4).

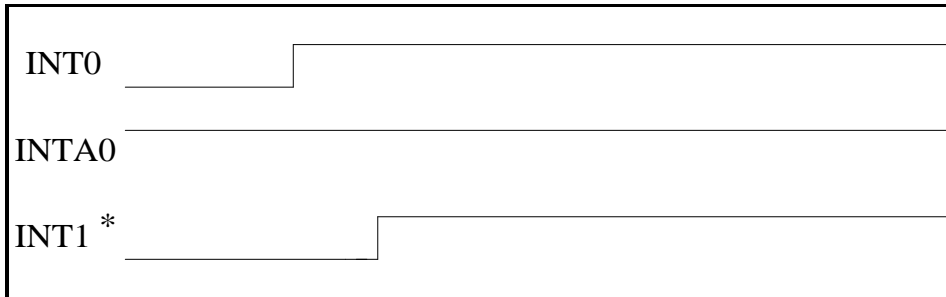
Figure 5. Incorrect INT 0 Acknowledge operation with a simultaneous INT 1

The errata occurs when INT 1, which is higher priority than INT 0, occurs between INT 0 and its expected acknowledge. The processor completes internal interrupt acknowledge cycles as seen on the status lines but no acknowledge cycle is sent on the INTA0# output (Figure 5).

*Note: This problem occurs only if INT 1 is higher priority than INT 0.

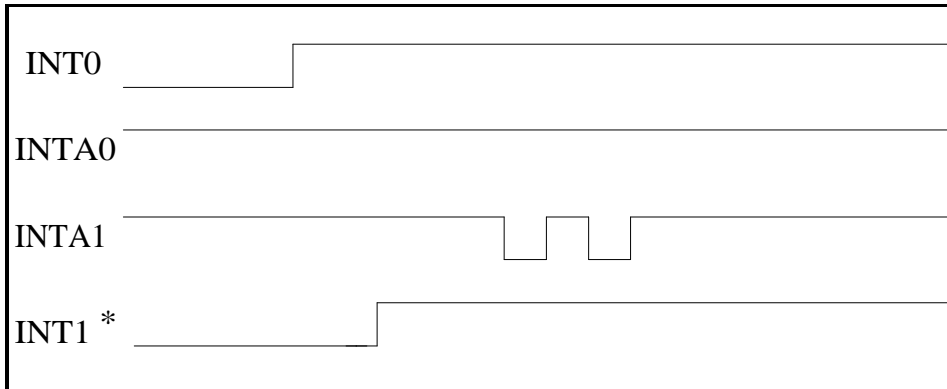
Figure 6. INT 0 and INT 1 Acknowledge Failure due to the higher priority INT 1.

If INT 0 and INT 1 are configured in cascade mode and the higher priority INT 1 occurs between INT 0 and its expected acknowledge, then the acknowledge will appear on INTA1# instead of INTA0# (Figure 6).

*Note: This problem occurs only if INT 1 is higher priority than INT 0.
