80C186EA/80C188EA AND 80L186EA/80L188EA EMBEDDED MICROPROCESSORS SPECIFICATION UPDATE

Release Date: July, 1996

Order Number: 272896-001

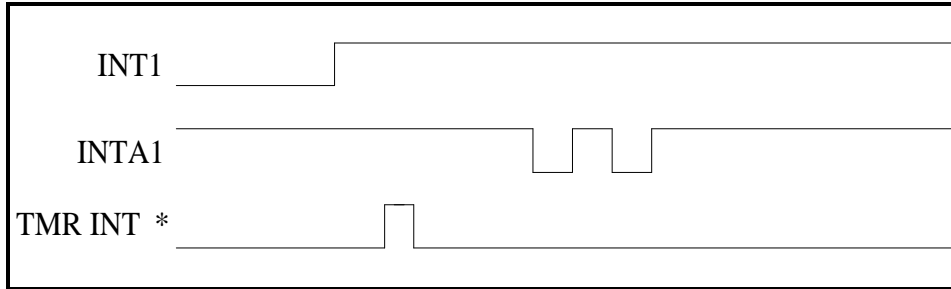
Figure 1. Correct INT 1 Acknowledge Sequence With Higher Priority Timer Interrupt

Correct operation of the device acknowledges the interrupt on INTA1# after an interrupt on INT1. Normally, this occurs even if there is a higher priority interrupt after INT1 but before the acknowledge (Figure 1).

*Note: This interrupt could be any of the following: DMA, Timers, Serial, INT0, or INT2.

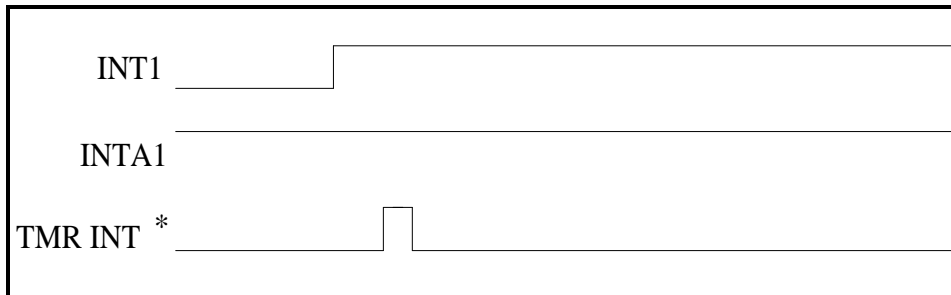
Figure 2. Incorrect INT 1 Acknowledge Sequence With A Higher Priority Timer Interrupt

The errata occurs when a higher priority interrupt occurs between INT 1 and its expected acknowledge. The processor completes internal interrupt acknowledge cycles as seen on the status lines but no acknowledge cycle is sent on the INTA1# output (Figure 2).

*Note: This interrupt could be any of the following: DMA, Timers, Serial, INT0, or INT2.

IMPLICATION: If two cascaded interrupt controllers are used, the interrupt acknowledge can be sent to the wrong controller. This can cause no acknowledge cycle on the INTA1# line after an interrupt on INT1 or on INTA0# after an interrupt on INT0.

- Use only INT 0 in cascade mode instead, or make INT 1 the least highest priority interrupt, or use hardware workaround.
- Use only one interrupt in cascade mode, or use hardware workaround.
- Make INT 0 higher priority than INT 1, or use hardware workaround.

- 1) Pull data bus lines 0 to 7 to a known value (using pull-up resistors) to force a defined value on the bus when the errata occurs.

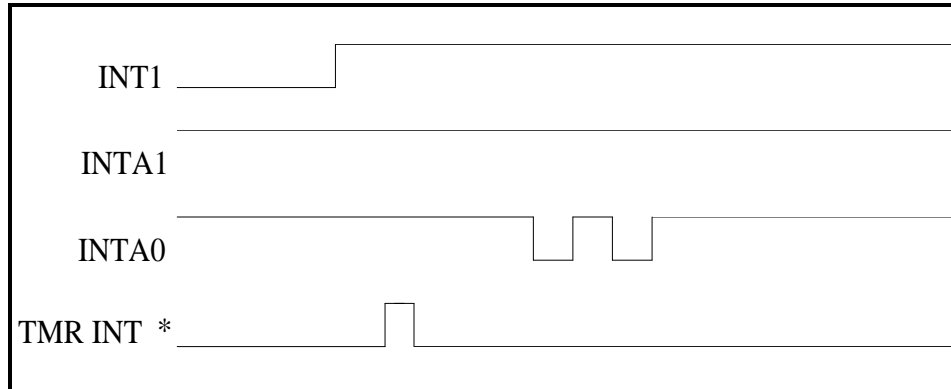
Figure 3. INT 0 And INT 1 Acknowledge Failure Due To Higher Priority Timer Interrupt

If INT 0 and INT 1 are configured in cascade mode and a higher priority interrupt occurs between INT 1 and its expected acknowledge, then the acknowledge will appear on INTA0# instead (Figure 3).

*Note: This interrupt could be any of the following: DMA, Timers, Serial, or INT 0.

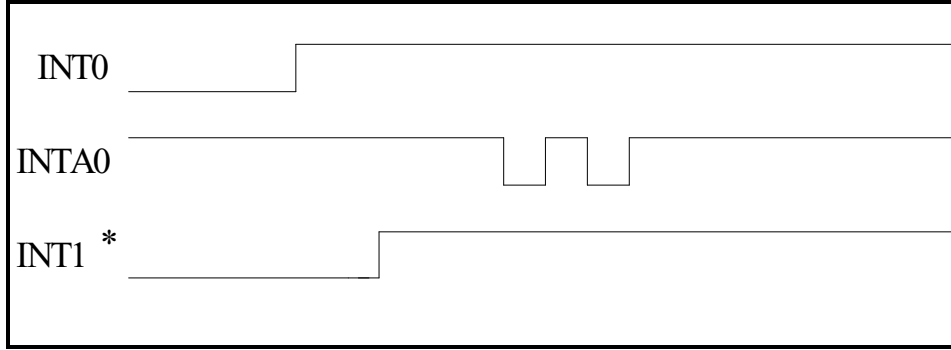
Figure 4. Correct INT 0 Acknowledge operation with a simultaneous INT 1

Correct operation acknowledges INT 0 on INTA0#. Normally, this occurs even if there is a higher priority INT 1 after INT 0 but before the acknowledge (Figure 4).

*Note: INT 1 is the only interrupt that causes the errata to occur.

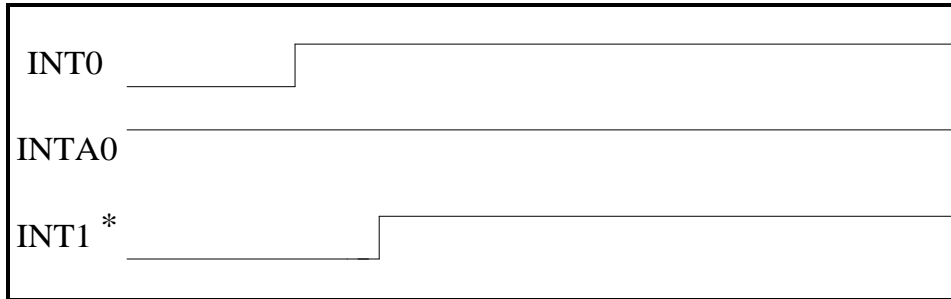
Figure 5. Incorrect INT 0 Acknowledge operation with a simultaneous INT 1

The errata occurs when INT 1, which is higher priority than INT 0, occurs between INT 0 and its expected acknowledge. The processor completes internal interrupt acknowledge cycles as seen on the status lines but no acknowledge cycle is sent on the INTA0# output (Figure 5).

*Note: This problem occurs only if INT 1 is higher priority than INT 0.

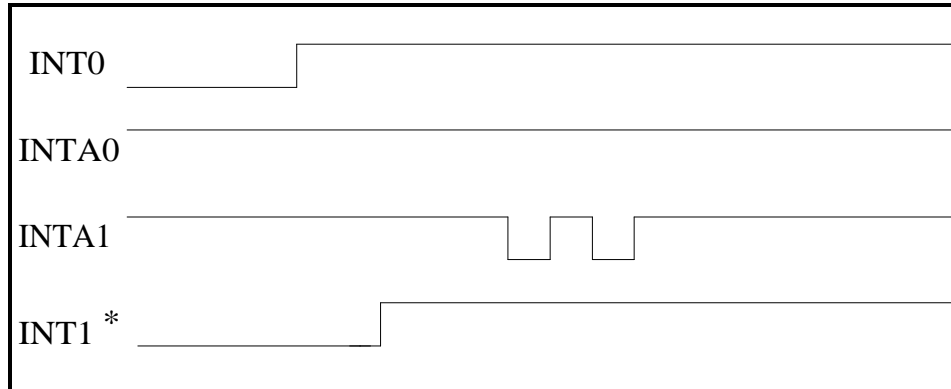
Figure 6. INT 0 and INT 1 Acknowledge Failure due to the higher priority INT 1.

If INT 0 and INT 1 are configured in cascade mode and the higher priority INT 1 occurs between INT 0 and its expected acknowledge, then the acknowledge will appear on INTA1# instead of INTA0# (Figure 6).

*Note: This problem occurs only if INT 1 is higher priority than INT 0.

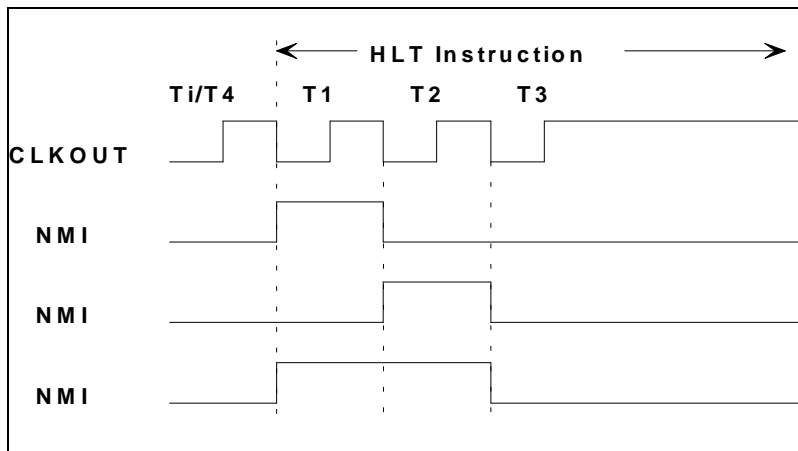
Figure 7. NMI ignored during HLT entering Powerdown

The problem occurs when an NMI occurs during execution of the HLT instruction. NMI is only serviced at valid instruction boundaries. The HLT instruction, when entering Powerdown, does not really have a boundary, it extends until Powerdown is exited. If NMI occurs between the beginning the T1 bus state and the end of the T2 state, but does not extend into T3, it will not be recognized, and the processor will enter Powerdown mode. The processor does not recognize the NMI request during the HLT instruction until the internal clock has stopped (at the end of T2).

The figures below show NMI occurring at different times during execution of the HLT instruction. Two cases are shown. Figure 7 shows cases where NMI is not recognized. Figure 8 shows cases where NMI is recognized. Both cases assume setup and hold time requirements are met for the NMI input.

If the system requires periodic NMI pulses, then the NMI pulse width must be long enough to ensure that it will extend into the T3 state of the HLT instruction. A NMI pulse width of three CLKOUT periods guarantees this.

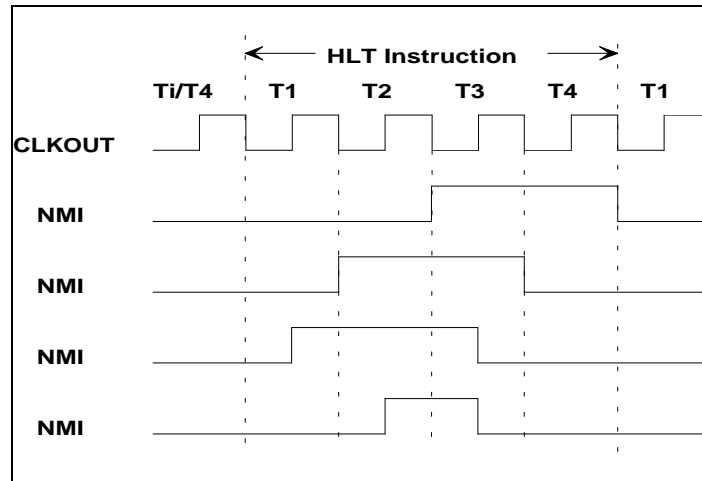
Figure 8. NMI Recognized During HLT Entering Powerdown

For the NMI to be recognized during the execution of the HLT instruction, the pulse must extend into T3. At this point, the processor has entered Powerdown and synchronized the NMI pulse. The NMI will be processed, but the processor will never enter Powerdown. Essentially, because NMI is active, the processor exits Powerdown as soon as it enters.
