80C186EC/80C188EC AND 80L186EC/80L188EC EMBEDDED MICROPROCESSORS SPECIFICATION UPDATE

Release Date: July, 1996

Order Number 272898-001

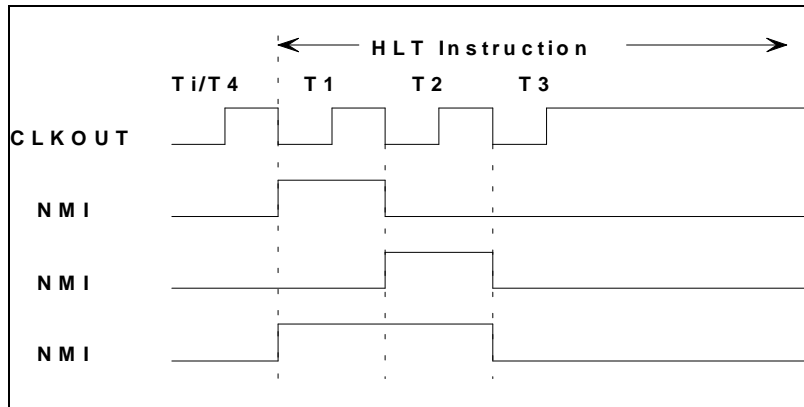
Figure 1. NMI Ignored During HLT Entering Powerdown

The problem occurs when an NMI occurs during execution of the HLT instruction. NMI is only serviced at valid instruction boundaries. The HLT instruction, when entering Powerdown, does not really have a boundary, it extends until Powerdown is exited. If NMI occurs between the beginning the T1 bus state and the end of the T2 state, but does not extend into T3, it will not be recognized, and the processor will enter Powerdown mode. The processor does not recognize the NMI request during the HLT instruction until the internal clock has stopped (at the end of T2).

The figures below show NMI occurring at different times during execution of the HLT instruction. Two cases are shown. Figure 1 shows cases where NMI is not recognized. Figure 2 shows cases where NMI is recognized. Both cases assume setup and hold time requirements are met for the NMI input.

If the system requires periodic NMI pulses, then the NMI pulse width must be long enough to ensure that it will extend into the T3 state of the HLT instruction. A NMI pulse width of three CLKOUT periods guarantees this.

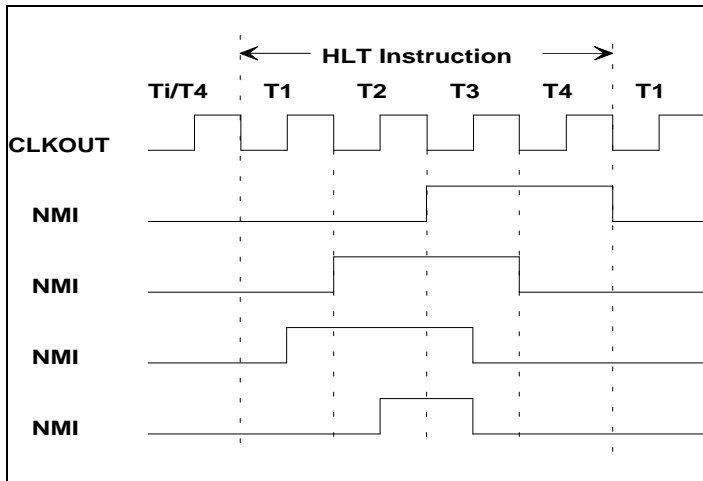
Figure 2. NMI Recognized During HLT Entering Powerdown

For the NMI to be recognized during the execution of the HLT instruction, the pulse must extend into T3. At this point, the processor has entered Powerdown and synchronized the NMI pulse. The NMI will be processed, but the processor will never enter Powerdown. Essentially, because NMI is active, the processor exits Powerdown as soon as it enters.
