8XC251Sx (8XC251SA, SB, SP, SQ) SPECIFICATION UPDATE

Release Date: September, 1996

Order Number 272836-003

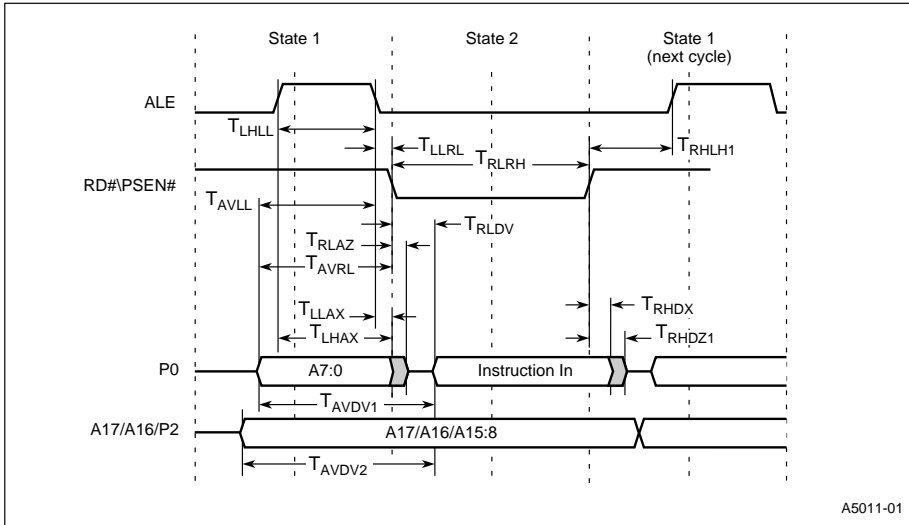
Figure 1. External Code Fetch, Nonpage Mode

PROBLEM: The TRHDZ1 (Instruction Float After RD#/PSEN# High) specification on the 8XC251Sx when operating at 12 MHz is 10 ns. However, a slow memory device such as an EPROM typically takes approximately 30 – 90 ns to float its output. (This specification generically called TPHZ, may vary from one manufacturer to another.) Figure 1 and Figure 2 illustrate the TRHDZ1 timing.

The difference between the TRHDZ1 and TPHZ specifications causes contention on the data bus (P0 in nonpage page, P2 in page mode). The 8XC251Sx begins to drive the address for the next bus cycle while the memory device is still driving data from the previous bus cycle.

To prevent this contention, designers can use a buffer to isolate the output of the memory device from the data bus (port 0 or port 2) of the 8XC251Sx. This will prevent the slow memory device from driving the data bus during the critical period after T_{RHDZ1} expires. We suggest a buffer such as the 74F541 octal, three-state line driver shown in Figure 3.
