8XC51SL

SPECIFICATION UPDATE

Release Date: July 1996

Order Number: 272877-001

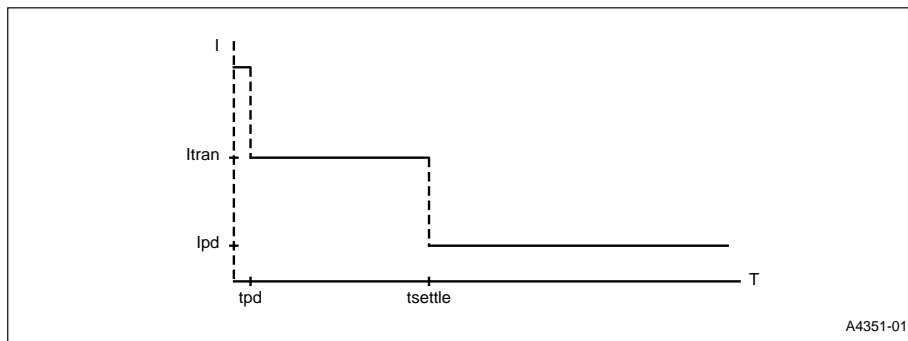
PROBLEM: Power down current (I_{pd}) transitions from I_{cc} typical to the low mA range before settling into the low μA range. I_{pd} is also higher than estimated in the product preview data sheet. The 80C51SL-BG must also have power applied at least one minute prior to entering power down mode.

WORKAROUND: No work around currently available. Limited characterization data was taken (three different lots, three units per lot) to estimate I_{pd} . The following data is not guaranteed, but should be characteristic of I_{pd} .

Symbol	Parameter	Typical (25°C)	Typical (0°C)
Itran	Transition current between Icc typical and Ipd	2 mA	3 mA
Ipd	Power down current	50 μ A	800 μ A
tsettle - tpd	Time for current to transition from Icc to Ipd	80 seconds	18 minutes

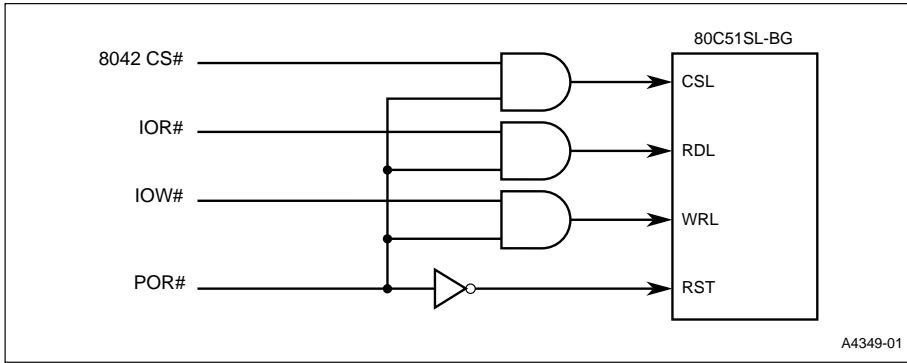
PROBLEM: Intel has confirmed that there is an intermittent reset problem with the 8XC51SL-BG. Abnormal ALE, PSEN, and Address have been observed after reset, and in some systems several of the Port 3 pins have toggled during reset.

IMPLICATION : During any of the 8XC51SL-BG resets listed, a floating node within the 8XC51SL-BG may cause internal clock signals to be killed thus not allowing a valid reset.

WORKAROUND: Workaround #1 (external logic: 3 gates). This is Intel's recommended workaround.

Drive the 8XC51SL-BG CSL, RDL, and WRL pins low during RST to guarantee a valid RST reset (typically used for power-on reset [POR]). Driving these 8XC51SL-BG pins low during reset drives the floating node to a proper state which allows reset to occur. During the time CSL, RDL, and WRL are driven low, LED0, LED2, and PCOB0-7 will be driven low from the 8XC51SL-BG.

Driving CSL, RDL, and WRL low during RST ensures that a valid RST reset (POR) occurs. It is possible for the problem node to float during non-RST resets after it has been initially set during a RST reset with the workaround in place. If this occurs the system user will have to issue one or more additional resets if the first non-RST reset fails. However, bench test experimentation has shown no reset failures after a valid PD. was applied to RST with the workaround in place. The tests were conducted at room, hot, and cold temperatures for over 8 hours with several million software resets issued. Your system should be verified to confirm that no quality issue exists on the non-RST resets after implementing this workaround. The following figure shows a typical implementation of this work around.
