# **8XC152JX**

## **SPECIFICATION UPDATE**

Release Date: July, 1996

Order Number: 272882-001

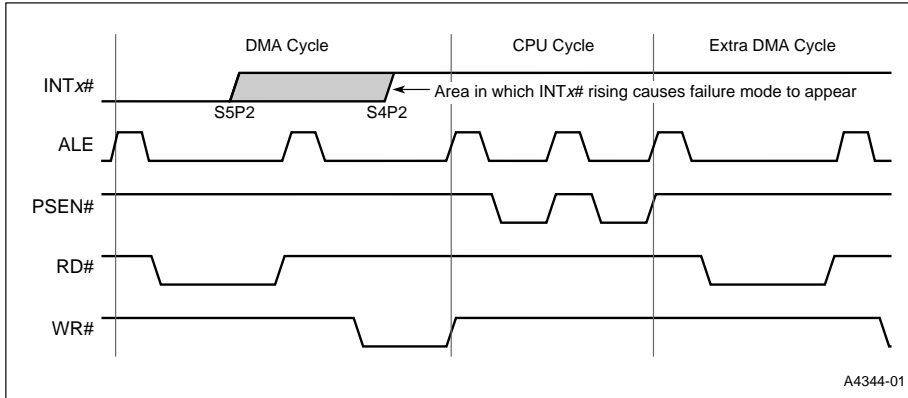
**PROBLEM:** On the 8XC152JA/JB/JC/JD, a failure mode occurs by using either DMA channel in level-sensitive, external demand mode. If, after a transfer begins, the INTx pin goes high between S5P2 and S4P2 of a DMA cycle, an extra DMA transfer will take place.

**IMPLICATION:** The condition above applies to all single-machine-cycle transfers. All DMA transfers take one machine cycle except the external-external transfer which takes two. For this mode, the bug appears only if INTx goes high between S5P2 of the first machine cycle, and S4P2 of the second.

**WORKAROUND:** At this point there are no known software or hardware workarounds. The following diagram gives a graphical description of the anomaly.

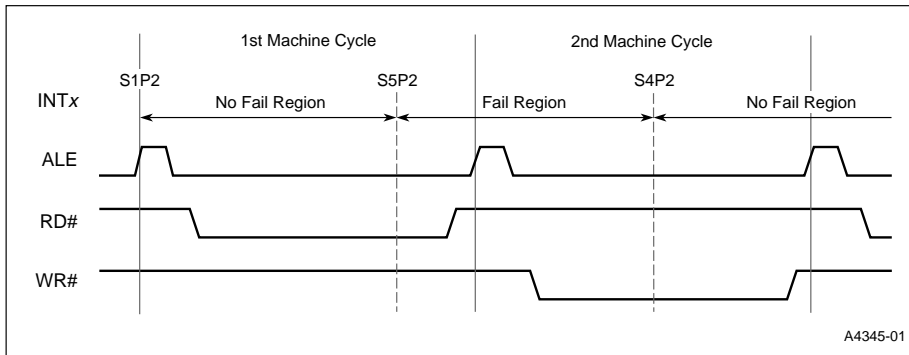
**External to External Transfer (1 Transfer Shown)**

The diagrams below illustrate the areas of a DMA transfer during which the rising edge of the INTx pin will and will not cause the bug to appear. Each of the four transfer modes are shown.
