8XC51RX

SPECIFICATION UPDATE

Release Date: July, 1996

Order Number: 272885-001

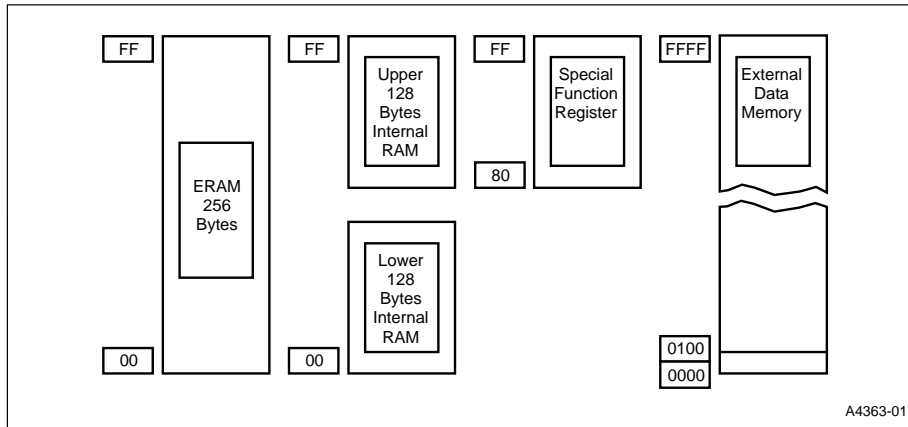
Figure 1. Internal and External Data Memory Address Space with EXTRAM = 0

Figure 1 contains the internal and external memory address space with EXTRAM = 0. This condition accesses the 256 bytes of extended RAM and disables external memory access.

PROBLEM: The default value of EXTRAM bit is 0. To use external memory, customers will need to set the EXTRAM bit to 1.
