# **8XC196KD COMMERCIAL APPLICATION SPECIFICATION UPDATE**

Release Date: July, 1996

Order Number 272833-001

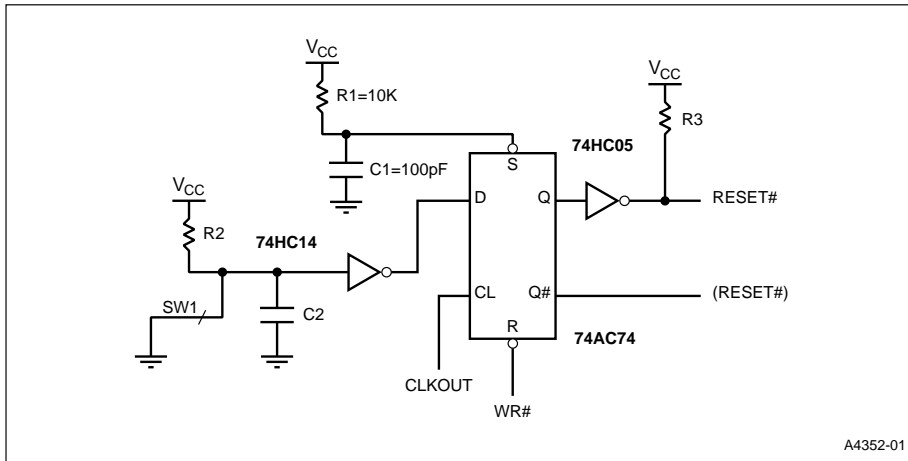
**PROBLEM:** The data bus floats asynchronously with RESET#. If reset occurs during an external write cycle, the contents of the external device may be corrupted. This is the normal operating condition for reset, and is not considered a bug. It is included on this list for those customers that may encounter corruption of data in external RAM during reset.

**IMPLICATION:** Anyone who resets a system while writing to external RAM will be affected. May have to add external circuitry if this is a problem.

**WORKAROUND:** Allow reset to occur only at the rising edge of CLKOUT and only if WR# is high. If a reset occurs during an external bus write cycle, RAM data on the external bus may be corrupted. This describes a logic design that will alleviate the problem.

The following circuit will allow a manual Reset to occur at the rising edge of CLKOUT only if WR# is high (inactive). If WR# is low (active) then RESET# will stay 'high' (inactive). The 74HC14 and 74HC05 are usually already in the system, so the only additional components are the 74AC74, R1, and C1.

1. R1 = 10K and C1 = 100 pF.
2. R2 and C2 should allow for Reset state times plus write wait states.

The  $R1 \cdot C1$  time constant is one microsecond to ensure that the flip-flop comes up 'on' after a power-up. The reset flip-flop at the rising edge of CLKOUT after the  $R2 \cdot C2$  time constant has expired.

For manual resets, the flip-flop will turn on at the next rising edge of CLKOUT unless WR# is low. If WR# is low, the flip-flop turn on will be delayed until the next rising edge of CLKOUT when WR# is not low. This may occur after any number of wait states. The  $R2 \cdot C2$  time constant must be long enough for the normal reset state times plus the maximum number of write wait states.

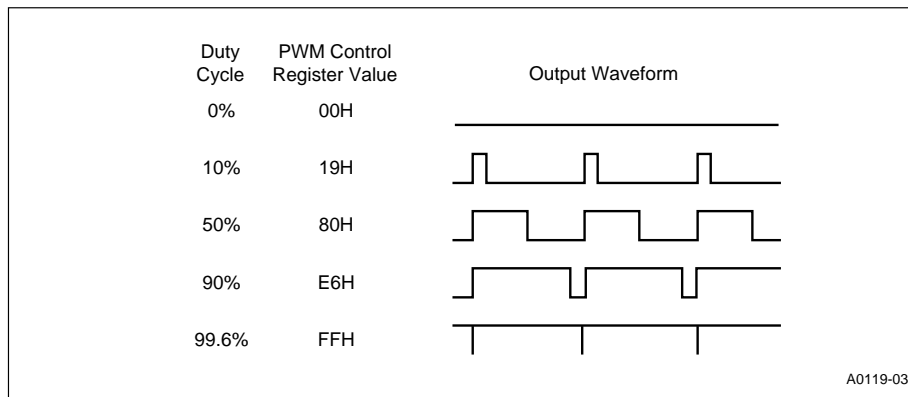
**PROBLEM:** Add the following sentences to the second paragraph after the first sentence: 'Since the value written to the control register is buffered, you can write a new 8-bit value to PWMx\_CONTROL before the counter overflows. The new value is used during the next period of PWMx.'

The following figure replaces Figure 10-2.

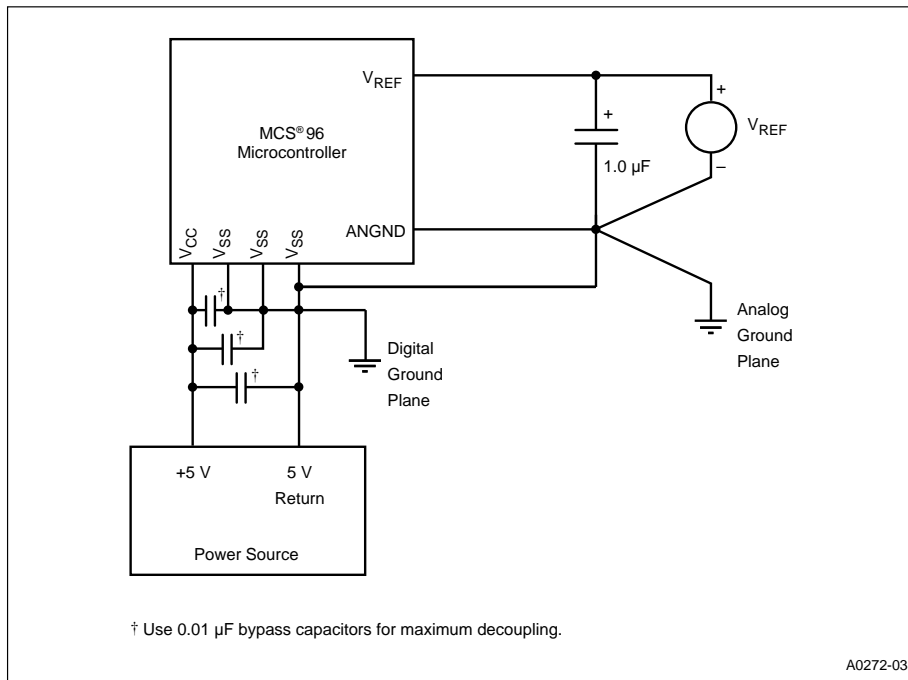
**006. Page 11-3**

**PROBLEM:** In Figure 11-2, the recommended capacitor value between  $V_{CC}$  and  $V_{SS}$  is **0.01  $\mu\text{F}$**  or greater. Also the recommended capacitor value between  $V_{REF}$  and ANGND is **1.0  $\mu\text{F}$** .

In Section 11.2.1 the reason for these capacitors is explained. However, the second to last line of the first paragraph should read as follows:

‘Connect a 0.01- $\mu\text{F}$  bypass capacitor between  $V_{CC}$  and each  $V_{SS}$  pin and a 1.0- $\mu\text{F}$  capacitor between  $V_{REF}$  and ANGND.’

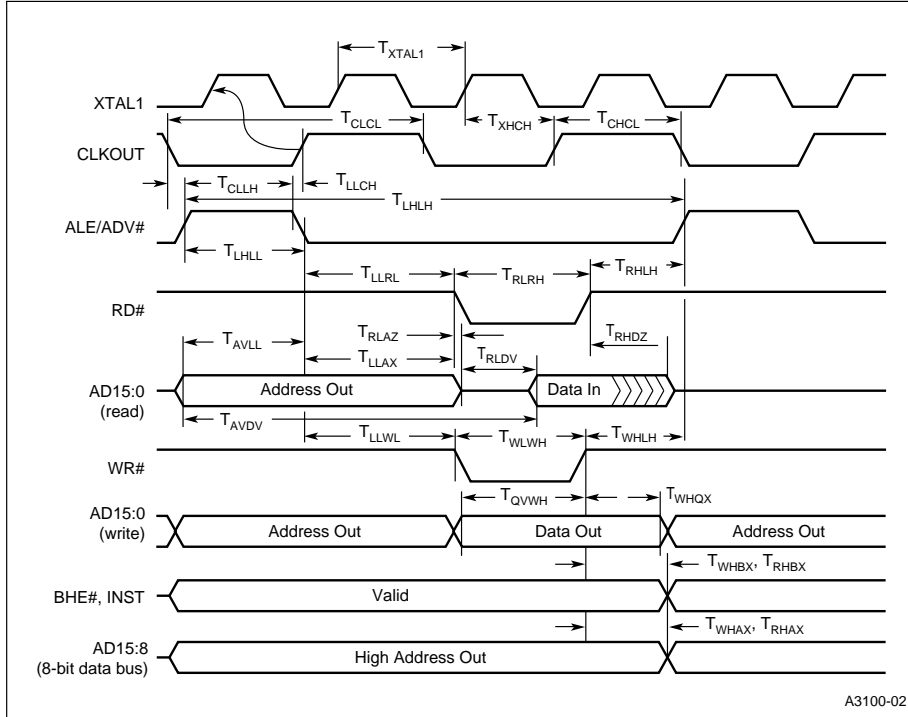
**009. Page 13-22**

**PROBLEM:** Figure 13-20 displays the system bus timing. However, there are a couple of mistakes. First, the **WR#** signal shows a range for the transition from high to low. This is incorrect, it should be a **single line**. Next, the signal labeled **BUS** should not refer to 16-bit mode only. This BUS signal shows **AD0-7 in 8-bit mode and the entire bus (AD0-15) in 16-bit mode**. The following figure replaces Figure 13-20.

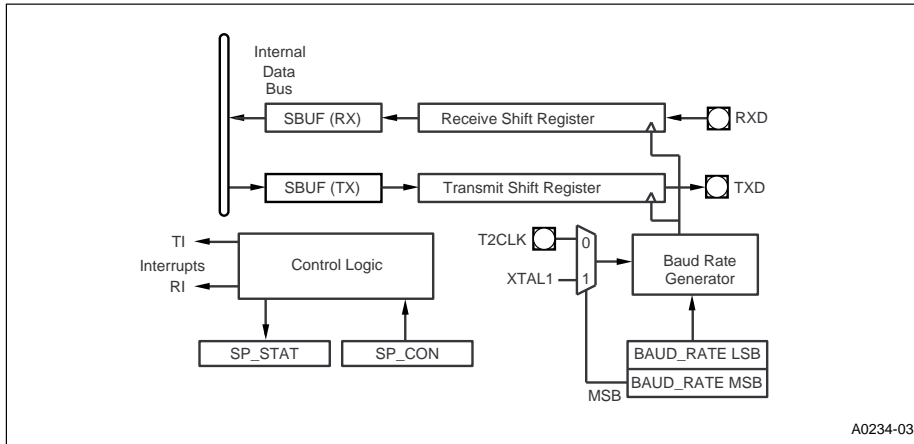
Serial Port Block Diagram

**ITEM:** The following block diagram will be included in future manuals.

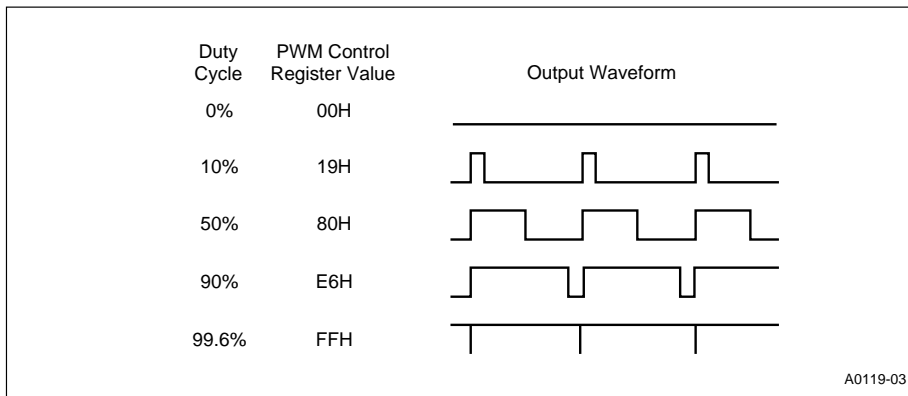
**ITEM:** On page 10-2, add the following sentences to the second paragraph after the first sentence: ‘Since the value written to the control register is buffered, you can write a new 8-bit value to PWMx\_CONTROL before the counter overflows. The new value is used during the next period of PWMx.’

The following figure replaces Figure 10-2.

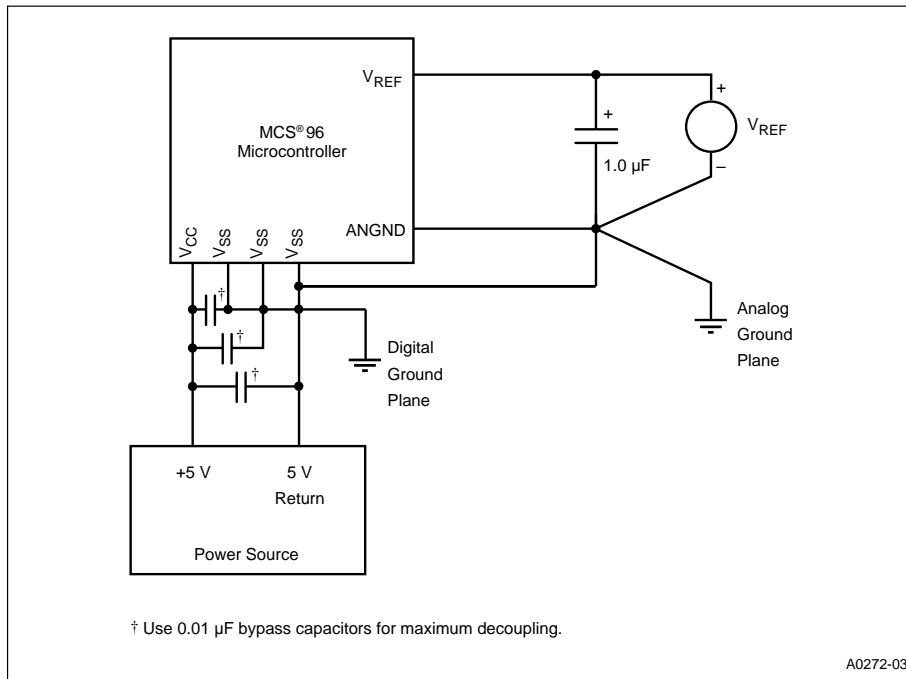
**026. Page 11-3**

**ITEM:** In Figure 11-2, the recommended capacitor value between  $V_{CC}$  and  $V_{SS}$  is **0.01**  $\mu\text{F}$  or greater. Also the recommended capacitor value between  $V_{REF}$  and ANGND is **1.0**  $\mu\text{F}$ . The following figure replaces Figure 11-2:

In Section 11.2.1, the reason for these capacitors is explained. However, the second to last line of the first paragraph should read as follows:

‘Connect a 0.01- $\mu\text{F}$  bypass capacitor between  $V_{CC}$  and each  $V_{SS}$  pin and a 1.0- $\mu\text{F}$  capacitor between  $V_{REF}$  and ANGND.’

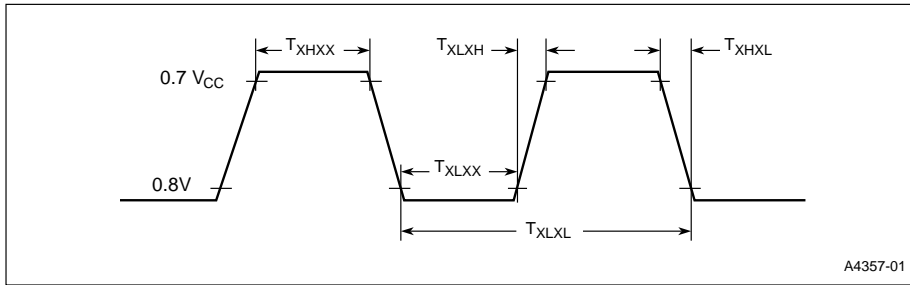
Figure 11-6. External Clock Drive

**ITEM:** In Figure 11-6, the timing diagram incorrectly represents the  $T_{xld}$  and  $T_{xhd}$  timing specifications. The timing diagram below replaces Figure 11-6.

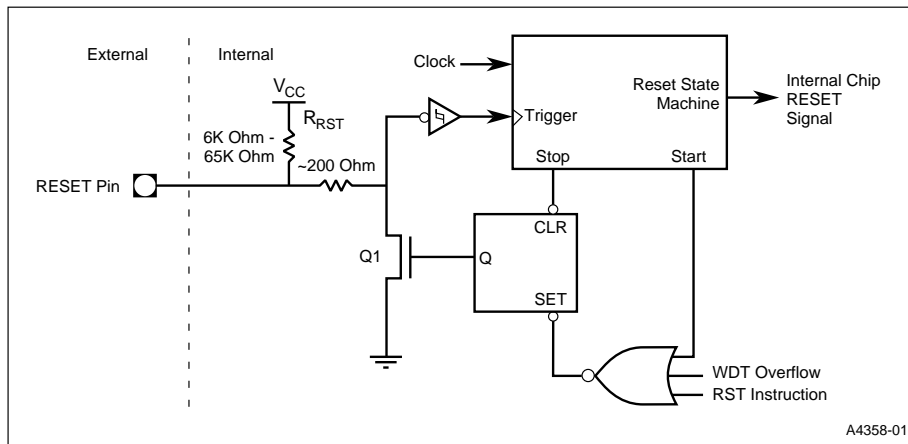
**Figure 11-8. Reset Pin Internal Circuit**

**ITEM:** Figure 11-8 shows the reset pin internal circuit. However, there are a couple of mistakes; the following figure shows the corrected version. The **inverter** at the Reset State Machines Trigger input and the **OR gate** at the SET input of the latch are the corrections to this figure.
