# **8XC196KC SPECIFICATION UPDATE**

Release Date: March, 1997

Order Number: 272834-003

The 8XC196KC may contain design defects or errors known as errata. Characterized errata that may cause the 8XC196KC's behavior to deviate from published specifications are documented in this specification update.

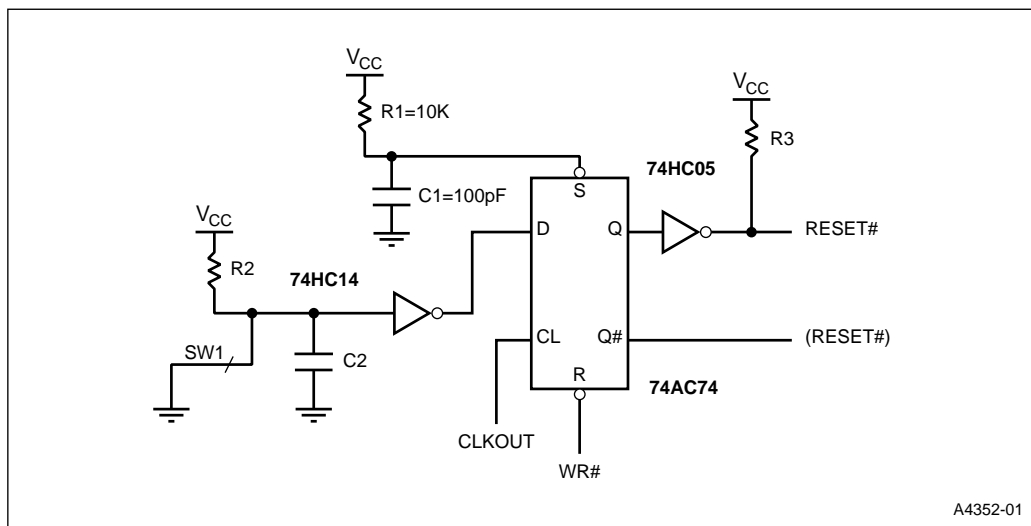
**PROBLEM:** The data bus floats asynchronously with RESET#. If reset occurs during an external write cycle, the contents of the external device may be corrupted. This is the normal operating condition for reset, and is not considered a bug. It is included on this list for those customers who may encounter corruption of data in external RAM during reset.

**WORKAROUND:** Allow reset to occur only at the rising edge of CLKOUT and only if WR# is high. If a reset occurs during an external bus write cycle, RAM data on the external bus may be corrupted. This describes a logic design that will alleviate the problem.

The following circuit will allow a manual reset to occur at the rising edge of CLKOUT only if WR# is high (inactive). If WR# is low (active) then RESET# will stay high (inactive). The 74HC14 and 74HC05 are usually already in the system, so the only additional components are the 74AC74, R1, and C1.

1. R1 = 10K ohms and C1 = 100 pF.
2. R2 and C2 should allow for reset state times plus write wait states.

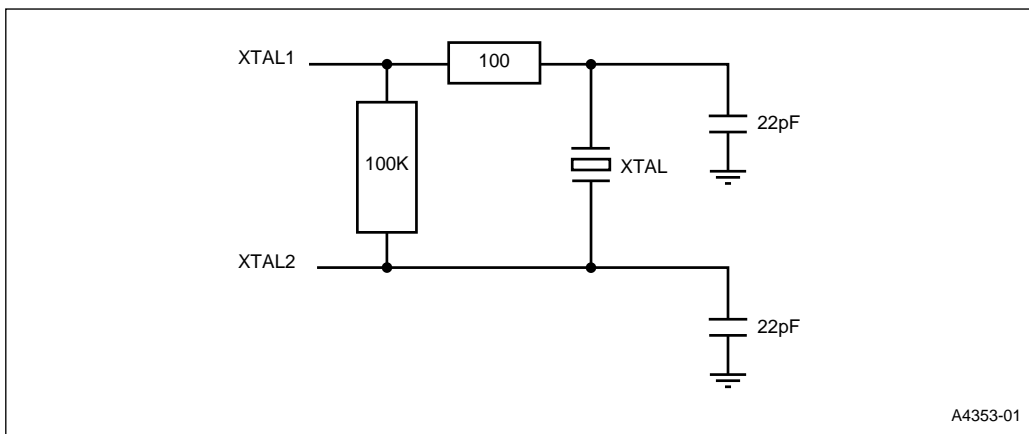
**Figure 1. Options for Decreasing Noise Sensitivity**

More than 1.2 volts of peak-to-peak noise between internal  $V_{SS}$  and  $V_{SS1}$  may cause the oscillator to enter state 2 or state 3. A clean design with good decoupling minimizes the voltage difference between  $V_{SS}$  and  $V_{SS1}$ . Noise can be caused by both internal device switching and external circuitry.

**IMPLICATION:** Several customers have reported noise sensitivity when using the on-chip oscillator of the 80C196KC. Only devices with either no suffix after the topside tracking number or a "B" suffix are involved. Designs using an external oscillator are not affected. The B-3 stepping with a "C" suffix fixes the problem. All customers who use a crystal or ceramic resonator and do not follow the recommendations will be affected. Customers using an external oscillator will not be affected.

6. Decouple each  $V_{SS}$  and  $V_{SS1}$  pin to  $V_{CC}$ .
7. Place a 100 K resistor between XTAL1 and XTAL2. (See Figure 1.)
8. Place a 100 K resistor in series between XTAL1 and the crystal. (See Figure 1.)
9. Thoroughly test each system over its operating range.
10. Use an external oscillator if possible.

Some or all of these suggestions should allow the oscillator to function properly in a system. We have had no reported failures over commercial temperatures ( $0^{\circ}$  to  $70^{\circ}\text{C}$ ) in designs using suggestions 1 through 6.

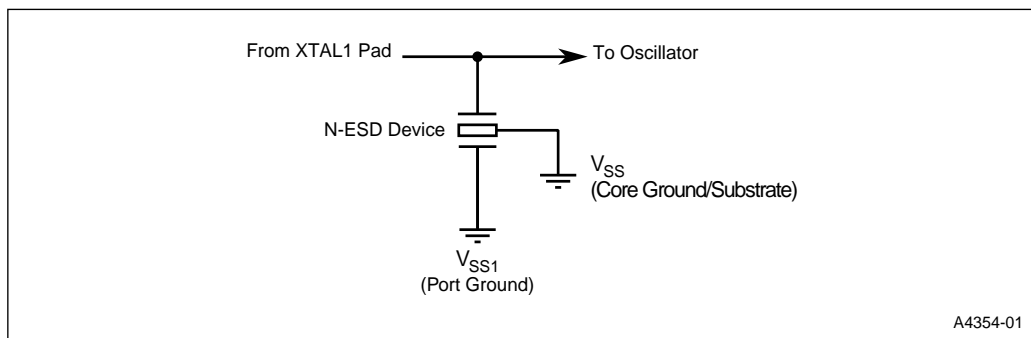
**Figure 2. Internal ESD Protection**

There are two grounds within the chip, core  $V_{SS}$  and port  $V_{SS1}$ . They are not tied together in the chip in order to isolate the core  $V_{SS}$  from noise on port  $V_{SS1}$ . Normally, noise on  $V_{SS}$  and  $V_{SS1}$  is decoupled externally by filter capacitors and a ground plane. If the grounding and decoupling are not sufficient, a voltage difference can occur between  $V_{SS}$  and  $V_{SS1}$ . From Figure 2, one can see that when  $V_{SS1}$  is around 0.6 volts negative with respect to  $V_{SS}$ , the protection device can start to turn on. The resulting current is well below the leakage specs for the I/O pins and has negligible effect except on the extremely high impedance XTAL1 input.

This minute leakage may cause the DC bias level on XTAL1 to decrease, resulting in reduced gain in the oscillator stage. The oscillation magnitude decreases from the normal rail-to-rail transitions to the point that it may not trigger the internal clocks. CLKOUT then stops or exhibits missing transitions and a decrease in frequency. The signal at XTAL2 drops to about 1.5 volts peak-to-peak centered around 3.5 volts ( $V_{CC} = 5$  volts). The impedance of the internal 2 M-ohm resistor between XTAL2 and XTAL1 is too large to return the oscillator bias level to the region of maximum gain.

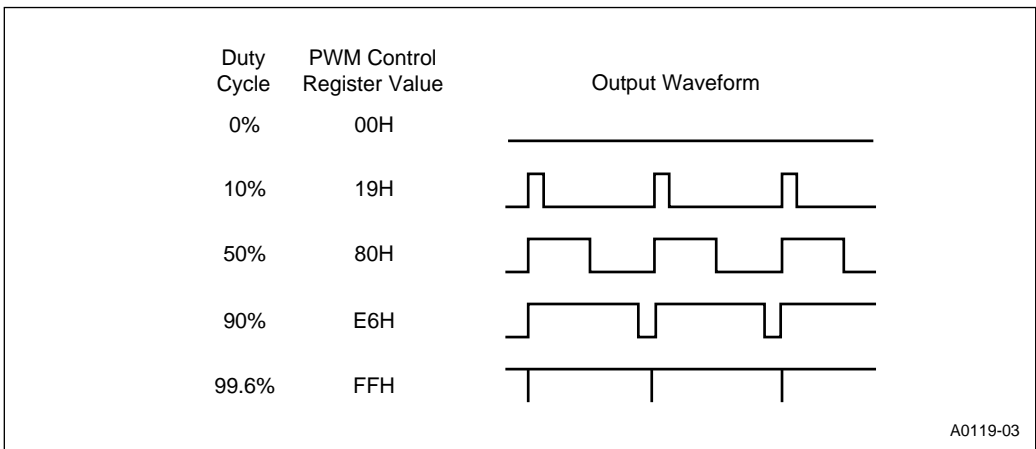
**PROBLEM:** Add the following sentences to the second paragraph after the first sentence: 'Since the value written to the control register is buffered, you can write a new 8-bit value to PWMx\_CONTROL before the counter overflows. The new value is used during the next period of PWMx.'

The following figure replaces Figure 10-2.

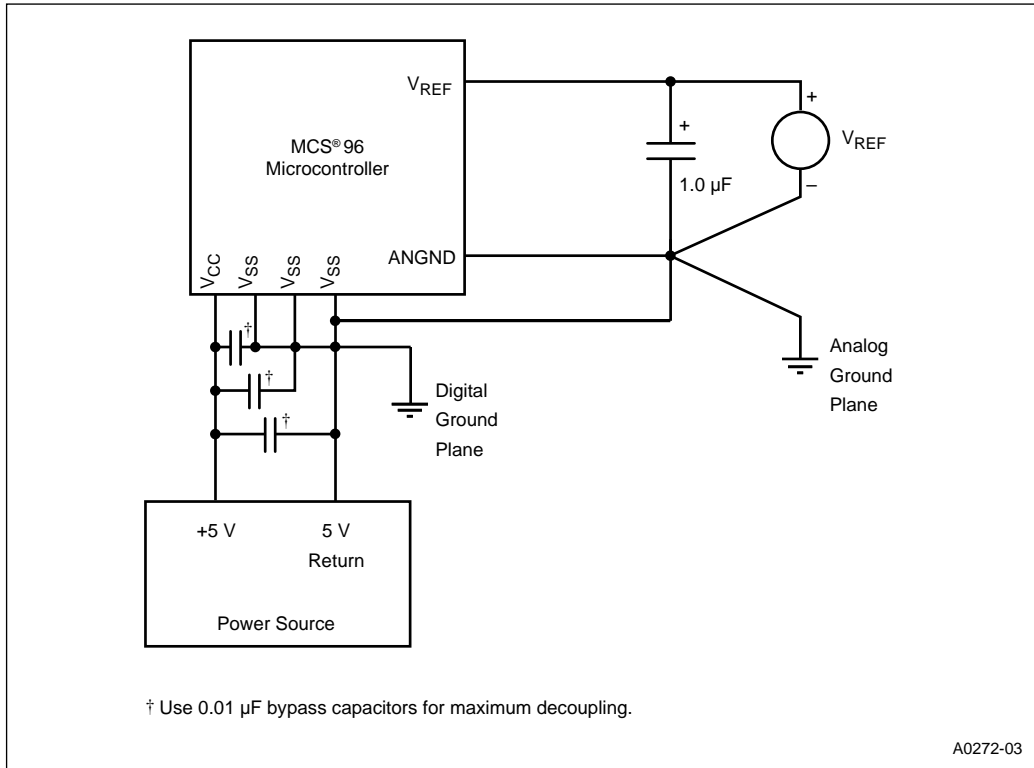
**006. Page 11-3**

**PROBLEM:** In Figure 11-2, the recommended capacitor value between  $V_{CC}$  and  $V_{SS}$  is 0.01  $\mu\text{F}$  or greater. Also the recommended capacitor value between  $V_{REF}$  and ANGND is 1.0  $\mu\text{F}$ .

Section 11.2.1 explains the reason for these capacitors. However, the second to last line of the first paragraph should read as follows: 'Connect a 0.01- $\mu\text{F}$  bypass capacitor between  $V_{CC}$  and each  $V_{SS}$  pin and a 1.0- $\mu\text{F}$  capacitor between  $V_{REF}$  and ANGND.'

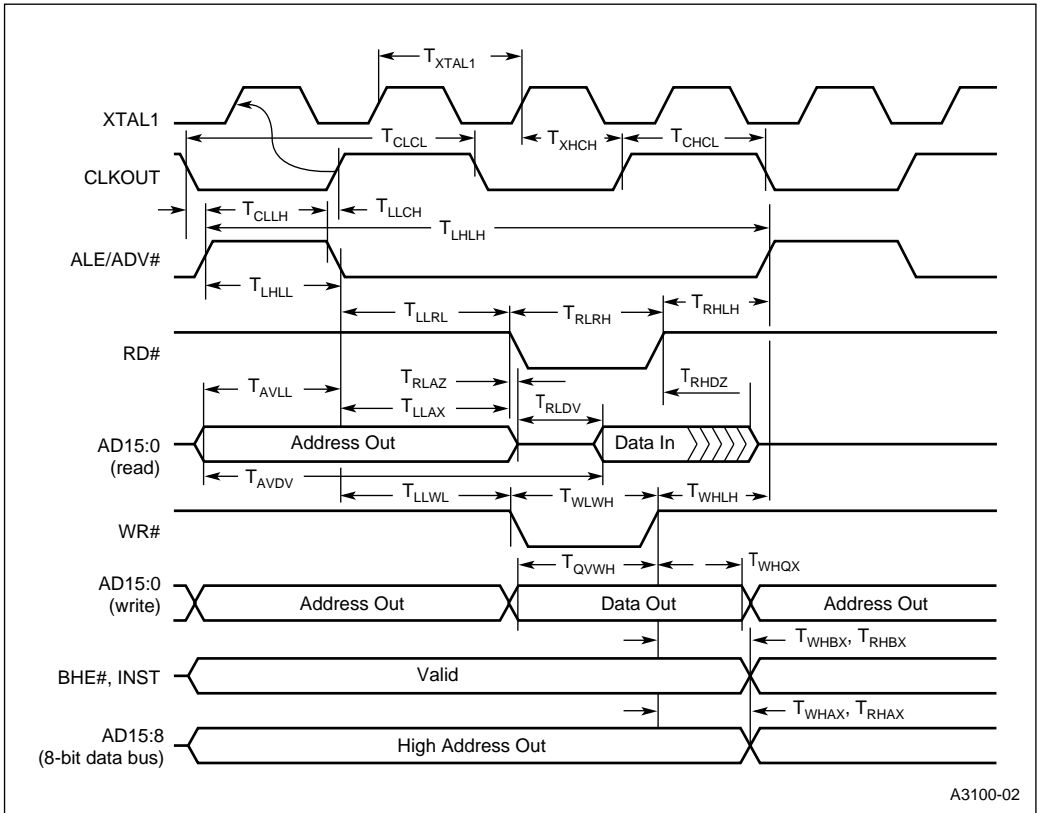
**009. Page 13-22**

**PROBLEM:** Figure 13-20 displays the system bus timing. However, there are a couple of mistakes. First, the WR# signal shows a range for the transition from high to low. This is incorrect; it should be a single line. Next, the signal labeled BUS should not refer to 16-bit mode only. This BUS signal shows AD0-7 in 8-bit mode and the entire bus (AD0-15) in 16-bit mode. The corrected diagram is as follows:

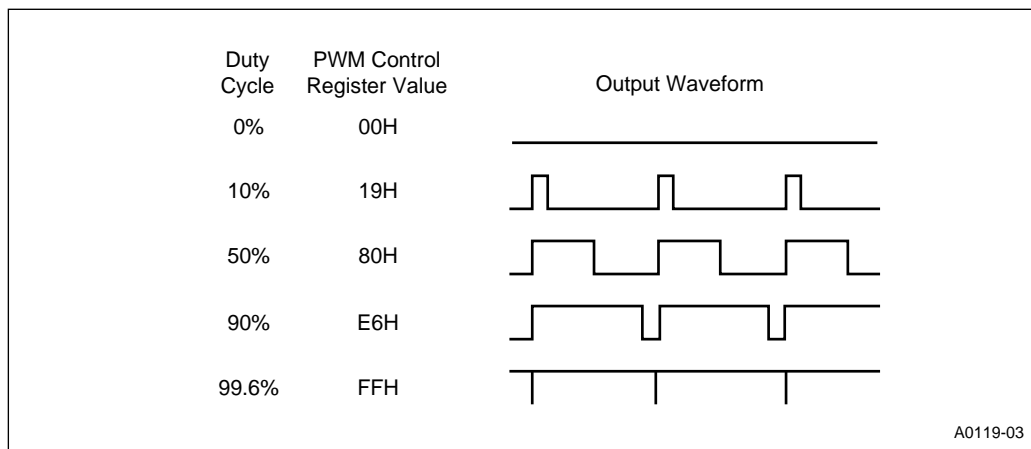
**ITEM:** On page 10-2, add the following sentences to the second paragraph, after the first sentence: 'Since the value written to the control register is buffered, you can write a new 8-bit value to PWMx\_CONTROL before the counter overflows. The new value is used during the next period of PWMx.'

The following figure replaces Figure 10-2.

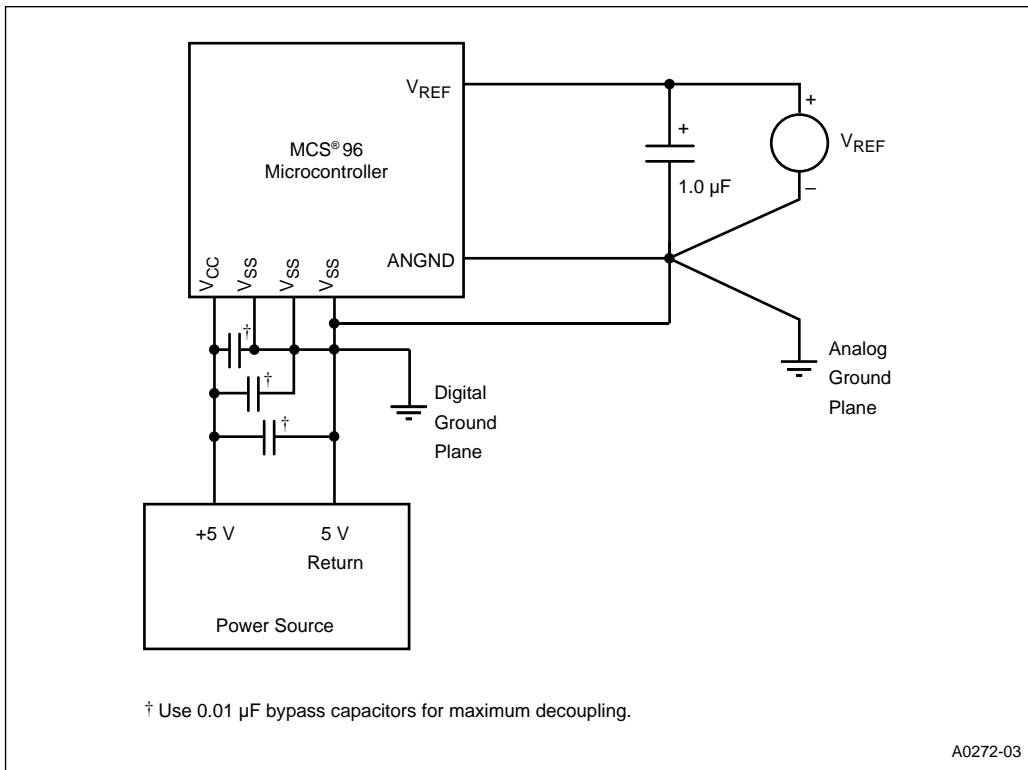
**026. Page 11-3**

**ITEM:** In Figure 11-2, the recommended capacitor value between  $V_{CC}$  and  $V_{SS}$  is **0.01  $\mu\text{F}$**  or greater. Also, the recommended capacitor value between  $V_{REF}$  and ANGND is **1.0  $\mu\text{F}$** . The following figure replaces Figure 11-2:

In Section 11.2.1, the reason for these capacitors is explained. However, the second to last line of the first paragraph should read as follows:

‘Connect a 0.01- $\mu\text{F}$  bypass capacitor between  $V_{CC}$  and each  $V_{SS}$  pin and a 1.0- $\mu\text{F}$  capacitor between  $V_{REF}$  and  $ANGND$ .’

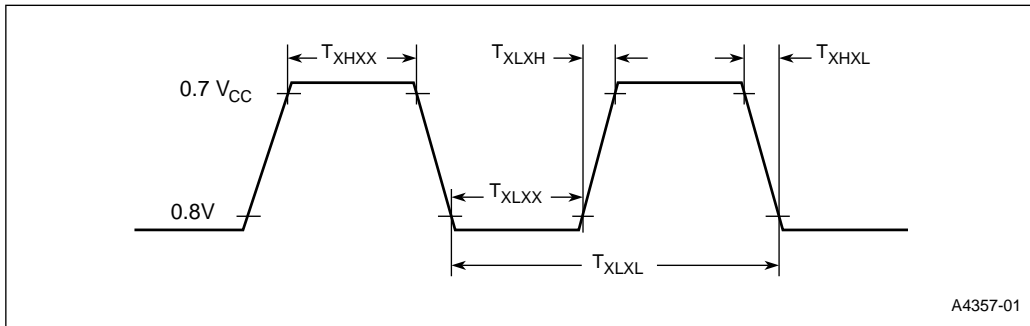
Figure 11-6. External Clock Drive

**ITEM:** In Figure 11-6, the timing diagram incorrectly represents the  $T_{XLXL}$  and  $T_{XHXL}$  timing specifications. The timing diagram below replaces Figure 11-6.

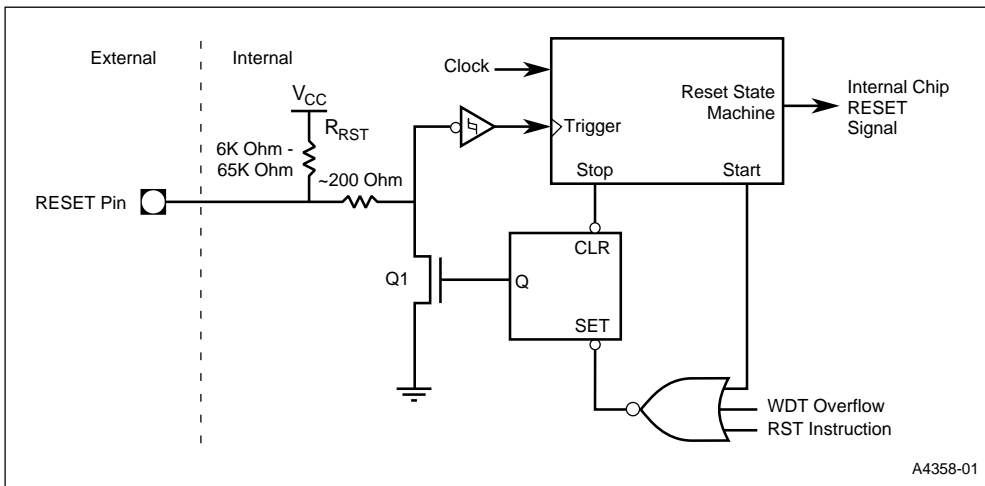
Figure 11-8. Reset Pin Internal Circuit

**ITEM:** Figure 11-8 shows the reset pin internal circuit. However, there are a couple of mistakes; the following figure shows the corrected version. The **inverter** at the Reset State Machine’s Trigger input and the **OR gate** at the SET input of the latch are the corrections to this figure.
