8XC196KB SPECIFICATION UPDATE

Release Date: December, 1996

Order Number: 272835-002

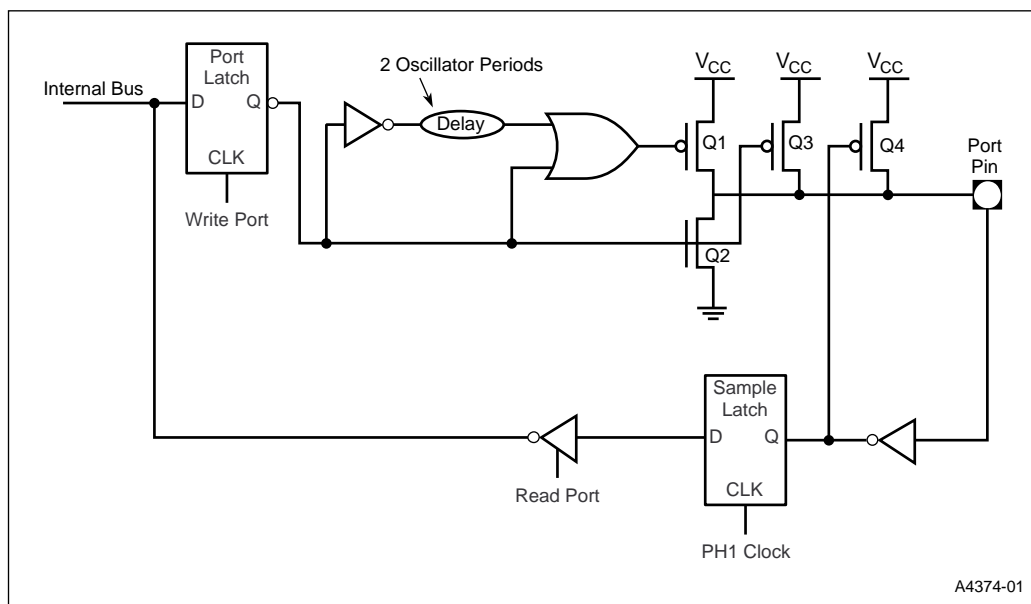
Figure 1. Quasi-bidirectional Port Circuit

PROBLEM: To meet the device characteristics at low temperatures, the specification for I_{TL} on the 8XC198 and 8XC196KB/8XC196KB16 (where X = 0, 3, or 7) devices has changed from -650 μA to -800 μA .

The I_{TL} specification is the maximum current that the 8XC196KB quasi-bidirectional pins can source during the transition from a logic 1 to a logic 0 input. Figure 1 shows the quasi-bidirectional port circuit. When the port is configured as an input, the output of the port latch is a '0'. Therefore, Q3 is weakly pulling the port pin high. When the external circuitry drives the pin high, Q4 also is turned on and holds the port pin signal high. As the external circuitry decreases the voltage below V_{CC} toward logic 0, Q4 begins to turn off. However, due to transistor characteristics, Q4 will source increasing amounts of current until the threshold voltage of the transistor is reached. Then Q4 will turn off, leaving only Q3 driving the port pin signal high.

IMPLICATION: Customers using the quasi-bidirectional pins as input should analyze their applications to see if their external circuitry can handle 80 μ A of current from the quasi-bidirectional pins during the transition period explained above.

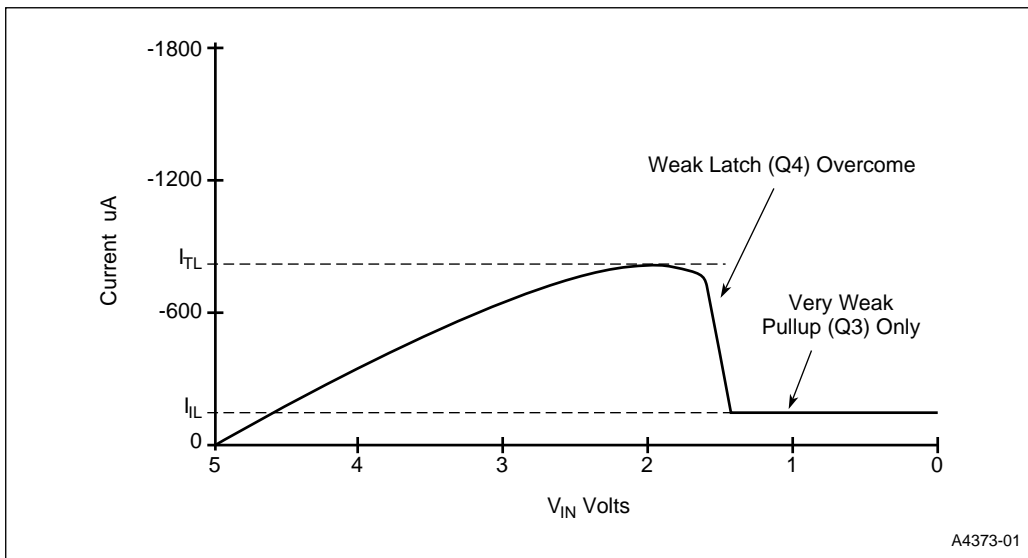
Figure 2. Quasi-bidirectional Port DC Characteristics (“1” Written to Port Pin)

Figure 2 shows the transfer characteristic of the port pin during the input's transition from logic 1 to logic 0. The I_{IL} specification shows the amount of current Q3 will source after Q4 turns off. The I_{TL} specification gives the maximum amount of current that Q4 will source during the input's transition from logic 1 to logic 0.

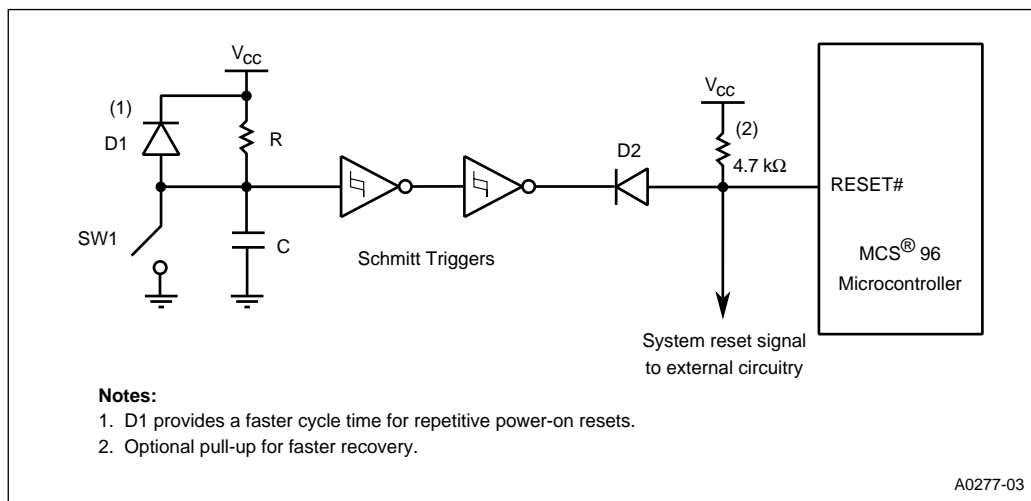
Figure 3. Improved System Reset Circuit

PROBLEM: The following improved system reset circuit shown in Figure 3 may be used in conjunction with the *80C196KB User's Guide (270651-003)*.

The system reset circuit in the *80C196KB User's Guide* has been used successfully by many customers for a long period of time. Both circuits should be evaluated in the user's system.
