# **87C196KQ SPECIFICATION UPDATE**

Release Date: January, 1997

Order Number: 272837-002

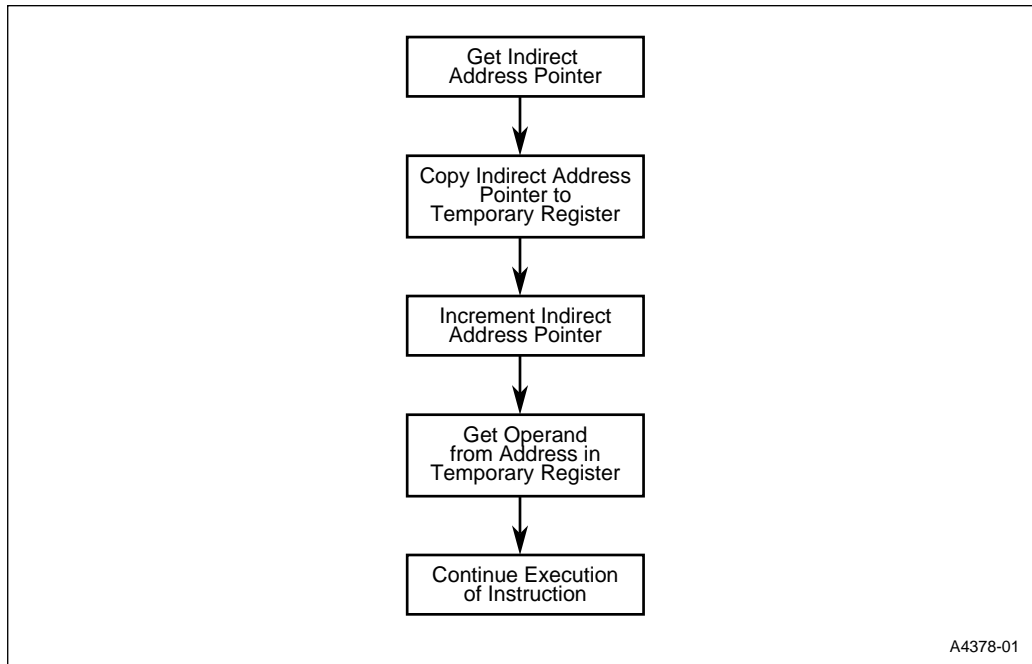
**PROBLEM:** For indirect addressing with autoincrement, a pointer that points to itself results in an access to the incremented pointer address rather than the original pointer address.

The CPU stores the pointer's value in a temporary register, increments the pointer, then accesses the operand at the address contained in the temporary register, as shown in this flowchart.

Therefore, if the pointer points to itself, the CPU accesses the operand at the incremented address contained in the pointer.

**WORKAROUND:** Avoid using an indirect address pointer that points to itself. For example, assume ax = 1CH, bx = 1DH, and cx = 40H. The following code causes the CPU to access the operand at the intended, unincremented address:

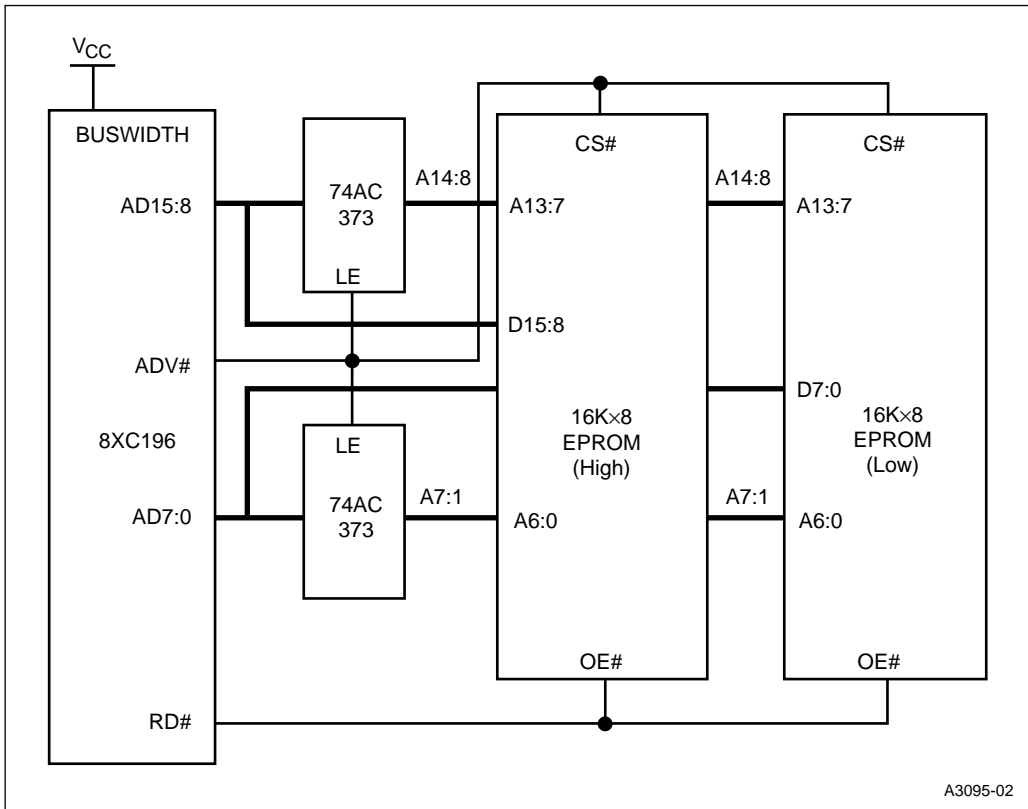
**Figure 1. 16-bit System with EPROM**

- 001.**        *High address inputs to the low EPROM should be A14:8 in Figure 15-18.*

**ITEM:** The next revision of the user's manual will include the following corrected graphic.
