8XC196KD AUTOMOTIVE APPLICATION SPECIFICATION UPDATE

Release Date: July, 1996

Order Number 272839-001

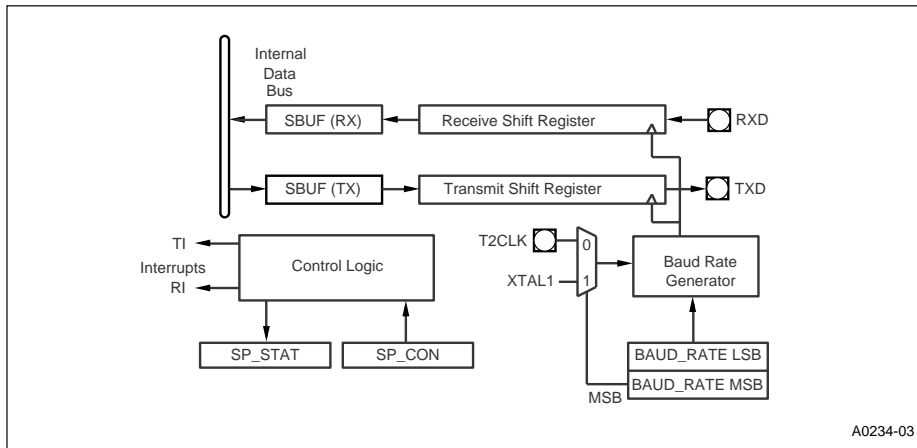
Serial Port Block Diagram

ITEM: The following block diagram will be included in future manuals.

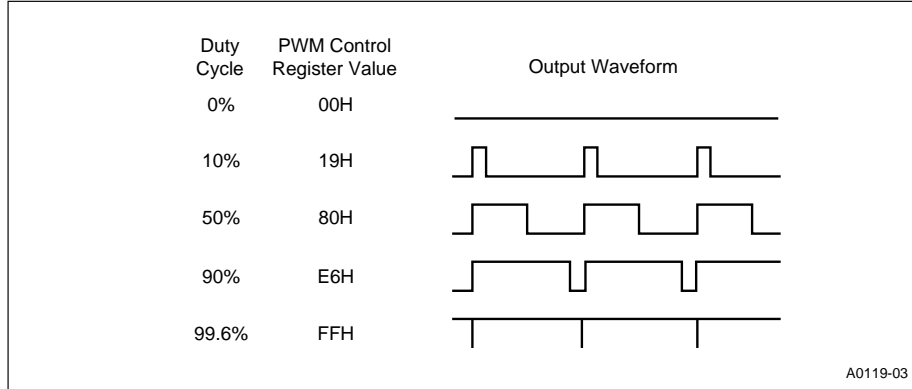
ITEM: On page 10-2, add the following sentences to the second paragraph after the first sentence: 'Since the value written to the control register is buffered, you can write a new 8-bit value to PWMx_CONTROL before the counter overflows. The new value is used during the next period of PWMx.'

The following figure replaces Figure 10-2:

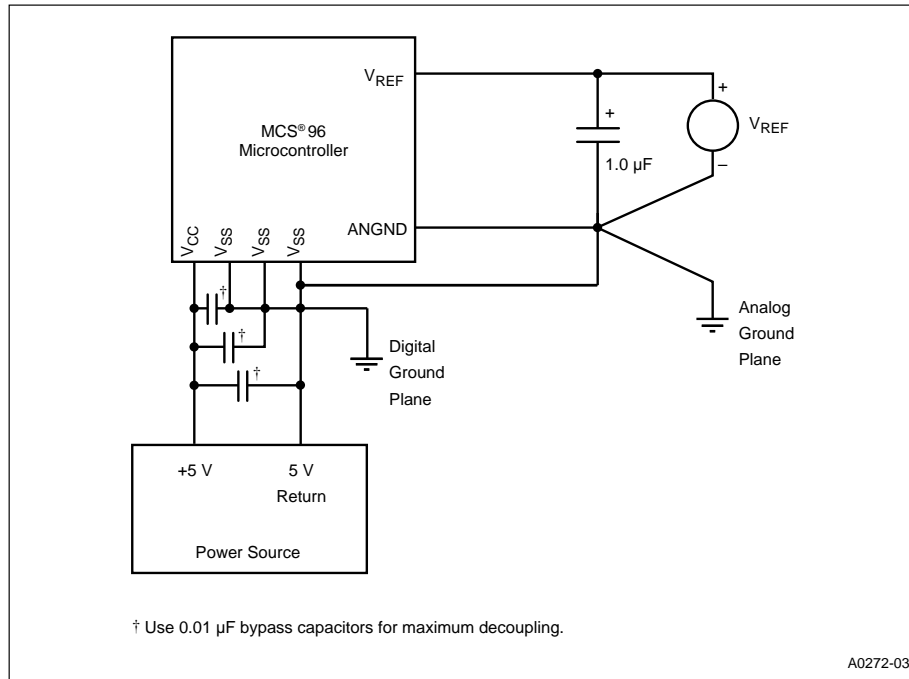
ITEM: In Figure 11-2, the recommended capacitor value between V_{CC} and V_{SS} is **0.01 μF** or greater. Also the recommended capacitor value between V_{REF} and ANGND is **1.0 μF** . The following figure replaces Figure 11-2:

In Section 11.2.1, the reason for these capacitors is explained. However, the second to last line of the first paragraph should read as follows:

'Connect a 0.01- μF bypass capacitor between V_{CC} and each V_{SS} pin and a 1.0- μF capacitor between V_{REF} and ANGND.'

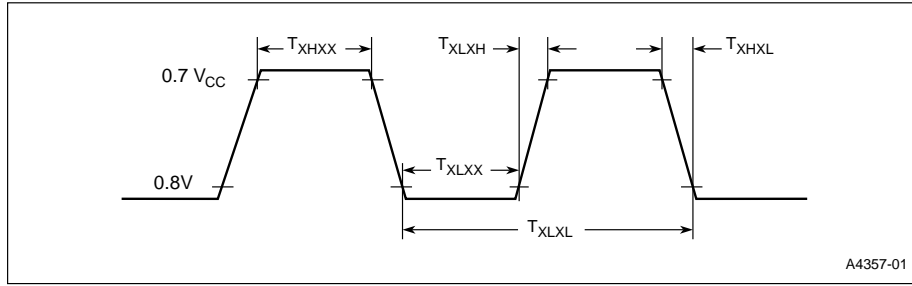
Figure 11-6. External Clock Drive

ITEM: In Figure 11-6, the timing diagram incorrectly represents the T_{xkl} and T_{xhkl} timing specifications. The timing diagram below replaces Figure 11-6.

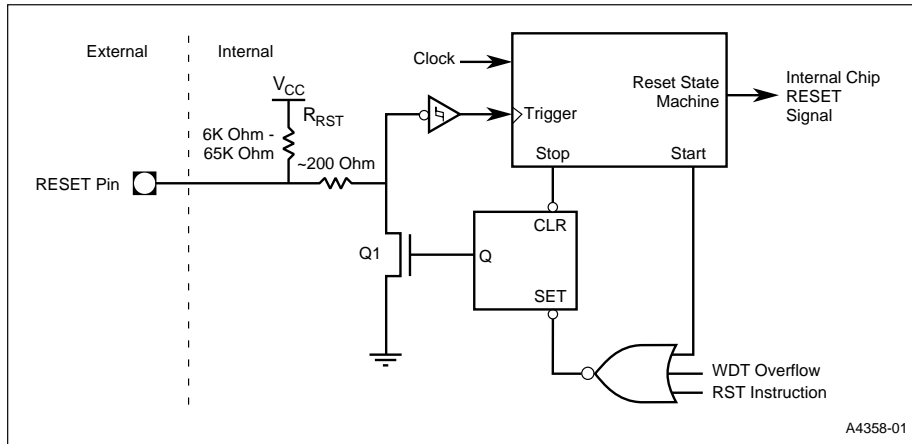
Figure 11-8. Reset Pin Internal Circuit

ITEM: Figure 11-8 shows the reset pin internal circuit. However, there are a couple of mistakes; the following figure shows the corrected version. The **inverter** at the Reset State Machines Trigger input and the **OR gate** at the SET input of the latch are the corrections to this figure.
