# **87C196JQ SPECIFICATION UPDATE**

Release Date: January, 1997

Order Number: 272857-002

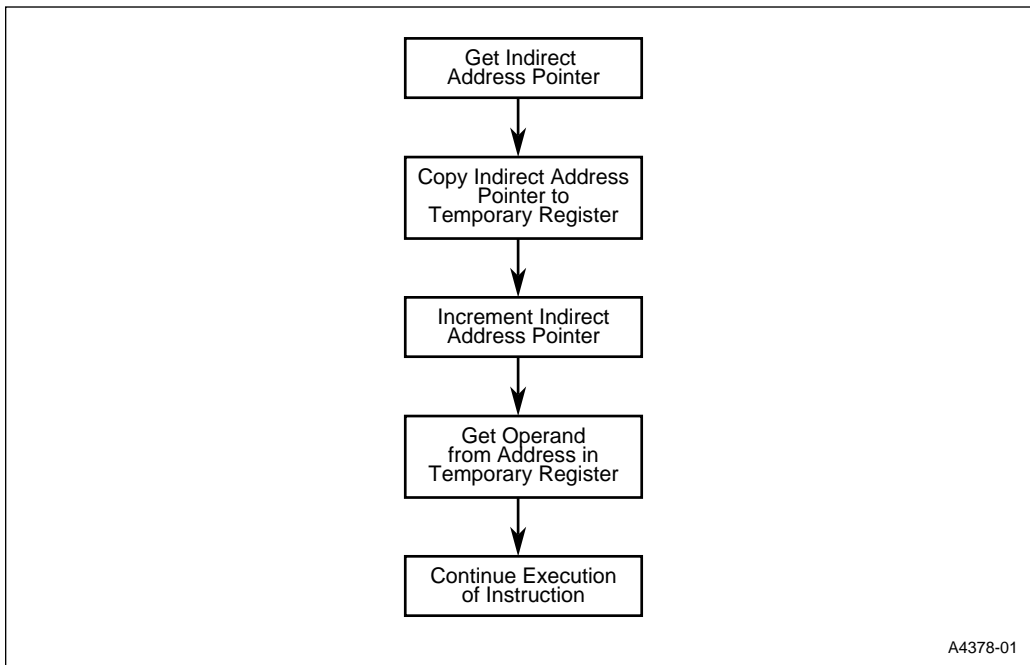
**008. Indirect Addressing With AutoIncrement**

**PROBLEM:** For indirect addressing with autoincrement, a pointer that points to itself results in an access to the incremented pointer address rather than the original pointer address.

The CPU stores the pointer's value in a temporary register, increments the pointer, then accesses the operand at the address contained in the temporary register, as shown in this flowchart.

Therefore, if the pointer points to itself, the CPU accesses the operand at the incremented address contained in the pointer.

**WORKAROUND:** Avoid using an indirect address pointer that points to itself.
