# **87C196JR SPECIFICATION UPDATE**

Release Date: March, 1997

Order Number: 272858-003

The 87C196JR may contain design defects or errors known as errata. Characterized errata that may cause the 87C196JR's behavior to deviate from published specifications are documented in this specification update.

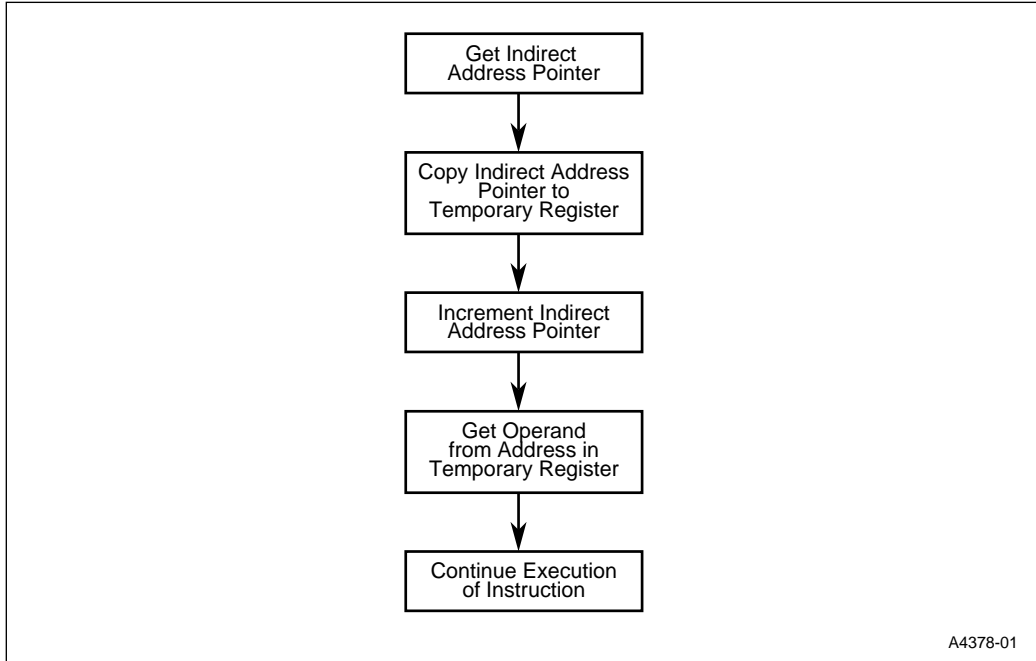
**008. Indirect Addressing With AutoIncrement**

**PROBLEM:** For indirect addressing with autoincrement, a pointer that points to itself results in an access to the incremented pointer address rather than the original pointer address.

The CPU stores the pointer's value in a temporary register, increments the pointer, then accesses the operand at the address contained in the temporary register, as shown in this flowchart.

Therefore, if the pointer points to itself, the CPU accesses the operand at the incremented address contained in the pointer.

**WORKAROUND:** Avoid using an indirect address pointer that points to itself.

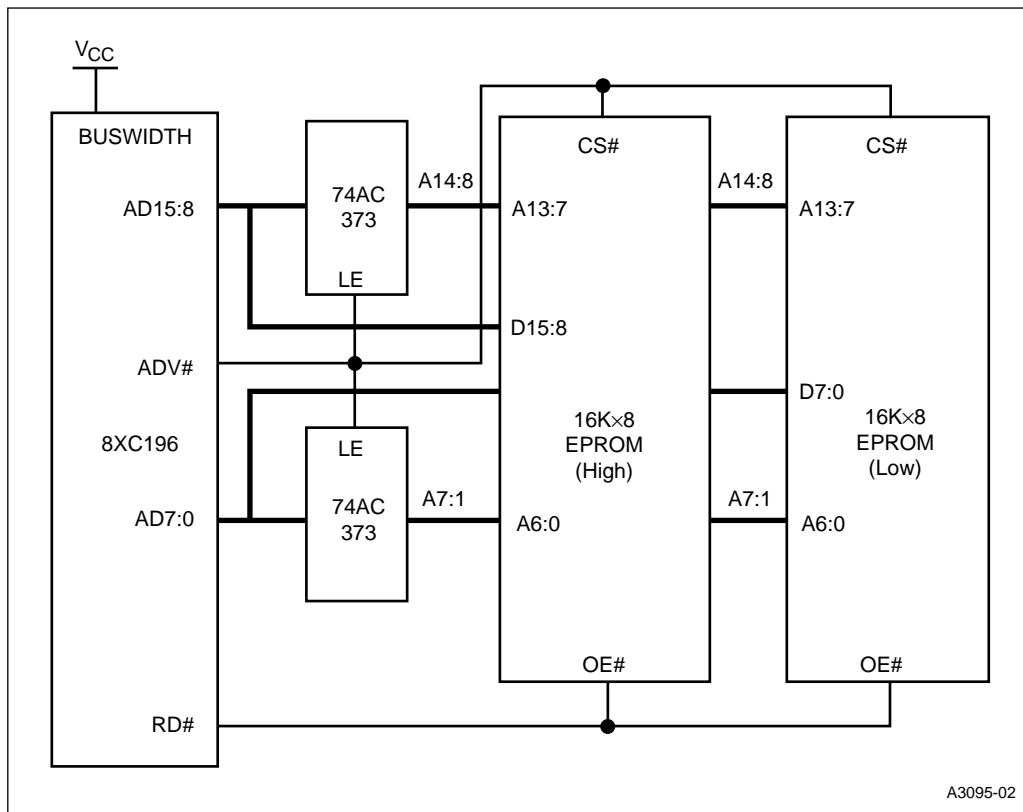
**Figure 1. 16-bit System with EPROM**

**001.** *High address inputs to the low EPROM should be A14:8 in Figure 15-18.*

**ITEM:** The next revision of the user's manual will include the following corrected graphic.
