# **87C196JT/87C196JT 20 MHz SPECIFICATION UPDATE**

Release Date: March, 1997

Order Number: 272859-003

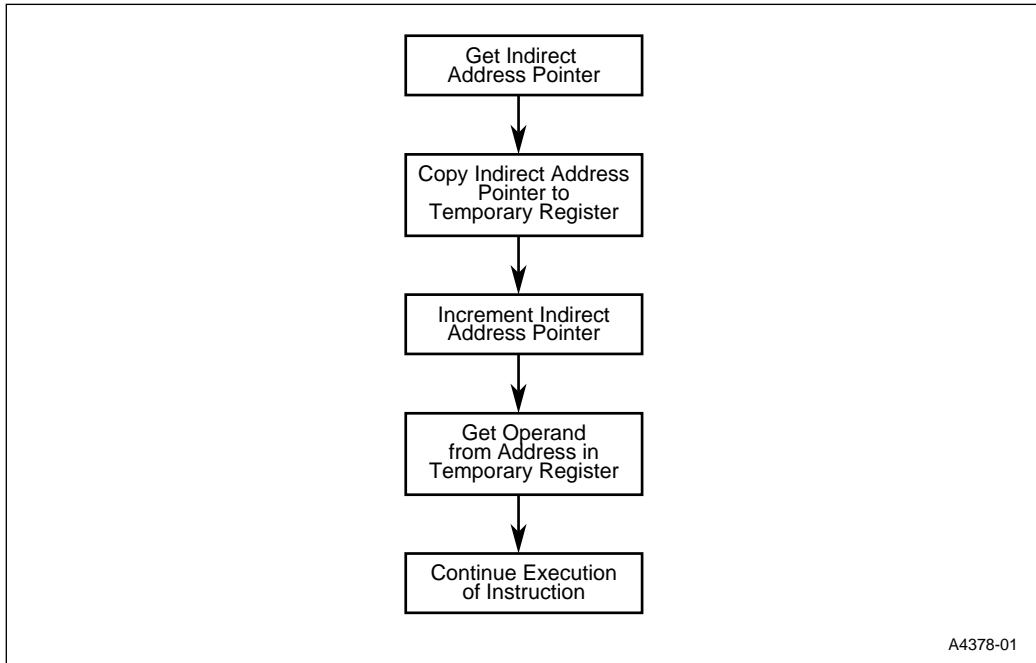
**008. Indirect Addressing With AutoIncrement**

**PROBLEM:** For indirect addressing with autoincrement, a pointer that points to itself results in an access to the incremented pointer address rather than the original pointer address.

The CPU stores the pointer's value in a temporary register, increments the pointer, then accesses the operand at the address contained in the temporary register, as shown in this flowchart.

Therefore, if the pointer points to itself, the CPU accesses the operand at the incremented address contained in the pointer.

**WORKAROUND:** Avoid using an indirect address pointer that points to itself.

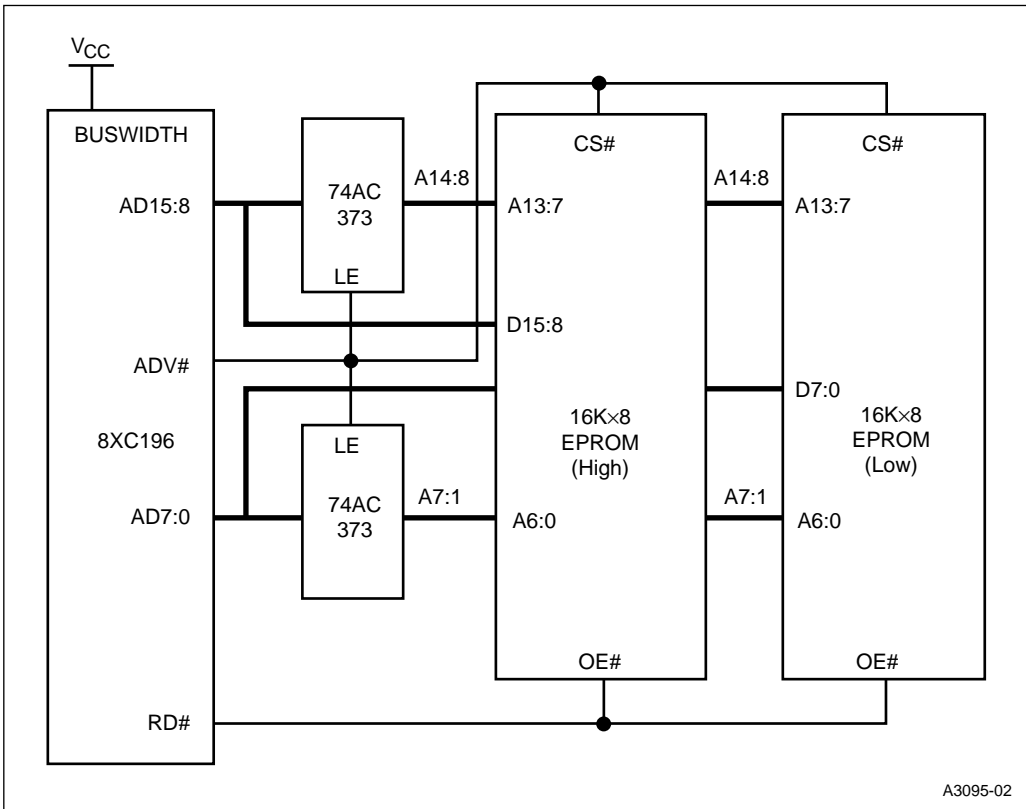
Figure 1. 16-bit System with EPROM

- 001.** *High address inputs to the low EPROM should be A14:8 in Figure 15-18.*

**ITEM:** The next revision of the user's manual will include the following corrected graphic.
