# **87C196JV/87C196JV 20 MHz SPECIFICATION UPDATE**

Release Date: January, 1997

Order Number: 272860-002

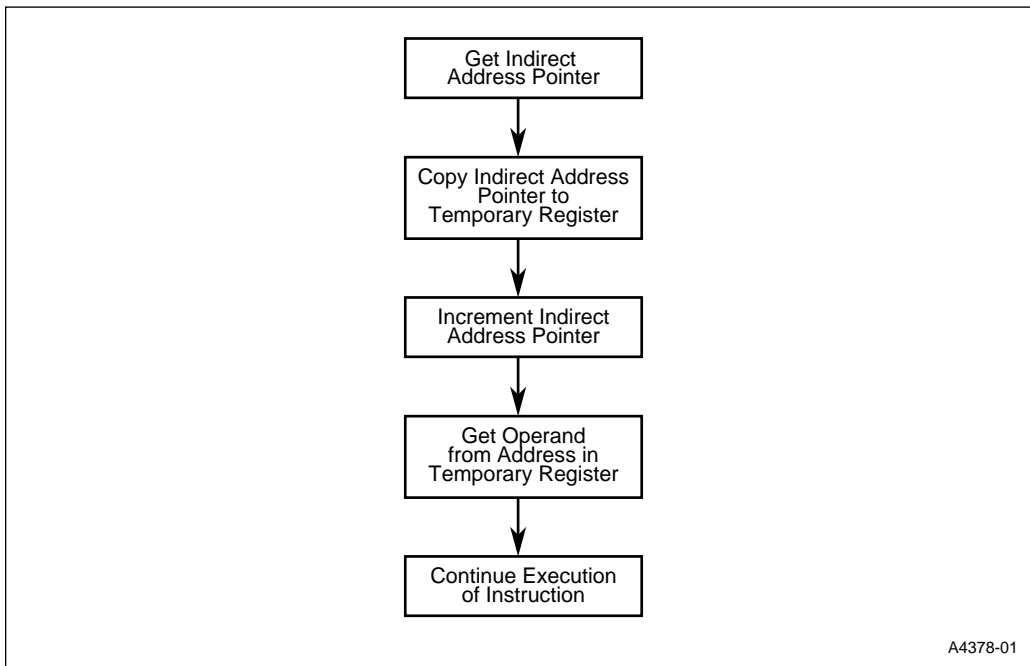
**PROBLEM:** For indirect address0ith autoincrement, a pointer that points to itself results in an access to the incremented pointer address rather than the original pointer address.

The CPU stores the pointer's value in a temporary register, increments the pointer, then accesses the operand at the address contained in the temporary register, as shown in this flowchart.

Therefore, if the pointer points to itself, the CPU accesses the operand at the incremented address contained in the pointer.

**WORKAROUND:** Avoid using an indirect address pointer that points to itself.
