87C196KR SPECIFICATION UPDATE

Release Date: January, 1997

Order Number: 272861-002

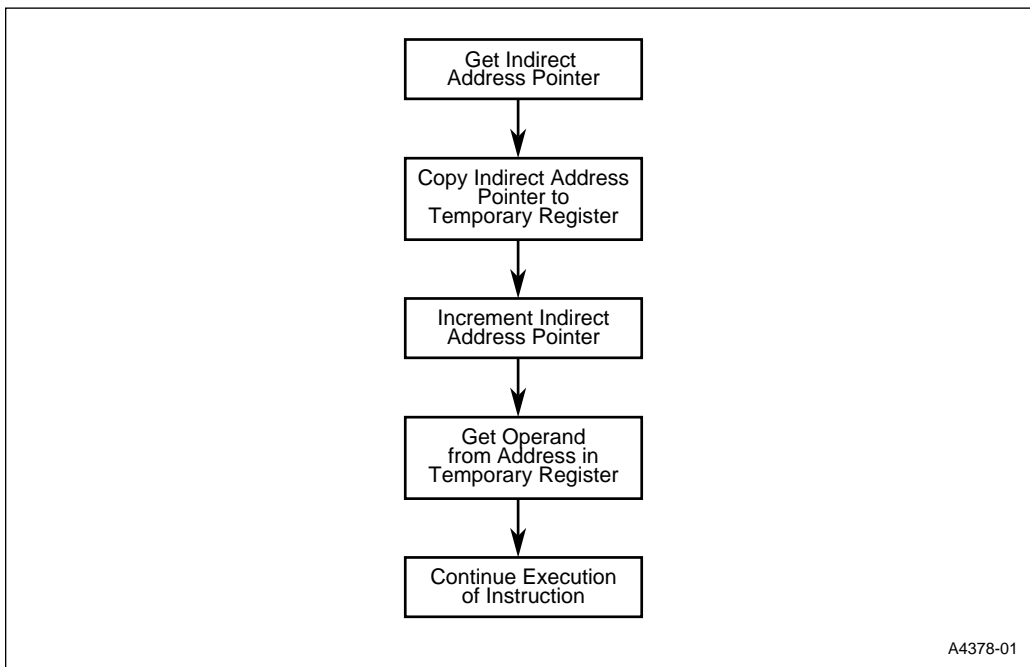
A4378-01

008. *Indirect Addressing With AutoIncrement*

PROBLEM: For indirect addressing with autoincrement, a pointer that points to itself results in an access to the incremented pointer address rather than the original pointer address.

The CPU stores the pointer's value in a temporary register, increments the pointer, then accesses the operand at the address contained in the temporary register, as shown in this flowchart.

Therefore, if the pointer points to itself, the CPU accesses the operand at the incremented address contained in the pointer.

WORKAROUND: Avoid using an indirect address pointer that points to itself.

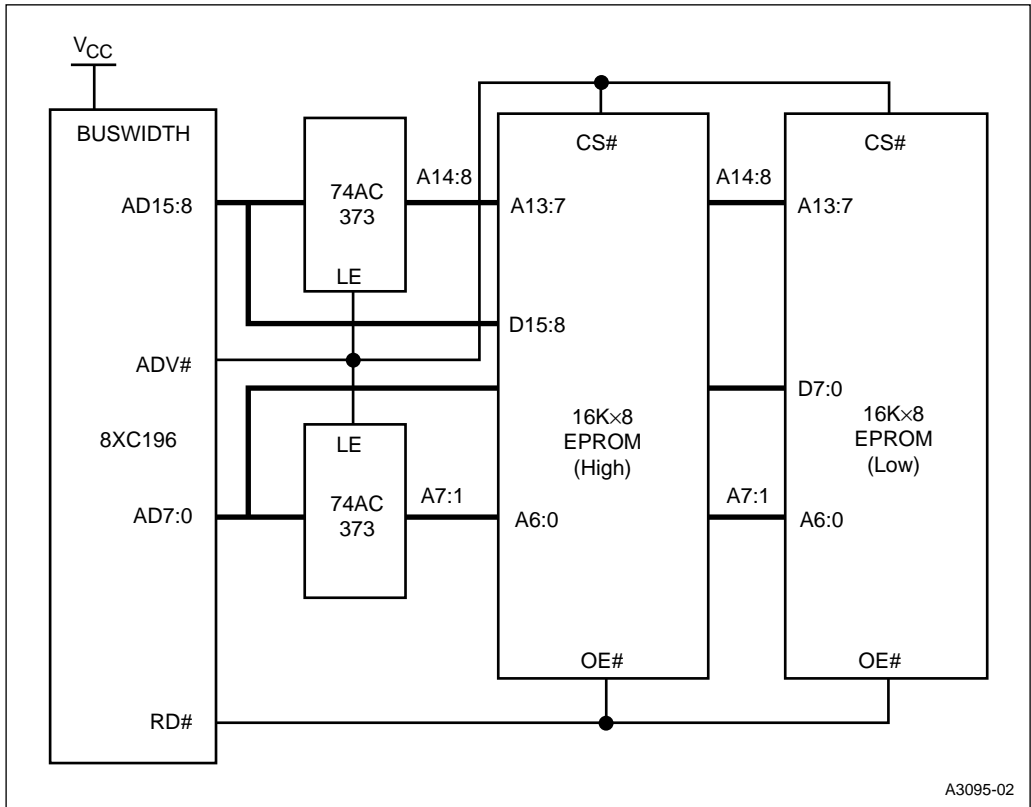
Figure 1. 16-bit System with EPROM

001. *High address inputs to the low EPROM should be A14:8 in Figure 15-18.*

ITEM: The next revision of the user's manual will include the following corrected graphic.
