87C196KT/87C196KS SPECIFICATION UPDATE

Release Date: January, 1997

Order Number: 272862-002

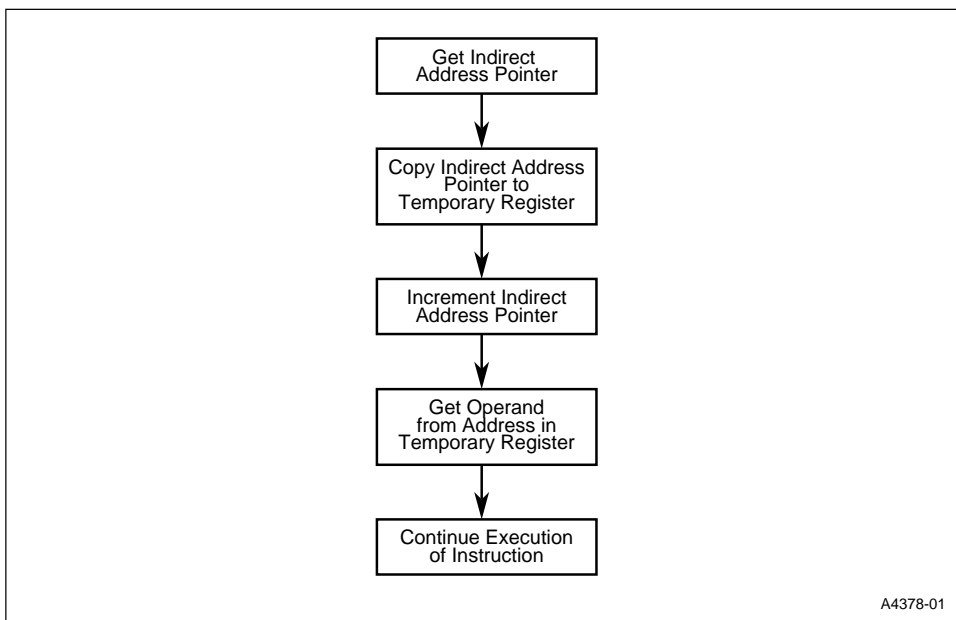
008. *Indirect Addressing With AutoIncrement*

PROBLEM: For indirect addressing with autoincrement, a pointer that points to itself results in an access to the incremented pointer address rather than the original pointer address.

The CPU stores the pointer's value in a temporary register, increments the pointer, then accesses the operand at the address contained in the temporary register, as shown in this flowchart.

Therefore, if the pointer points to itself, the CPU accesses the operand at the incremented address contained in the pointer.

WORKAROUND: Avoid using an indirect address pointer that points to itself.

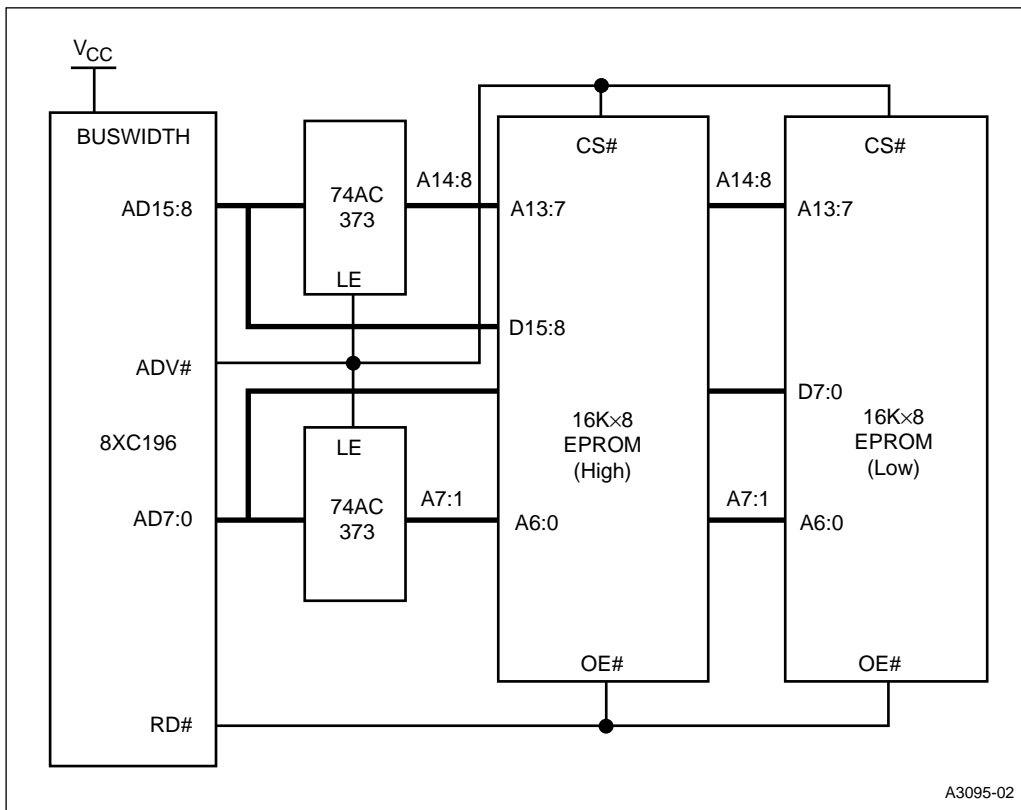
Figure 1. 16-bit System with EPROM

001. *High address inputs to the low EPROM should be A14:8 in Figure 15-18.*

ITEM: The next revision of the user's manual will include the following corrected graphic.
