87C196KT/87C196KS 20 MHz SPECIFICATION UPDATE

Release Date: January, 1997

Order Number: 272863-002

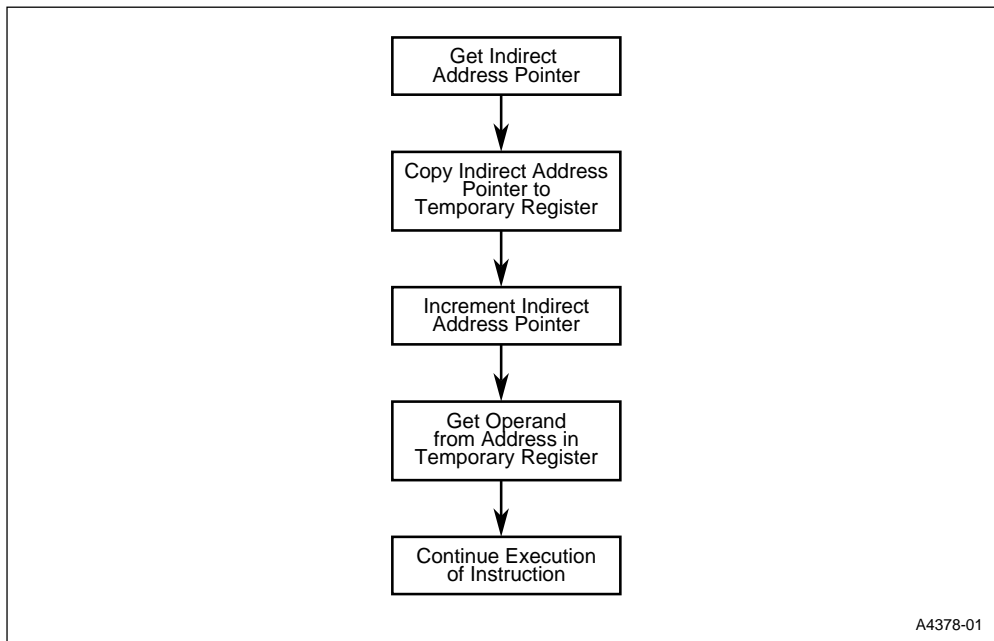
008. *Indirect Addressing With AutoIncrement*

PROBLEM: For indirect addressing with autoincrement, a pointer that points to itself results in an access to the incremented pointer address rather than the original pointer address.

The CPU stores the pointer's value in a temporary register, increments the pointer, then accesses the operand at the address contained in the temporary register, as shown in this flowchart.

Therefore, if the pointer points to itself, the CPU accesses the operand at the incremented address contained in the pointer.

WORKAROUND: Avoid using an indirect address pointer that points to itself.
