80C196NU, 83C196NU SPECIFICATION UPDATE

Release Date: November, 1996

Order Number: 272864-002

The 80C196NU, 83C196NU may contain design defects or errors known as errata. Characterized errata that may cause the 80C196NU, 83C196NU's behavior to deviate from published specifications are documented in this specification update.

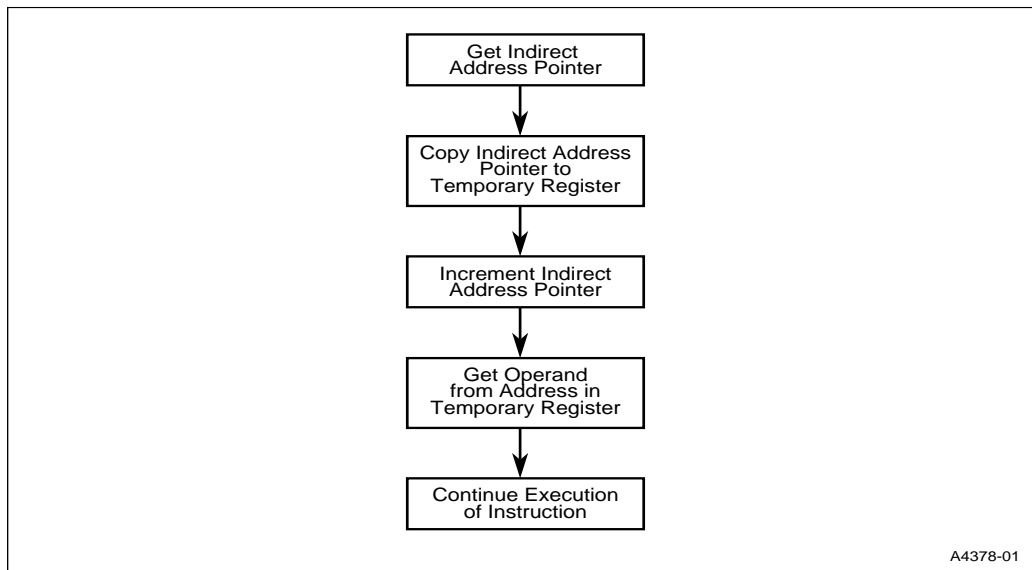
006. Indirect Addressing with Autoincrement

PROBLEM: For indirect addressing with autoincrement, a pointer that points to itself results in an access to the incremented pointer address rather than the original pointer address.

The CPU stores the pointer's value in a temporary register, increments the pointer, then accesses the operand at the address contained in the temporary register, as shown in this flowchart.

Therefore, if the pointer points to itself, the CPU accesses the operand at the incremented address contained in the pointer.

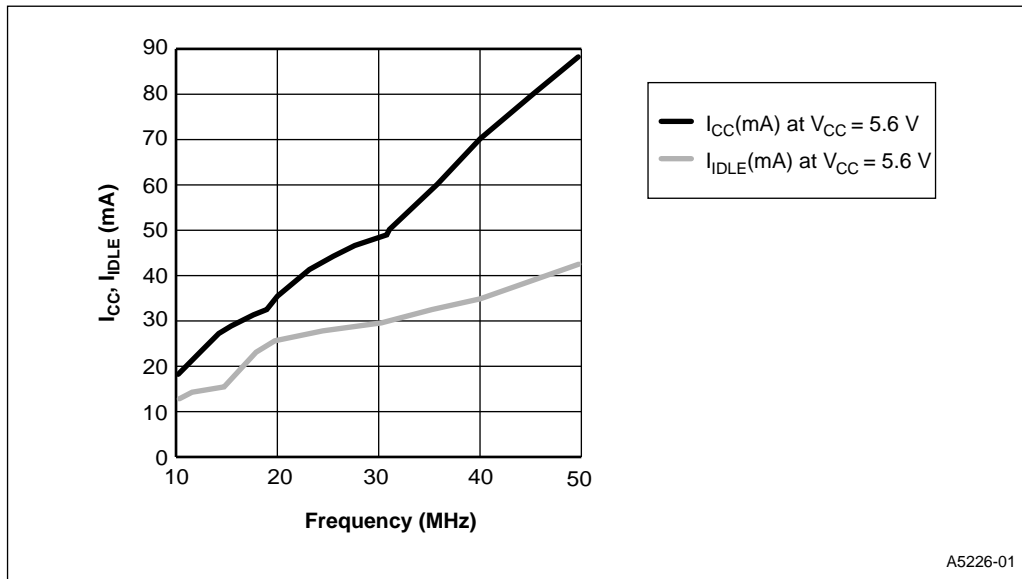
**80C196NU I_{CC} , I_{IDLE} versus Frequency**

024. I_{CC} , I_{IDLE} versus Frequency**ITEM:** 8XC196NU Commercial CHMOS 16-bit Microcontroller datasheet (272644-003)

The following figures will be added to the next revision of the datasheet:
