80296SA MICROCONTROLLER SPECIFICATION UPDATE

Release Date: February, 1997

Order Number: 272908-006

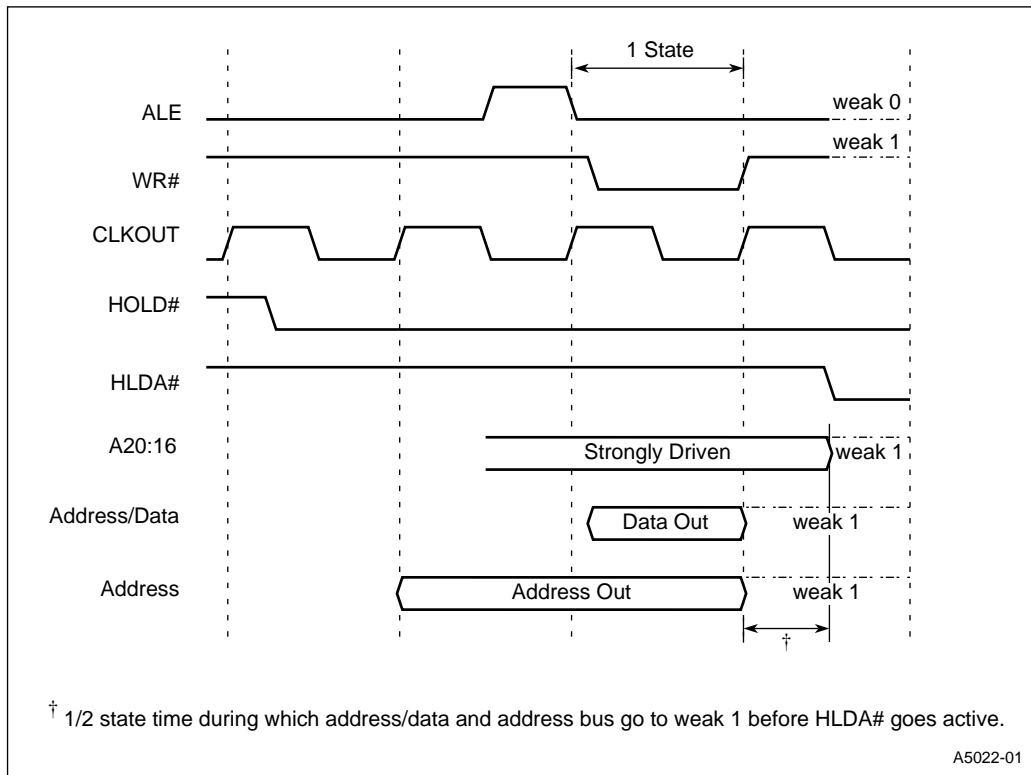
PROBLEM: When going into bus hold, the address/data bus and address bus pins go to their hold values about 1/2 state early before HLDA# goes low. The other bus signals, such as the EPORT, ALE, RD#, WR#, etc., remain strongly driven for about 1/2 state longer until HLDA# goes active. Please refer to the diagram:

Behavior of Bus Signals When Entering Bus Hold

IMPLICATION: In the figure above, a write cycle is occurring just before the 80296SA releases the bus and goes into hold mode. This write cycle cannot be relied upon, since the 80296SA stops driving valid information on the address and address/data bus at nearly the same time as WR# goes high. The address behaves the same as in normal bus cycles. The data is held longer, though, in the normal bus cycle.

This may make bus hold unreliable and unusable.

WORKAROUND: There is no workaround unless the device receiving data does not expect the data to be held after rising edge of WR#.

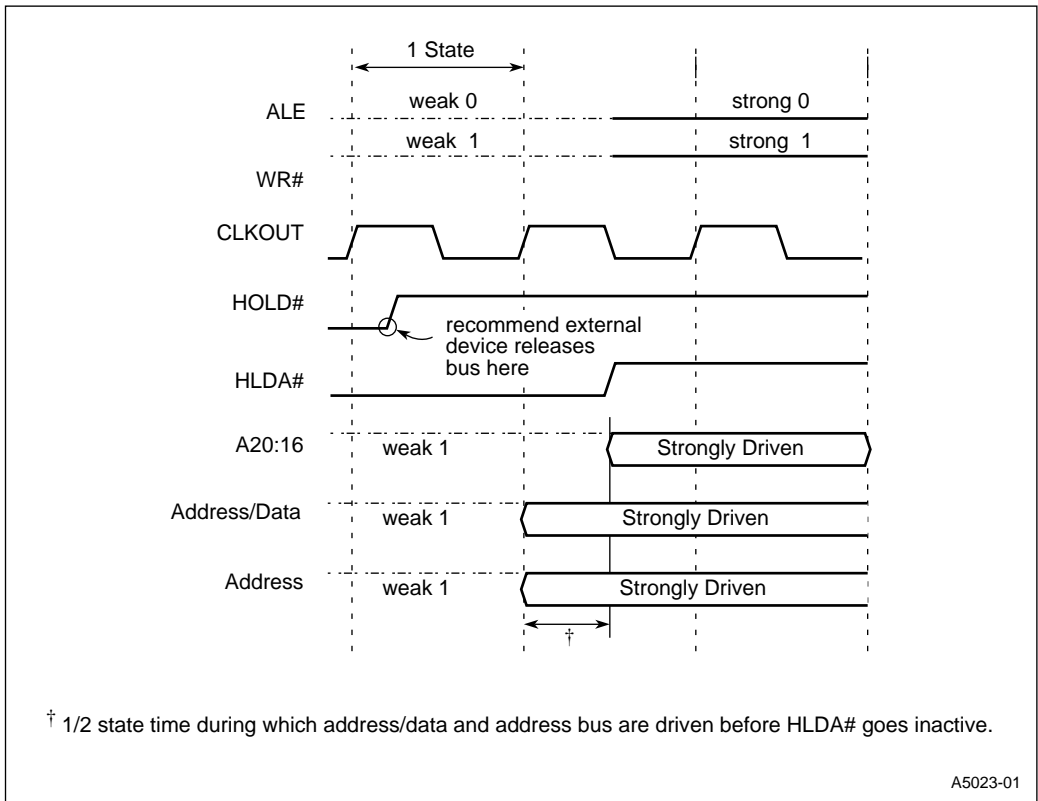
PROBLEM: When coming out of bus hold, the 80296SA starts to strongly drive the address/data and address bus pins about 1/2 state early before HLDA# goes inactive. The other bus signals such as EPORT, ALE, RD#, WR#, etc. start being driven about the same time as HLDA# gets released, but the address/data and address bus start being driven about 1/2 state before HLDA# gets released. Please refer to the diagram:

Behavior Of Bus Signals When Exiting Bus Hold

IMPLICATION: There may be contention on the address/data and address bus, but this is not likely, since HOLD# has already been released.

WORKAROUND: If the external device releases the bus when HOLD# goes inactive, the signals driven before HLDA# goes inactive are not an issue and should not cause bus contention. It is recommended that HOLD# be used as the signal to inform devices to release the bus.

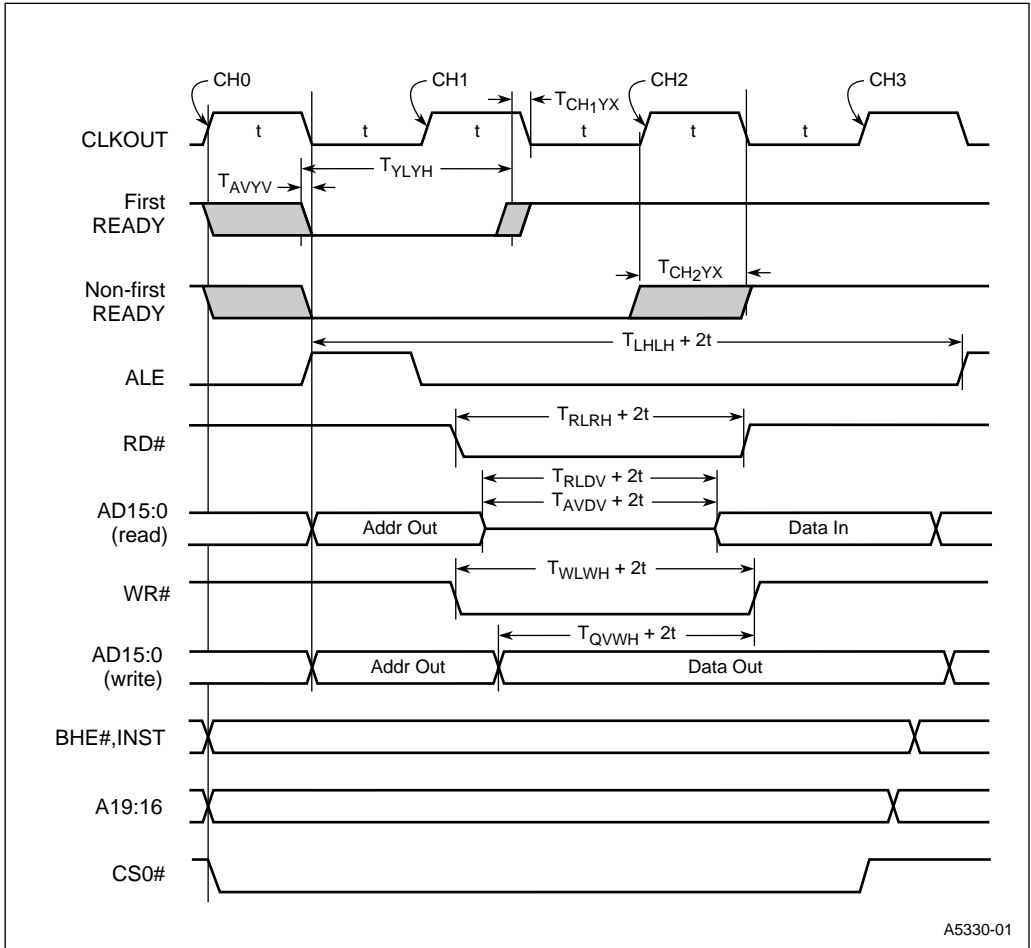
1. If using the READY signal to insert wait states, you must program at least one wait state in the BUSCONx register because the first falling edge of READY is not synchronized with a CLKOUT edge.
2. If using the BUSCONx register **without** the READY signal to insert wait states, add $2t \times n$, where n = number of wait states.
3. If using the BUSCONx register to insert wait states, add $2t \times (n-1)$, where n = number of wait states.
4. Exceeding the maximum specification causes additional wait states.
5. If you program two or more wait states in the BUSCONx register, the T_{CH1YX} minimum does not apply.

Example READY Timings at 50 MHz, Multiplexed Bus, BUSCONx = 1 Wait State

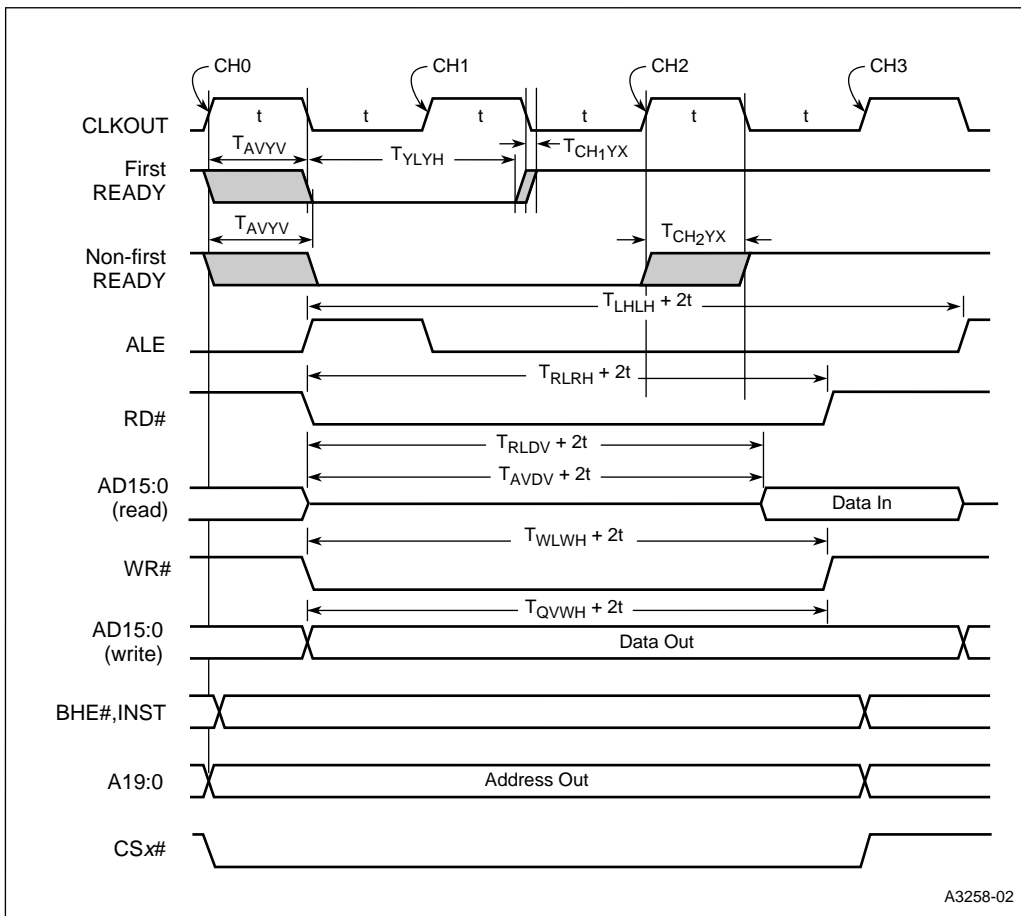
1. If using the READY signal to insert wait states, you must program at least one wait state in the BUSCONx register because the first falling edge of READY is not synchronized with a CLKOUT edge.
2. If using the BUSCONx register **without** the READY signal to insert wait states, add $2t \times n$, where n = number of wait states.
3. If CSx# changes or if a write cycle follows a read cycle, add $2t$ (1 state).
4. If using the BUSCONx register to insert wait states, add $2t \times (n-1)$, where n = number of wait states.
5. Exceeding the maximum specification causes additional wait states.
6. If you program two or more wait states in the BUSCONx register, the T_{CH1YX} minimum does not apply.

Example READY Timings at 50 MHz, Demultiplexed Bus, BUSCONx = 1 Wait State

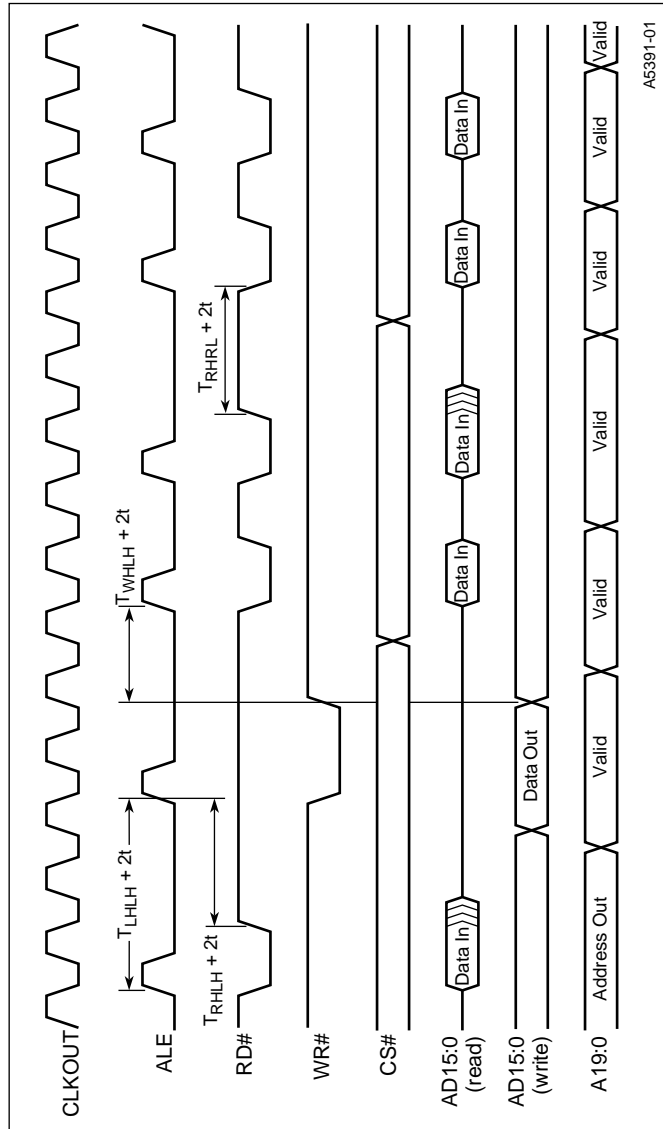
ITEM: In the 80296SA datasheet, first paragraph, the third sentence states, "In the deferred mode, a delay of the WR# signal and the next bus cycle will occur in the first bus cycle following a chip select change and in the first write cycle following a read cycle." It should state, "Delayed bus cycles cause a 2t delay in the last read bus cycle that occurs prior to a write cycle. A 2t delay will also occur in the last read or write cycle prior to a chip select change." Refer to the following deferred bus cycle diagram.
