8XC196KB AUTOMOTIVE APPLICATION SPECIFICATION UPDATE

Release Date: November, 1996

Order Number: 272970-001

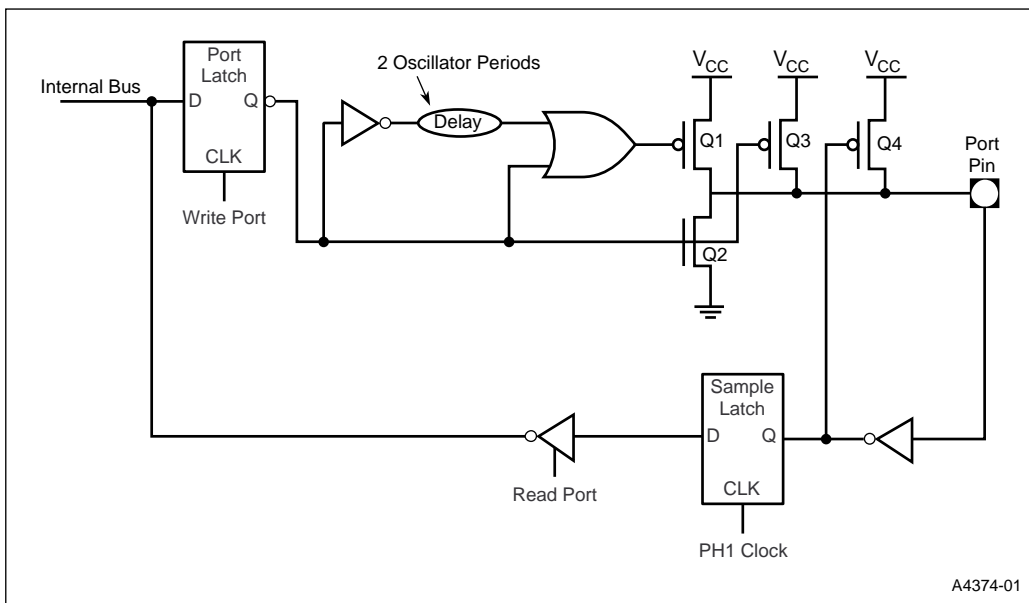
Figure 1. Quasi-bidirectional Port Circuit

PROBLEM: The specification for I_{TL} on the 8XC198 and 8XC196KB/8XC196KB16 devices has changed from $-650 \mu A$ to $-800 \mu A$ to meet the device characteristics at low temperatures.

The I_{TL} specification is the maximum current that the 8XC196KB quasi-bidirectional pins can source during the transition from a logic 1 to a logic 0 input. Figure 1 shows the quasi-bidirectional port circuit. When the port is configured as an input, the output of the port latch is a '0'. Therefore, Q3 is weakly pulling the port pin high. When the external circuitry drives the pin high, Q4 also is turned on and holds the port pin signal high. As the external circuitry decreases the voltage below V_{CC} toward logic 0, Q4 begins to turn off. However, due to transistor characteristics, Q4 will source increasing amounts of current until the threshold voltage of the transistor is reached. Then, Q4 will turn off, leaving only Q3 driving the port pin signal high.

IMPLICATION: Customers using the quasi-bidirectional pins as input should analyze their applications to see if their external circuitry can handle 80 μA of current from the quasi-bidirectional pins during the transition period described above.

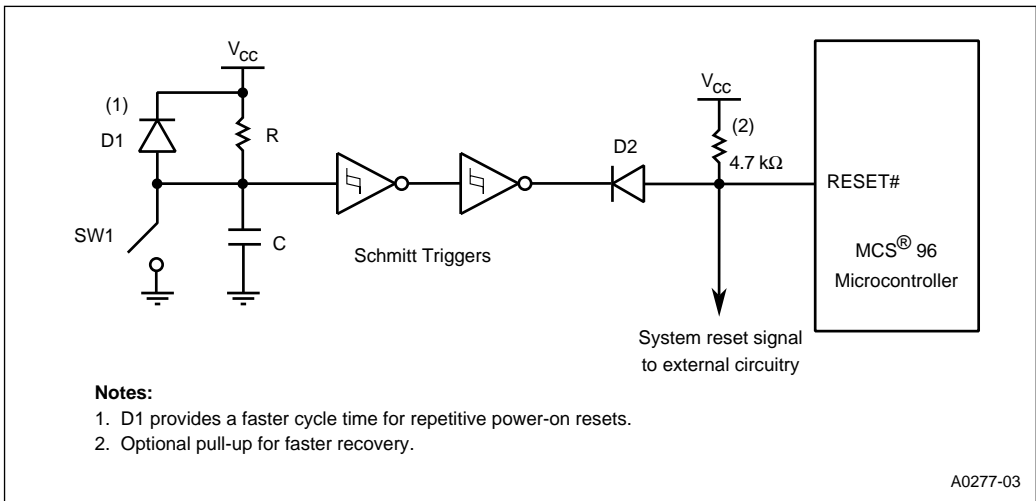
Figure 3. Improved System Reset Circuit

PROBLEM: The following improved system reset circuit shown in Figure 3 may be used in conjunction with the *80C196KB User's Guide* (270651-003).

The system reset circuit in the *80C196KB User's Guide* has been used successfully by many customers for a long period of time. Both circuits should be evaluated in the user's system.
