# **Pentium® Processor Specification Update**

Release Date: April, 1997

Order Number 242480-026

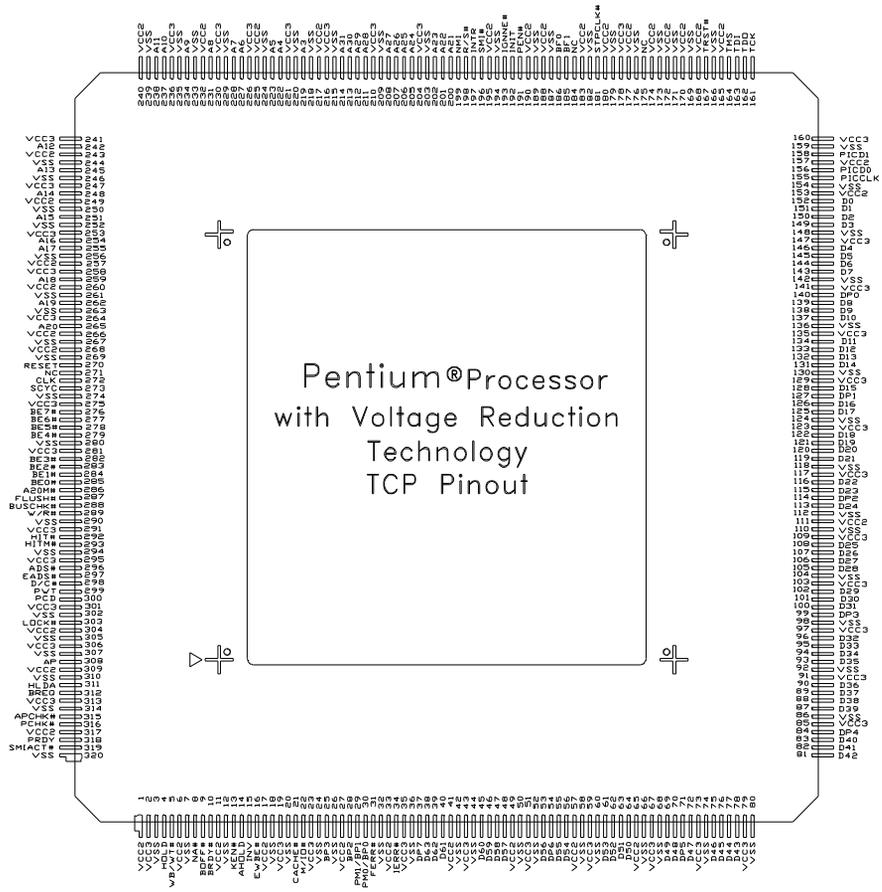
### 2. ***Incorrect TCP Pinout Drawing***

The TCP pinout drawing on page 8 of the Pentium Processor with Voltage Reduction Technology datasheet was inadvertently rotated. The correct orientation is shown below.

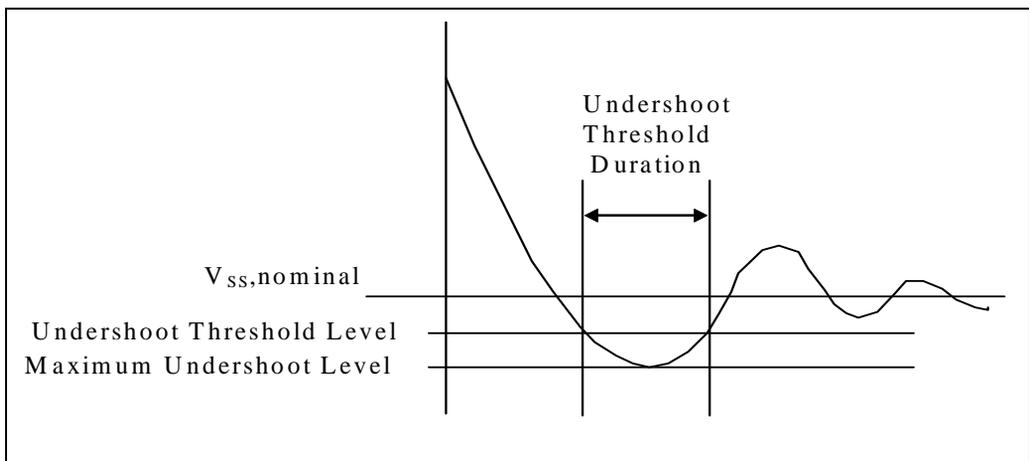
Figure14-1. Maximum Undershoot Level, Undershoot Threshold Level, and Undershoot

**UNDERSHOOT THRESHOLD DURATION SPECIFICATION:** A snapshot of the clock signal should be taken at 500 mV/div and 500 pS/div (for CLK). Adjust the vertical position and horizontal offset position to view the threshold duration. The undershoot threshold duration is defined as the sum of all time during which the clock signal is below -0.5V within a single clock period. The undershoot threshold duration must not exceed 20% of the period.

This undershoot specifications are illustrated graphically in Figure 14-1 and Figure 14-2.

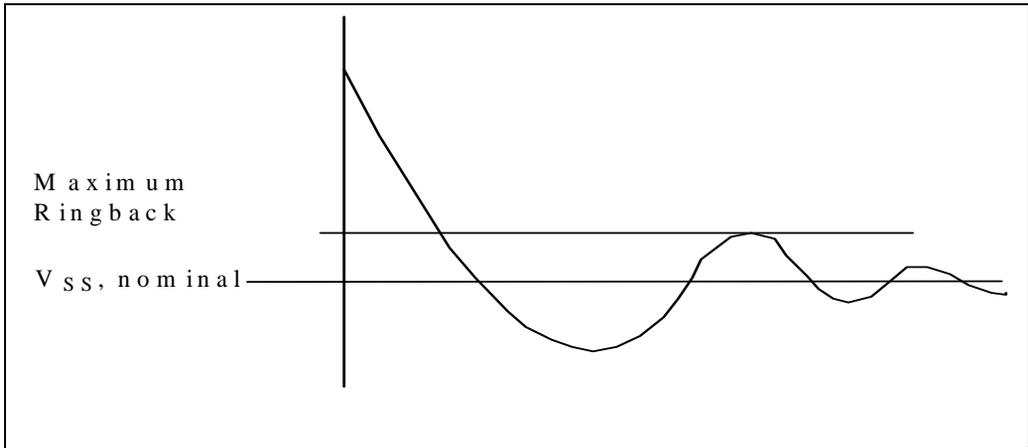
Figure 14-2. Maximum Ringback Associated with the Signal Low State

**MAXIMUM UNDERSHOOT AND MAXIMUM RINGBACK SPECIFICATIONS:** The display should show continuous sampling (e.g., infinite persistence) of the waveform at 500 mV/div and 5 nS/div (for CLK) for a recommended duration of approximately five seconds. Adjust the vertical position to measure the maximum undershoot and associated ringback. There is no allowance for crossing the maximum undershoot or maximum ringback specifications.
