# **8x930Hx (8x930HD, 8x930HE) SPECIFICATION UPDATE**

Release Date: March, 1997

Order Number: 272962-006

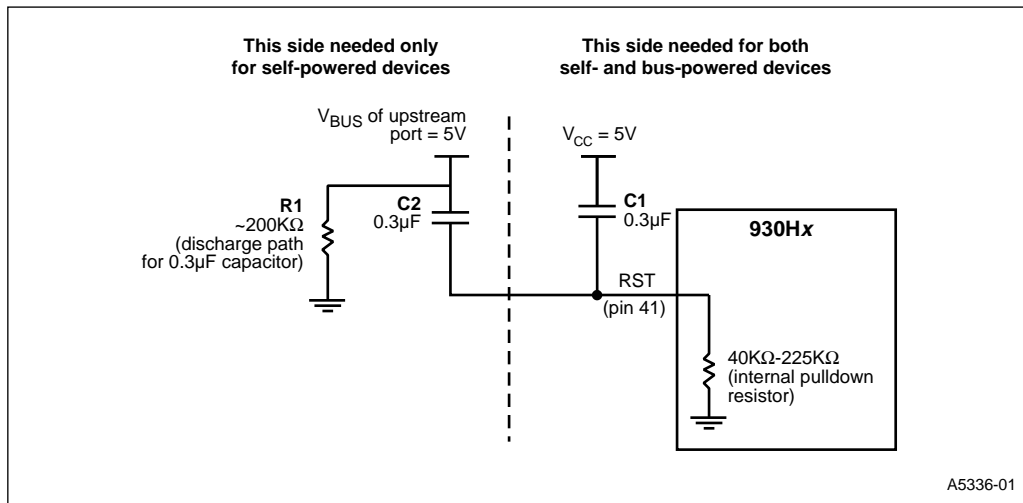
**Figure 1. RST Source From  $V_{CC}$  and  $V_{BUS}$**

**PROBLEM:** When a self-powered, suspended hub is reattached to the host, it could be accidentally recognized as a low-speed device. This is caused by the 8x930Hx A-1 driving K signaling upstream and the host incorrectly sampling the speed of the device immediately after connect instead of after USB reset.

**IMPLICATION:** Enumeration will fail due to the host sending low-speed packets to a high-speed device.

**WORKAROUND:** To fix this problem, you must modify the reset circuitry on current 8x930Hx designs. Figure 1 depicts two circuits, one for a bus-powered hub and another for a self-powered hub. For bus powered devices, the circuit is the same one that is given in Figure 14-1 on page 14-1 of the *8X930Ax, 8X930Hx Universal Serial Bus Microcontroller User's Manual*, except the capacitor value has been changed from 1.0  $\mu$ F to 0.3  $\mu$ F.

For self-powered devices there are two requirements:

- The reset circuit design needs to be activated when the board is first powered-on.
- If the board is already powered-on, then a connection to the host should initiate reset. By connecting another capacitor to  $V_{BUS}$  (C2, as shown in Figure 1), a reset pulse is sent to the chip by either a power-up or by a USB connect.

The circuit shown in Figure 1 uses the following components:

- C1 — Used in conjunction with the internal pull-down resistor to generate a 20 ms pulse of reset. For bus-powered devices,  $V_{CC} = V_{BUS}$ . This creates a 20 ms pulse upon connection to the host. For self-powered devices, a 20-ms pulse will occur regardless of the state of  $V_{BUS}$  if the capacitor ratios remain 1:1. The circuit operation and timing relationships rely on  $C1 = C2$ .
- C2 — Used only for self-powered devices. The capacitor delivers a 20-ms pulse to the RST pin when the  $V_{BUS}$  signal is detected upon device connection.
- R1 — Provides a discharge path for C2. This resistor is mandatory. If R1 is not present, C2 will not discharge the reset pulse and therefore will not allow a proper chip reset during device connection.

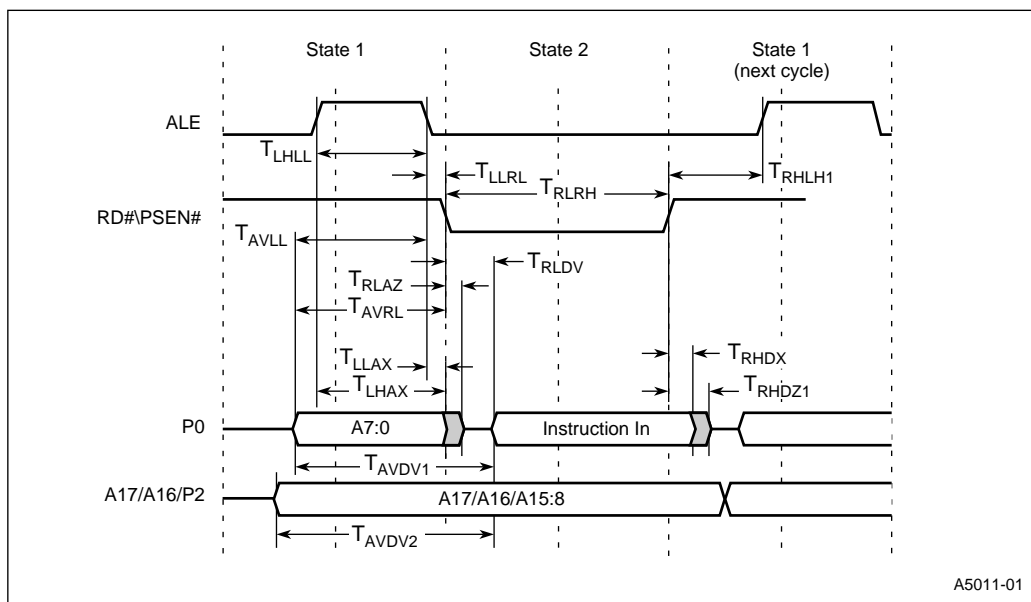
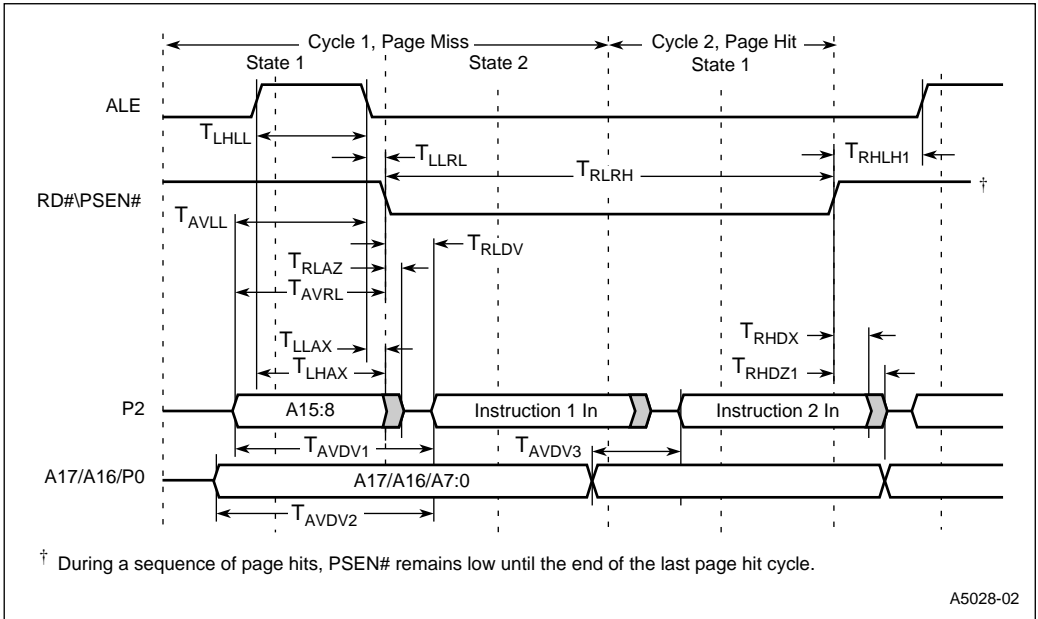
**PROBLEM:** The  $T_{RHDZ1}$  (Instruction Float After RD#/PSEN# High) specification on the 8x930Hx when operating at 12 MHz is 10 ns. However, a slow memory device such as an EPROM typically takes approximately 30 – 90 ns to float its output. (This specification, generically called  $T_{PHZ}$ , may vary depending on the memory type and manufacturer.) Figures 4 and 5 illustrate the  $T_{RHDZ1}$  timing.

The difference between the  $T_{RHDZ1}$  and  $T_{PHZ}$  specifications causes contention on the data bus (P0 in nonpage page, P2 in page mode). The 8X930Hx begins to drive the address for the next bus cycle while the memory device is still driving data from the previous bus cycle.
