8x930Ax (8x930AD, 8x930AE) SPECIFICATION UPDATE

Release Date: February 1997

Order Number: 272940-008

The 8x930Ax may contain design defects or errors known as errata. Characterized errata that may cause the 8x930Ax's behavior to deviate from published specifications are documented in this specification update.

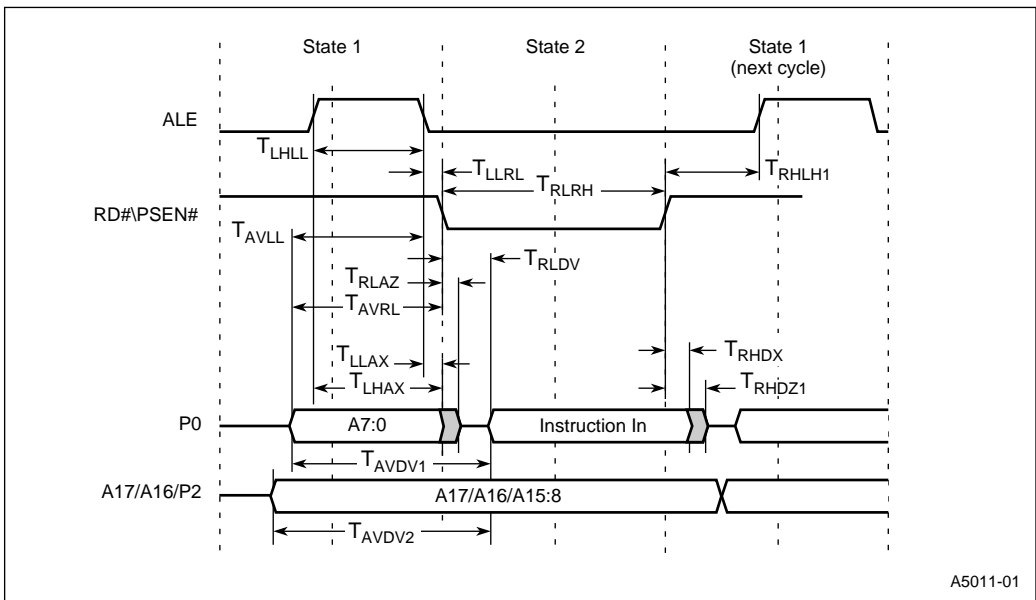
Figure 2. External Code Fetch, Nonpage Mode

PROBLEM: The T_{RHDZ1} (Instruction Float After RD#/PSEN# High) specification on the 8x930Ax when operating at 12 MHz is 10 ns. However, a slow memory device such as an EPROM typically takes approximately 30 – 90 ns to float its output. (This specification, generically called T_{PHZ} , may vary depending on the memory type and manufacturer.) Figure 2 and Figure 3 illustrate the T_{RHDZ1} timing.

The difference between the T_{RHDZ1} and T_{PHZ} specifications causes contention on the data bus (P0 in nonpage page, P2 in page mode). The 8X930Ax begins to drive the address for the next bus cycle while the memory device is still driving data from the previous bus cycle.

To prevent this contention, designers can use a buffer to isolate the output of the memory device from the data bus (port 0 or port 2) of the 8x930Ax. This will prevent the memory device from driving the data bus during the critical period after T_{RHDZ1} expires. We suggest a buffer such as the 74F541 octal, three-state line driver shown in Figure 4.
