28F016XS

SPECIFICATION UPDATE

Release Date: November 1996

Order Number 297553-007

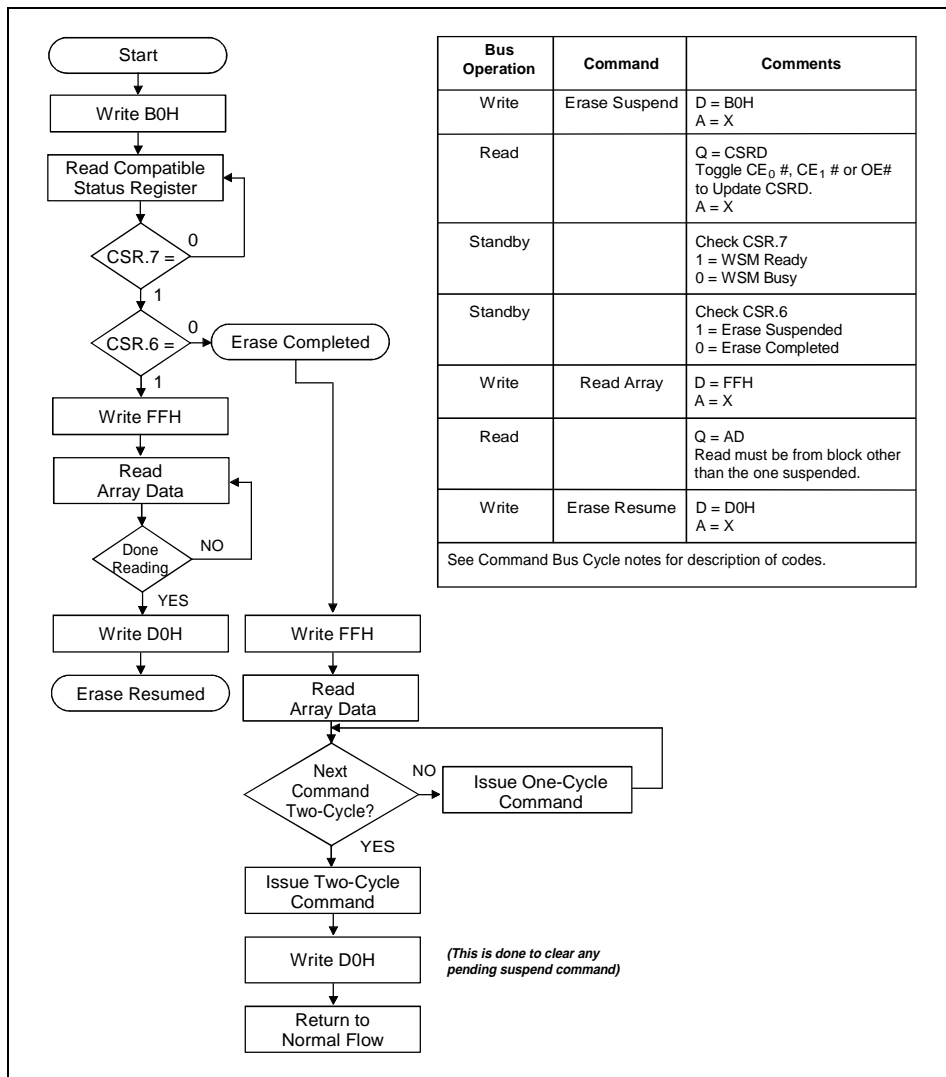
Erase Suspend to Read Array with Compatible Status Register

IMPACT: The following conditions are affected by this unserviced Suspend command:

Note that the device will not service the Suspend command if it is powered-down (RP# transitioning low) prior to either condition A or B.

AFFECTED PRODUCTS: All components with Device Version Number 00H are affected.

STATUS: This erratum has been fixed. Refer to Summary Table of Contents to determine the affected stepping.

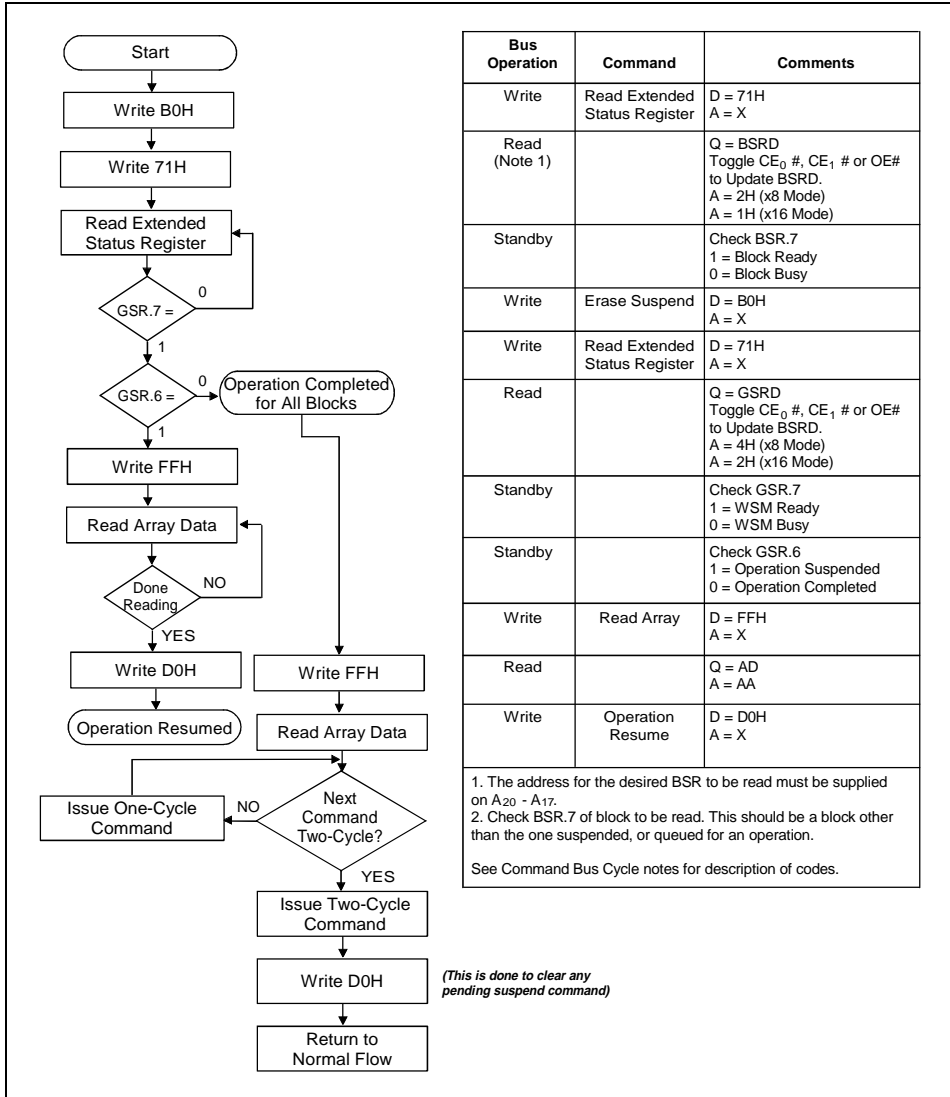
1. The address for the desired BSR to be read must be supplied on A₂₀ - A₁₇.
2. Check BSR.7 of block to be read. This should be a block other than the one suspended, or queued for an operation.
