80960HA/HD/HT SPECIFICATION UPDATE

Release Date: January, 1997

Order Number: 272830-002

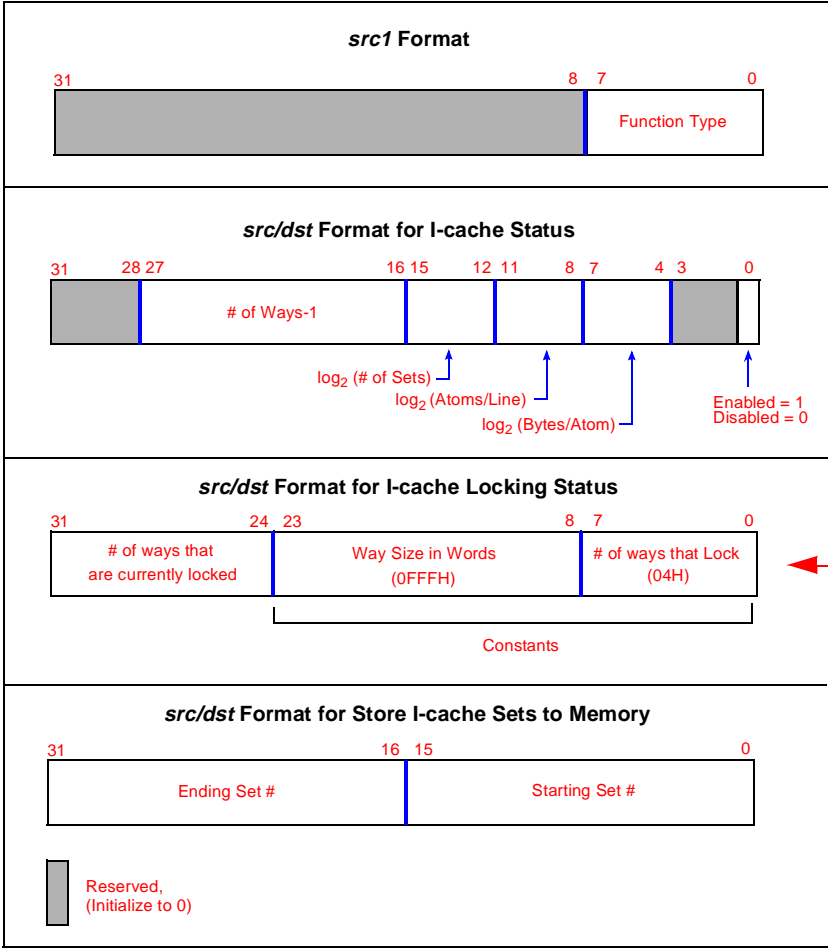
Figure 6-4. icctl *src1* and *src/dst* Formats

In Figure 6-4 under "Src/Dst Format for I-cache Locking Status" constant fixed values for bits 0 - 23 are shown.

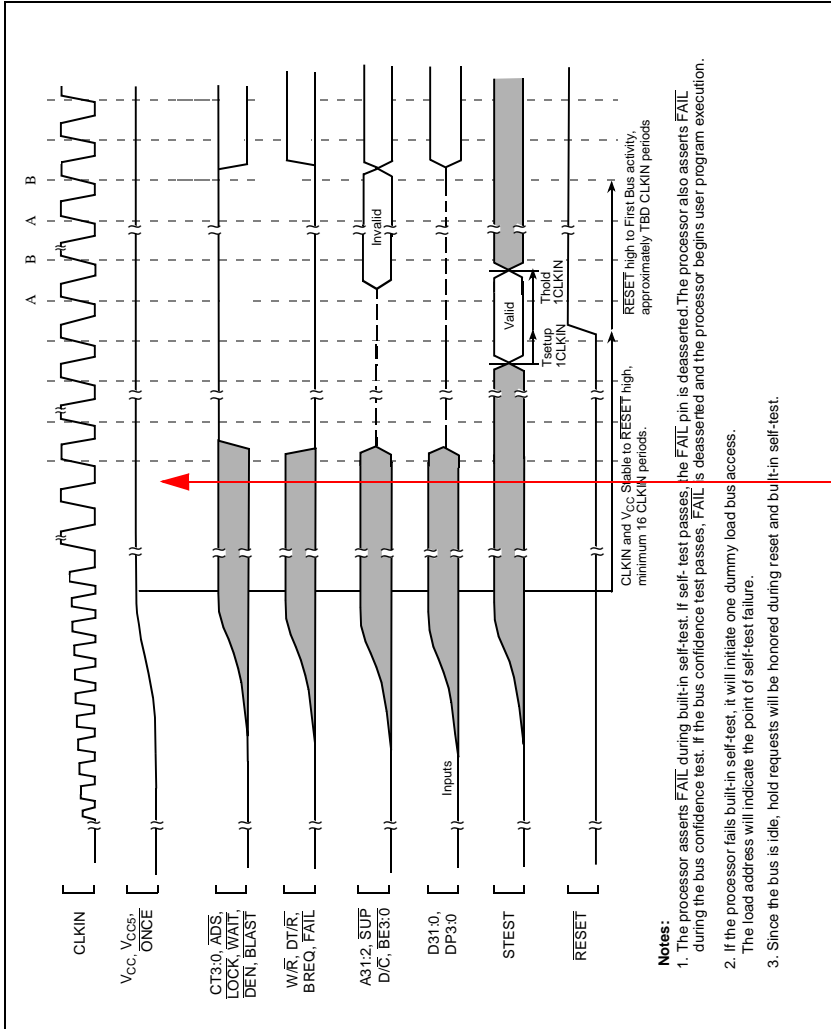
Figure 13-2. Cold Reset Waveform

Page 13-04, Figure 13-2
 The text that appeared near the top center of the diagram:
 V_{CC} and CLKIN Stable to Outputs Valid, maximum 32 CLKIN Periods.
 has been deleted.

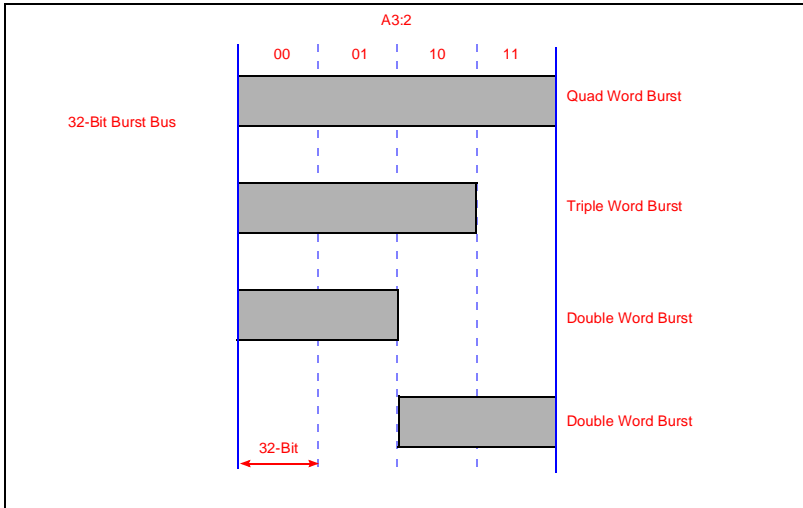
Figure 15-5. 32-Bit-Wide Data Bus Bursts

FROM/TO REFERENCE: Section 15.3.2 Burst Accesses, page 15-14. Insert the description and impact text above (sans the “Description” and “Impact” titles) to the bottom of the page, before Figure 15-5 on the following page.
