80960JA/JF/JD

SPECIFICATION UPDATE

Release Date: July, 1996

Order Number: 272852-001

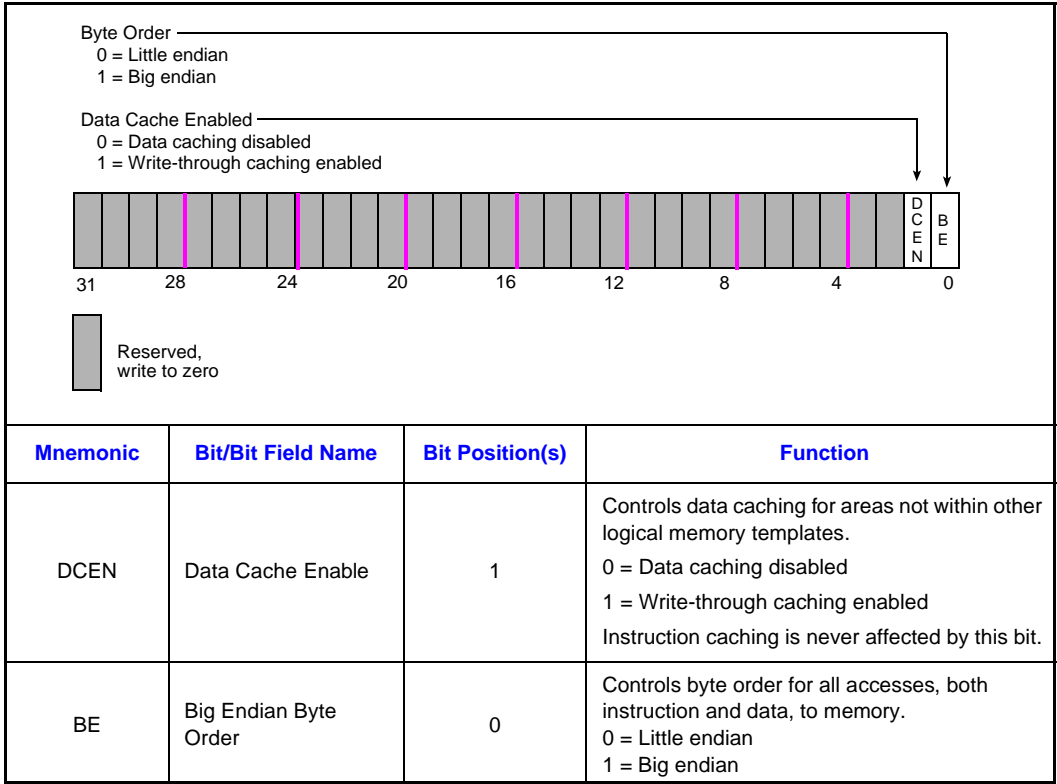
Figure 12-6. Default Logical Memory Configuration Register (DLMCON)

Errata 10-25-94 --BWL.

Added Trace Controls section to Example 11-6.

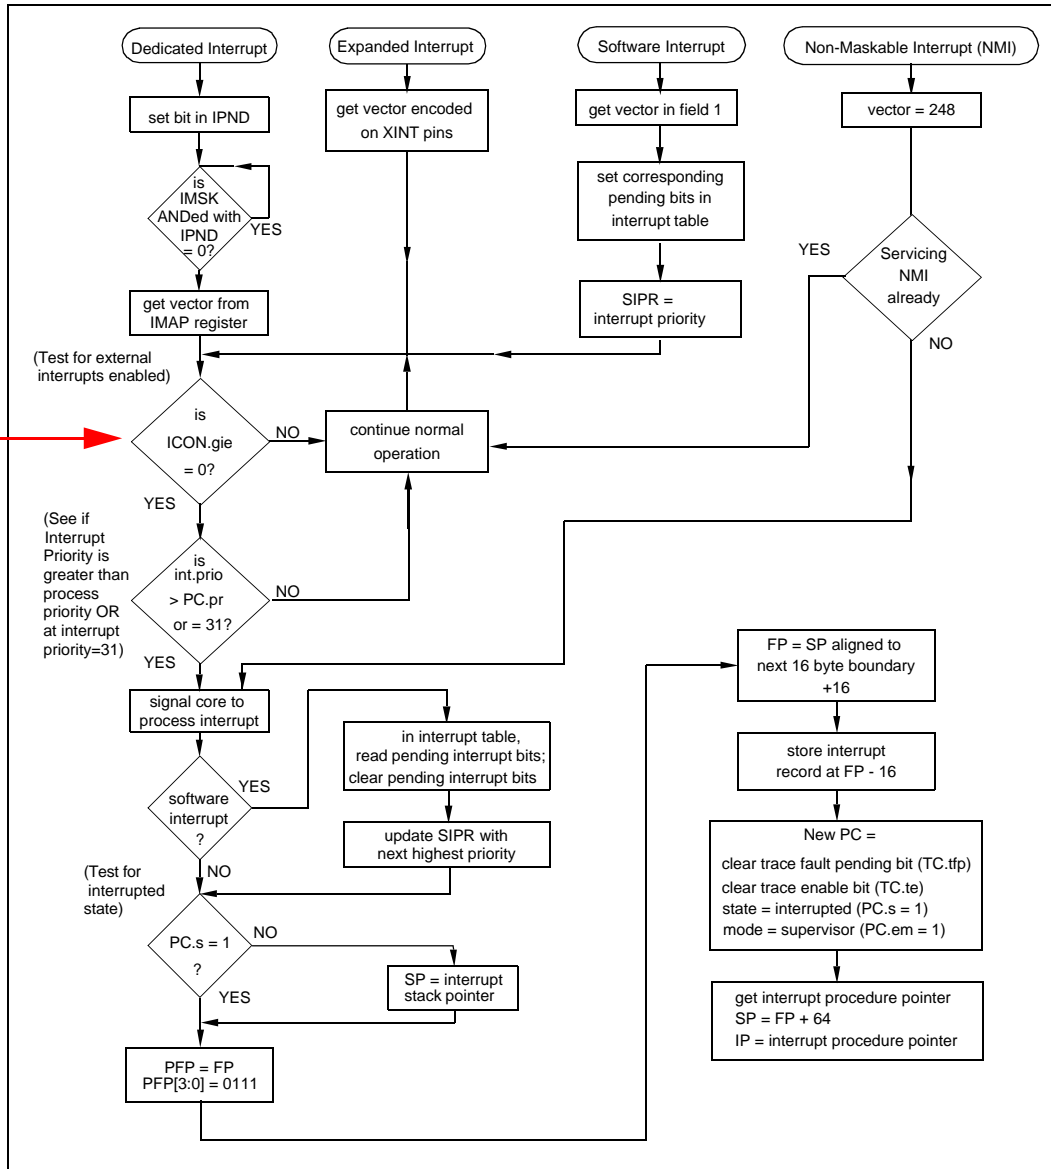
Figure 13-10. Interrupt Service Flowchart

Errata 4-8-96 BWL
