Intel386™ EX EMBEDDED PROCESSOR SPECIFICATION UPDATE

Release Date: January, 1997

Order Number: 272873-004

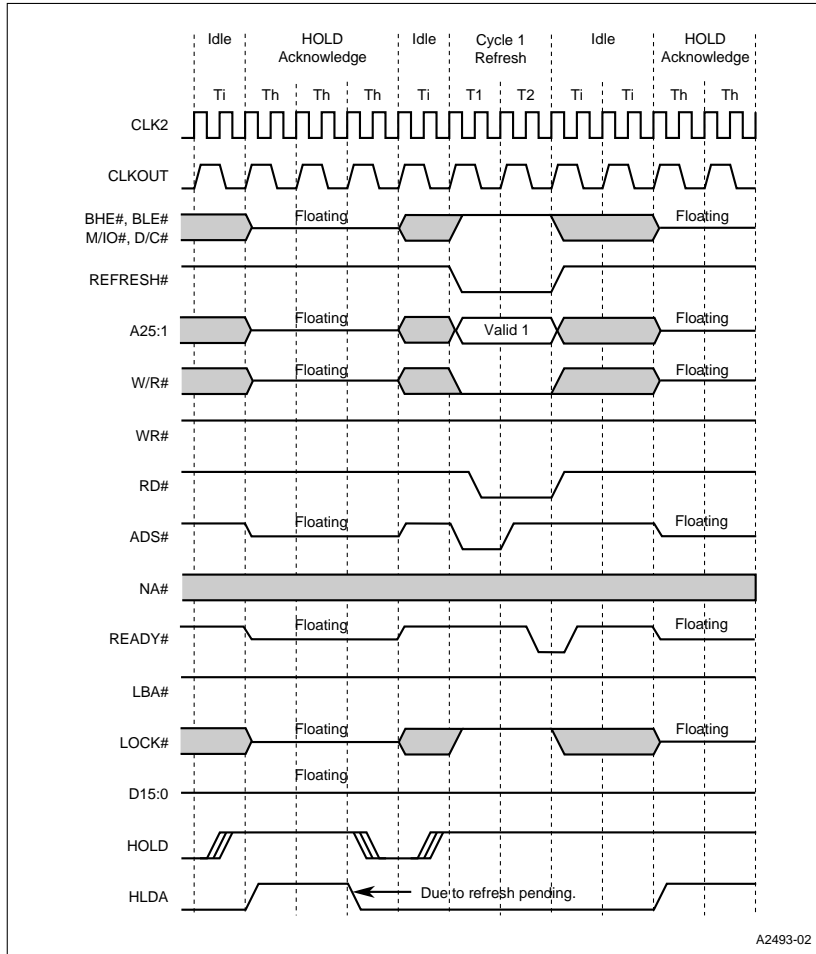
11. 272485-002, Section 6.3.6, Page 6-30, Figure 6-12.

ISSUE: Modified the ADS# and READY# waveforms to indicate floating. The corrected figure is shown below.

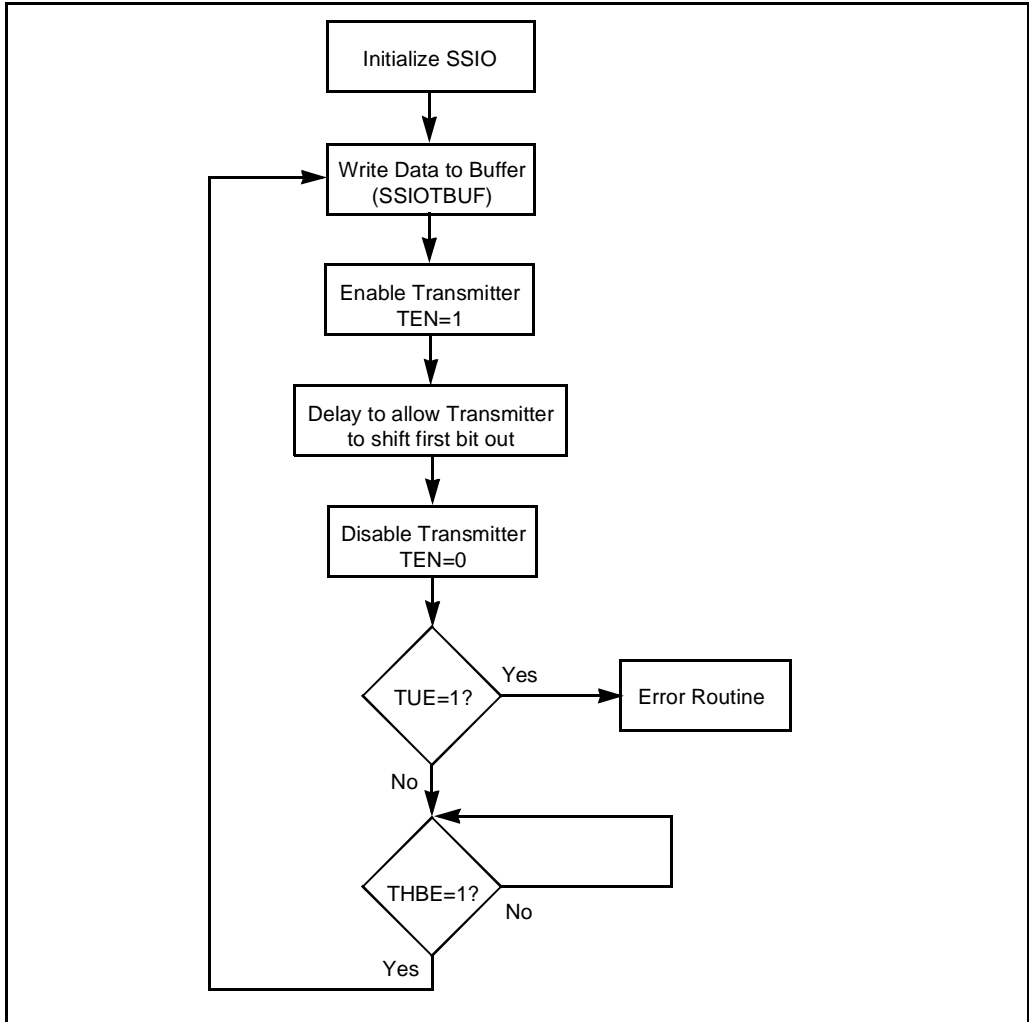
Figure 13-8a. Transmit Data by Polling

ISSUE: Replace figure 13-8 with Figures 13-8a and 13-8b as shown below.
