# **8XC196KD COMMERCIAL APPLICATION SPECIFICATION UPDATE**

Release Date: July, 1996

Order Number 272833-001

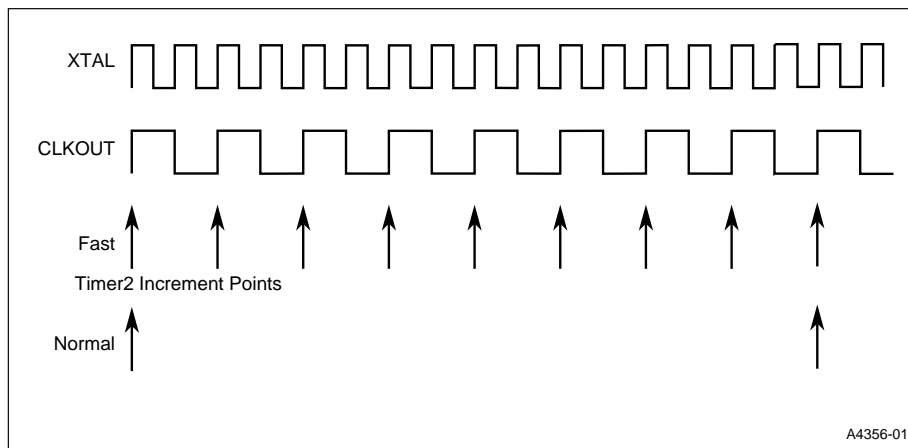
**PROBLEM:** Confusion has arisen regarding the fourth paragraph of Section 8.1.3.1. The following paragraph clarifies this text:

When FAST\_T2\_ENA is set (fast increment mode), Timer 2 increments once every state time, at the rate of  $F_{osc}/4$ . When FAST\_T2\_ENA is cleared (normal increment mode), Timer 2 increments once every eight state times at a rate of  $F_{osc}/32$ . See the timing diagram below for a depiction of the input clock signal, the clockout signal, and the points at which Timer 2 increments in the fast and normal modes.
