# **8XC196KC SPECIFICATION UPDATE**

Release Date: March, 1997

Order Number: 272834-003

The 8XC196KC may contain design defects or errors known as errata. Characterized errata that may cause the 8XC196KC's behavior to deviate from published specifications are documented in this specification update.

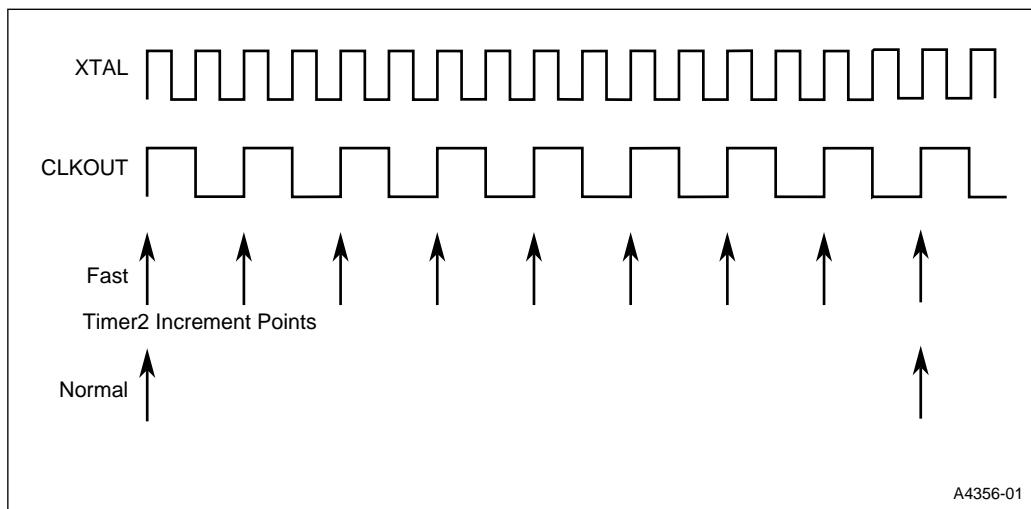
**PROBLEM:** Confusion has arisen regarding the fourth paragraph of Section 8.1.3.1. The following paragraph clarifies this text:

When FAST\_T2\_ENA is set (fast increment mode), Timer 2 increments once every state time, at the rate of  $F_{osc}/4$ . When FAST\_T2\_ENA is cleared (normal increment mode), Timer 2 increments once every eight state times, at the rate of  $F_{osc}/32$ . See the timing diagram below for a depiction of the input clock signal, the CLKOUT signal, and the points at which Timer 2 increments in the fast and normal modes.

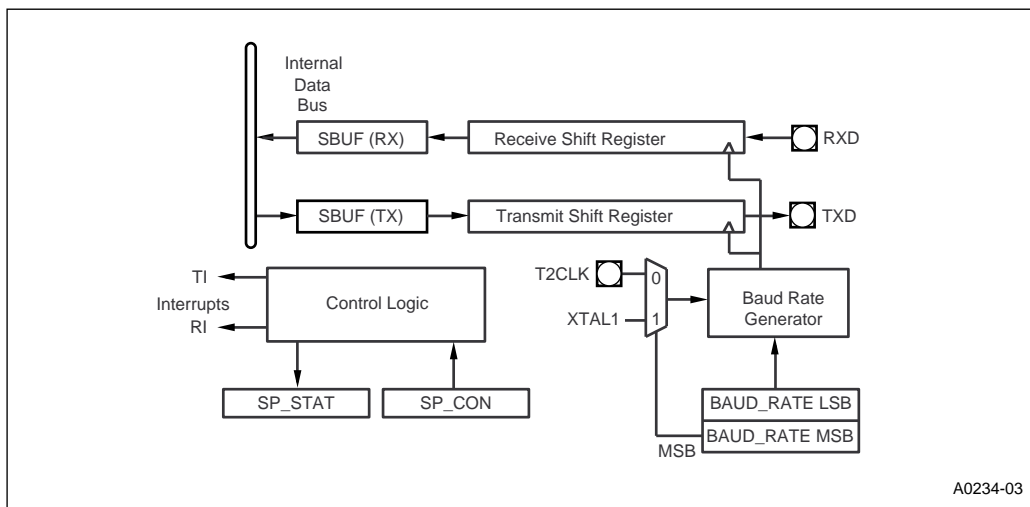
**Figure 4. Serial Port Block Diagram**

**ITEM:** The following block diagram will be included in future manuals.
