# **8XC196NT SPECIFICATION UPDATE**

Release Date: October, 1996

Order Number 272865-002

The 8XC196NT may contain design defects or errors known as errata. Characterized errata that may cause the 8XC196NT's behavior to deviate from published specifications are documented in this specification update.

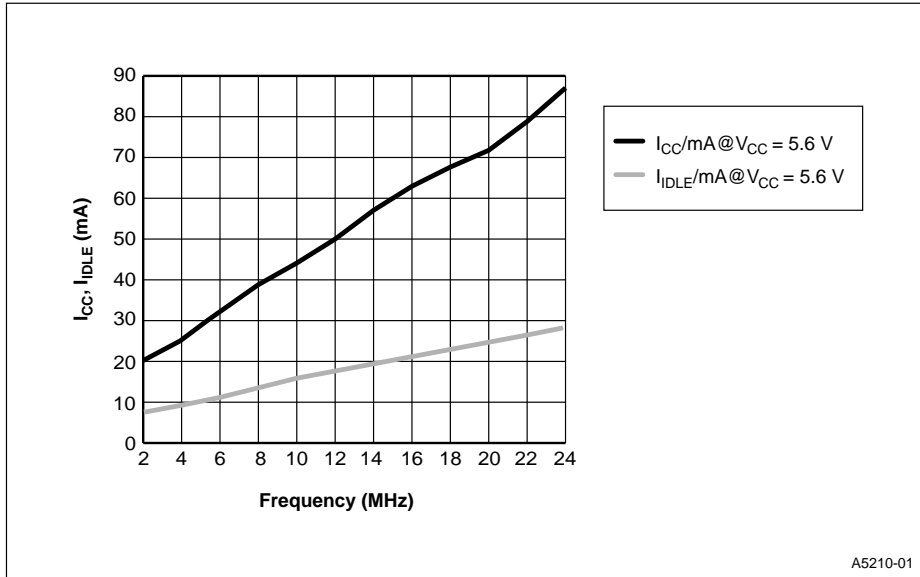
Figure 1. ICC, IDLE versus Frequency

**ITEM:** The following graphic illustrating ICC and IDLE versus Frequency will be added to the next revision (-005) of the 8XC196NT CHMOS Microcontroller datasheet.

### 001. *ICC, IDLE versus Frequency*
