Pentium[®] Pro Processor Specification Update

Release Date: March, 1997

Order Number 242689-017

The Pentium[®] Pro processor may contain design defects or errors known as errata. Characterized errata that may cause the Pentium Pro processor's behavior to deviate from published specifications are documented in this Specification Update.

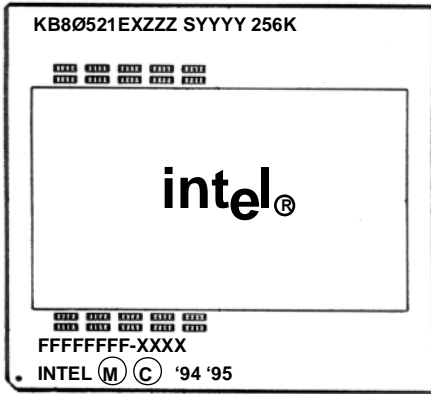
B-Step Production Units – Top:

- ZZZ = Speed (MHz).
 - QYYYY = Sample Specification Number.
 - SYYYY = S-spec Number.
 - LLLK = Level 2 Cache Size.
 - FFFFFFFF = FPO # (Test Lot Traceability #).
- XXXX = Serialization Code.
 - XXXXXXXXAA = Alternative Identification Number.
 - Top side: inner line indicates boundary of heat spreader.

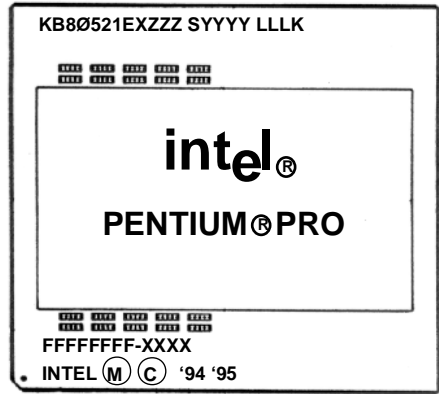
B-, C-, and sA-Step Production Units – Top:

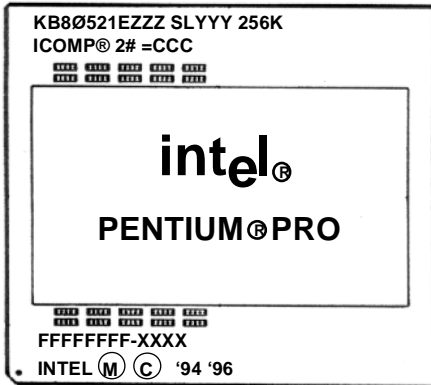
sB1-Step Production Units – Top:

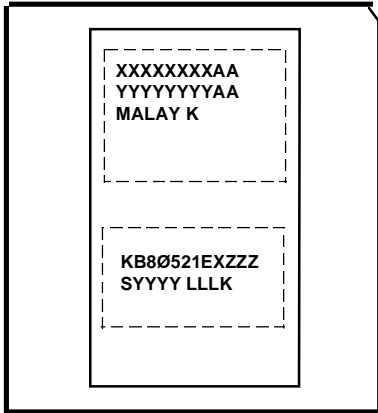
B-, C-, and sA-Step Production Units – Bottom:

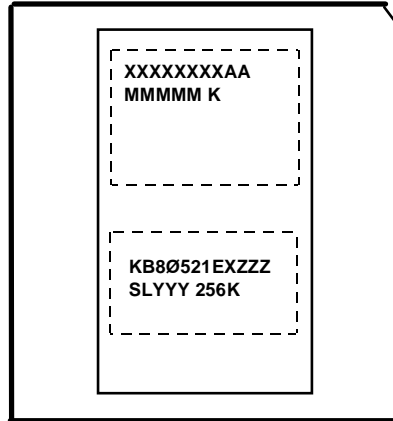
sB1-Step Production Units – Bottom:

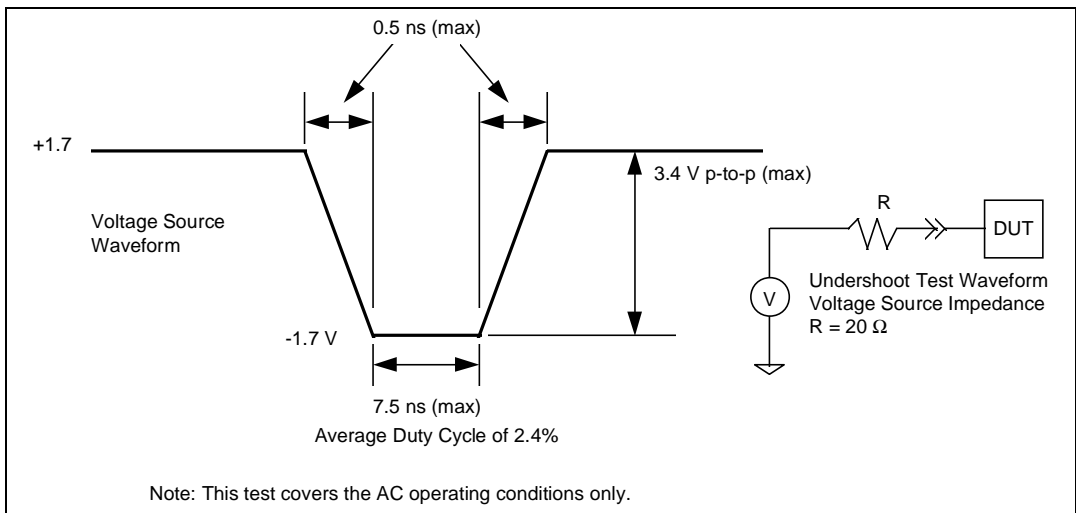
The *Pentium® Pro Family Developer's Manual, Volume 1: Specifications* Section 11.15., will include the following undershoot specification, to simplify signal integrity issues on signals that can be driven by more than one device simultaneously:

The Pentium Pro processor bus signals AERR#, BERR#, BINIT#, BNR#, HIT#, and HITM# (only) are capable of sinking an 85 mA current pulse at 2.4% average time duty cycle. This is equivalent to -1.7V applied to a 2Ω source in series with the device pin for 8 ns at 66 MHz with a utilization of 5%.

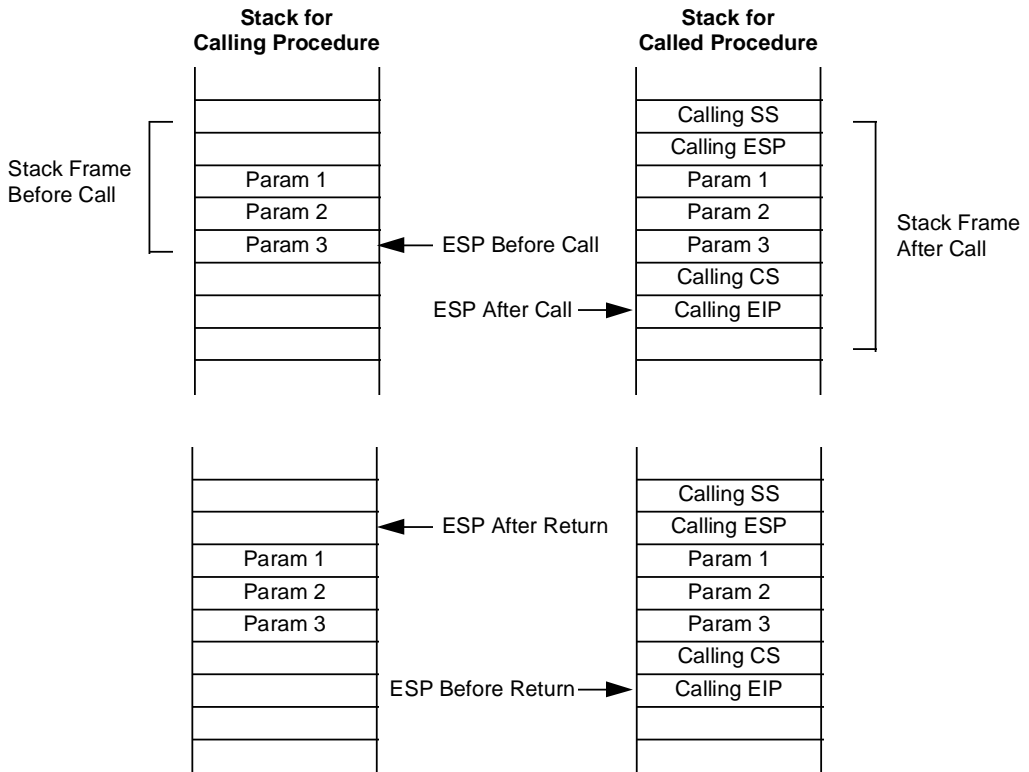
Figure 4-3. Stack Switch on a Call to a Different Privilege Level

Note: On a return, parameters are released on both stacks if the correct value is given for the *n* operand in the RET *n* instruction.

When making a call to a more privileged protection level, the processor does the following (see Figure 4-3):

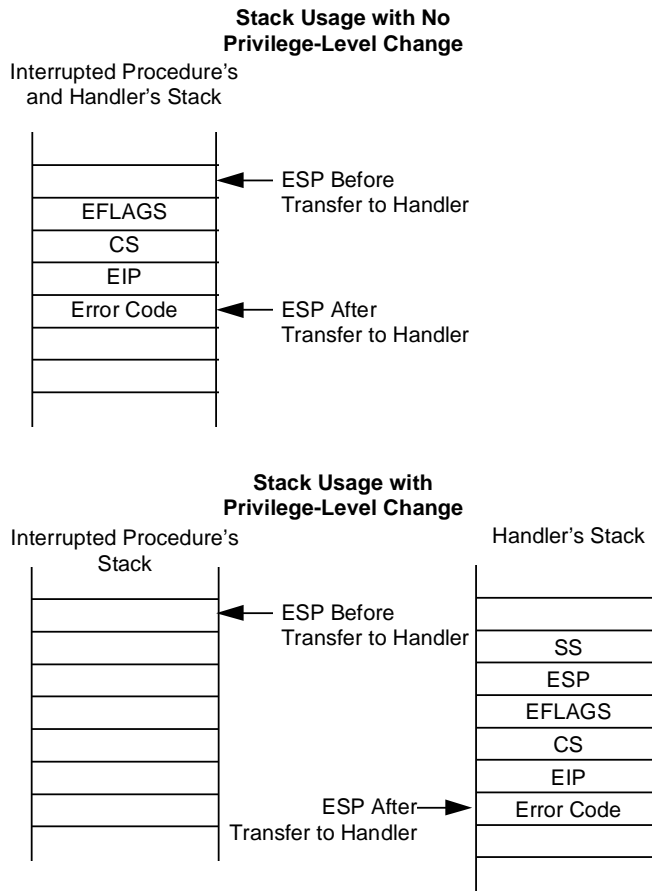
Figure 4-4. Stack Usage on Transfers to Interrupt and Exception Handling Routines

When executing a return from an interrupt or exception handler from a different privilege level than the interrupted procedure, the processor performs these actions:

1. Performs a privilege check.
2. Restores the CS and EIP registers to their values prior to the interrupt or exception.
3. Restores the EFLAGS register.
4. Restores the SS and ESP registers to their values prior to the interrupt or exception, resulting in a stack switch back to the stack of the interrupted procedure.
5. Resumes execution of the interrupted procedure.
